# Heritage Impact Assessment, Bridge 3-E Municipal Class Environmental Assessment, Township of Centre Wellington, Ontario

**Project Number:** 2024-0053

**Report Date:** August 19, 2024

**Parslow Heritage Consultancy Inc.**

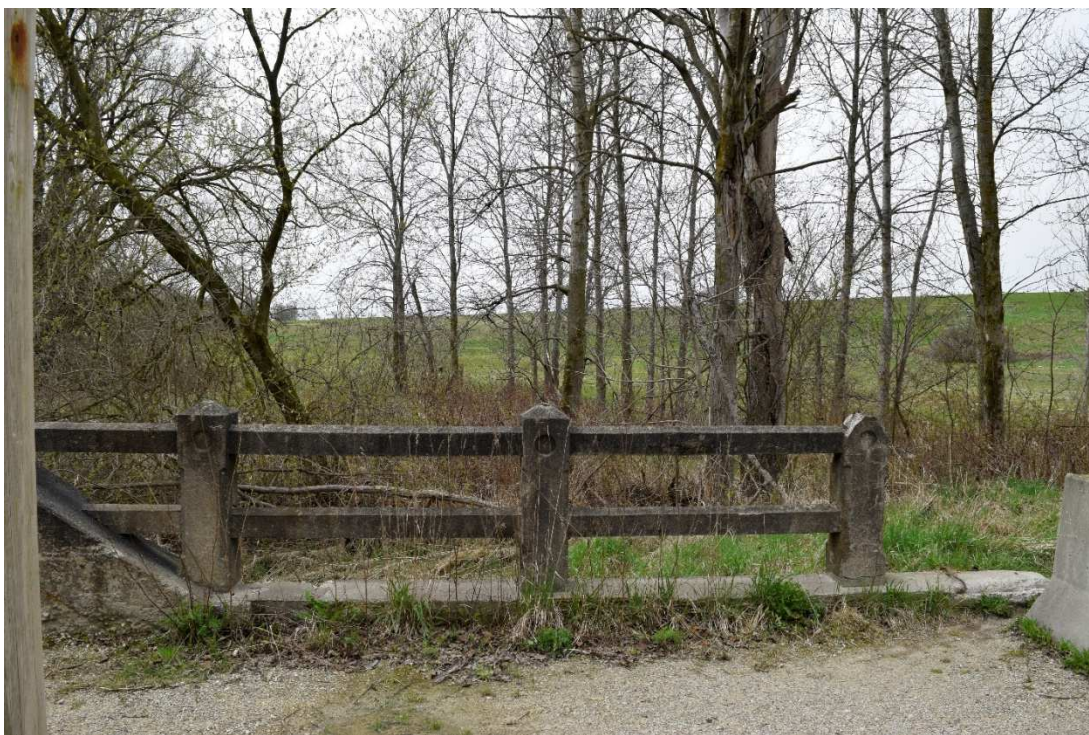
**FIGURE 4: BRIDGE 3-E, TYPICAL GUARDRAIL, SOUTH SIDE**

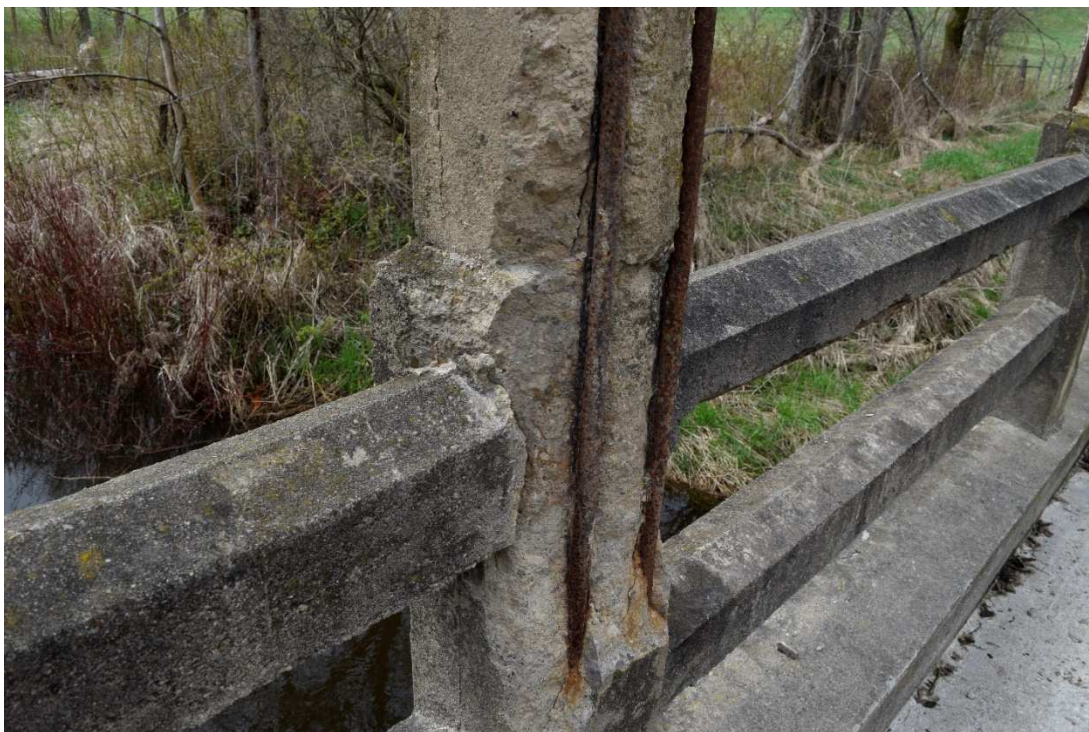
**FIGURE 7: BRIDGE 3-E, TYPICAL EXAMPLE OF DETERIORATION, EXAMPLE IS OF SUPERSTRUCTURE CENTRAL SUPPORT**

The bridge retains examples of all original finishes but exhibits significant degradation resulting in the exposure of the underlying square steel reinforcement bar. A single steel tie beam has been added to the upper limit of the arches, thereby imposing a height restriction to the structure that was not part of the original design.

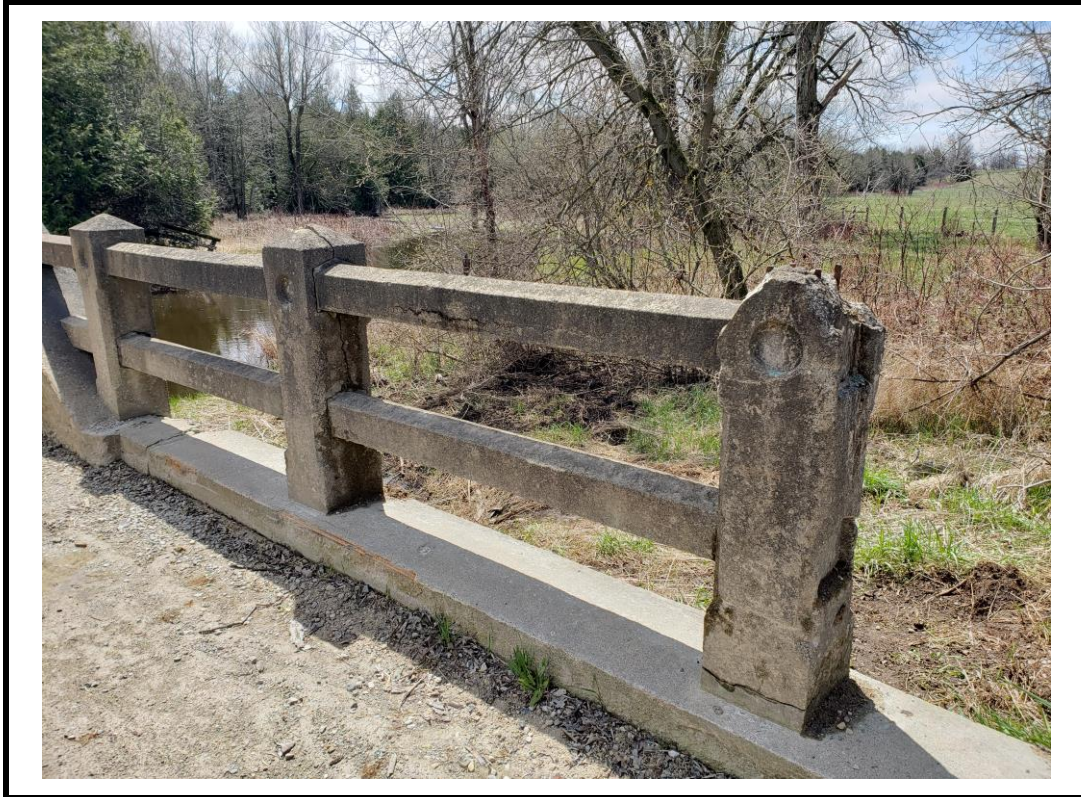
**Comments:**  
Two missing posts at southeast and southwest. Other posts exhibit wide cracks and spalls with exposed corroded reinforcement. Barrier is substandard and should be replaced with code compliant barrier. Localized moderate scaling and spalls noted throughout.

Photo 7 Concrete disintegration with exposed corroded rebar at northwest of deck barrier post

**Recommended Work:** Rehab ☐ Replace ☒  
Urgent ☐ 1-5 yrs ☒ 6-10 yrs ☐

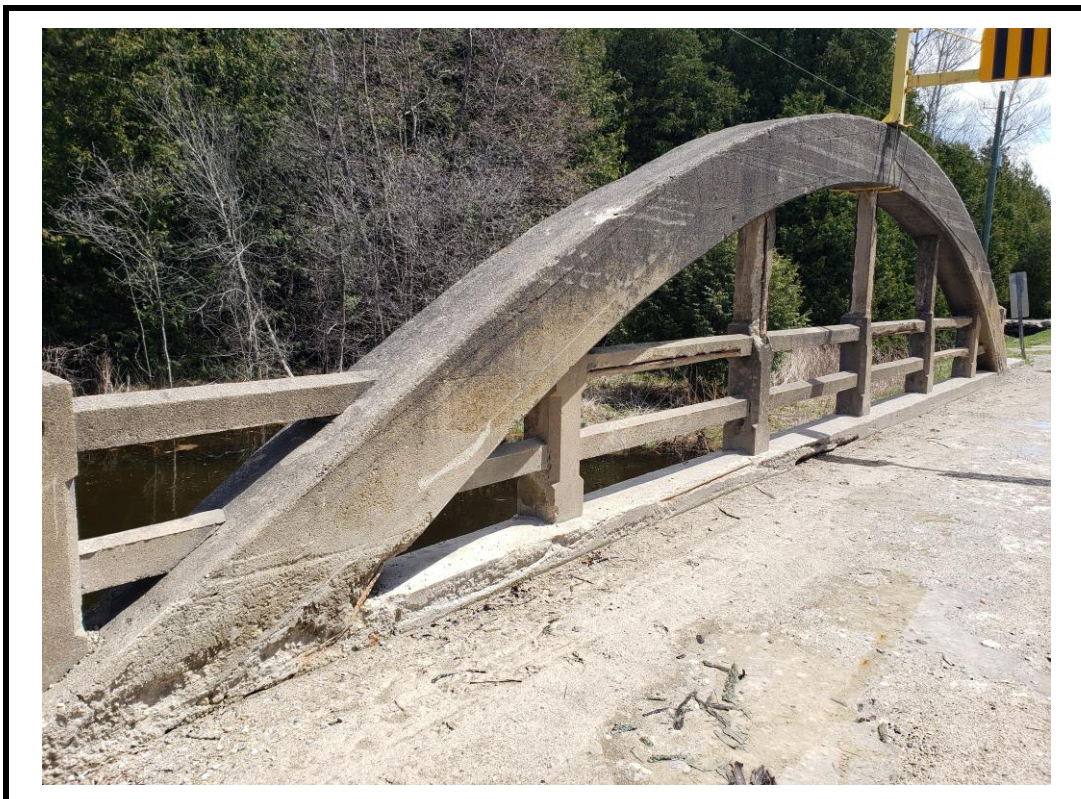
**Comments:**  
Numerous rails with wide cracks and spalls with exposed corroded reinforcement. Missing rails at south end. Barrier is substandard and should be replaced. Severe scaling also noted throughout.

Photo 8 Severe spalling with exposed corroded rebar at rail in deck barrier

**Recommended Work:** Rehab ☐ Replace ☒  
Urgent ☐ 1-5 yrs ☒ 6-10 yrs ☐

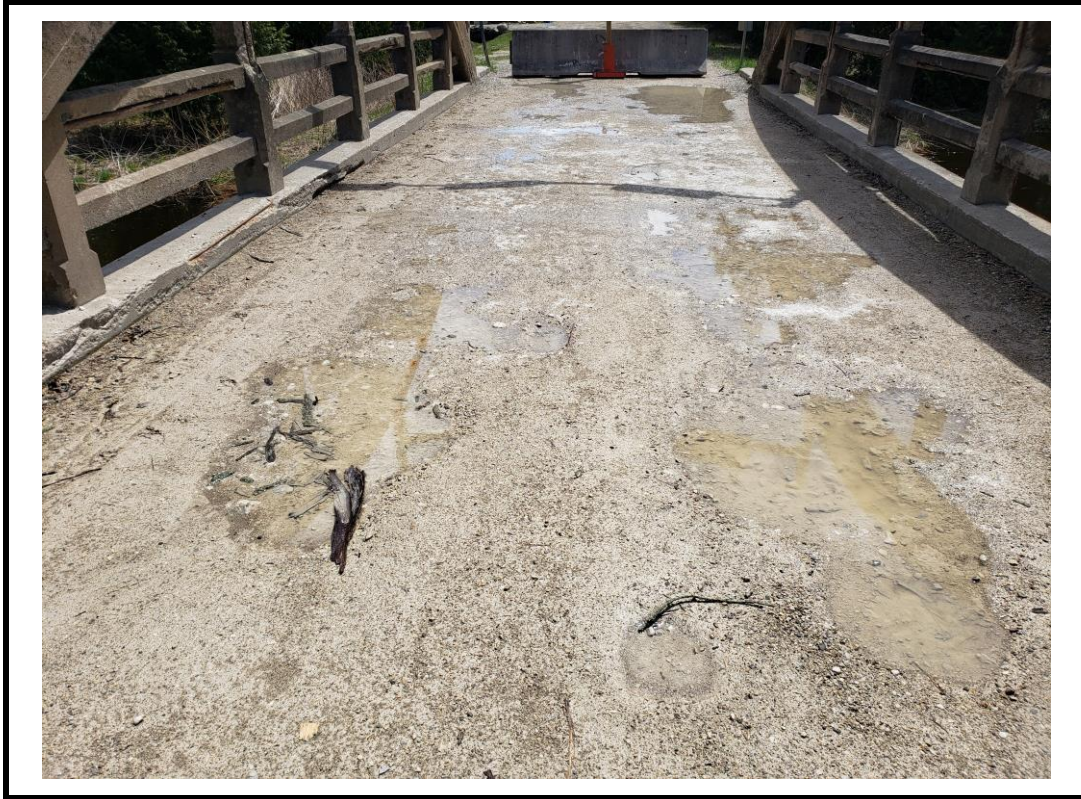
**Comments:**  
Moderate scaling and small spalls noted throughout. Deck partially covered in gravel. Severe concrete disintegration and spalls with exposed corroded reinforcement on bridge deck.

Photo 9 Spalls in exposed concrete deck top

**Recommended Work:** Rehab ☐ Replace ☒ Urgent ☐ 1-5 yrs ☒ 6-10 yrs ☐ Maint. Needs 02 Bridge Cleaning Urgent ☐ 1 year ☒

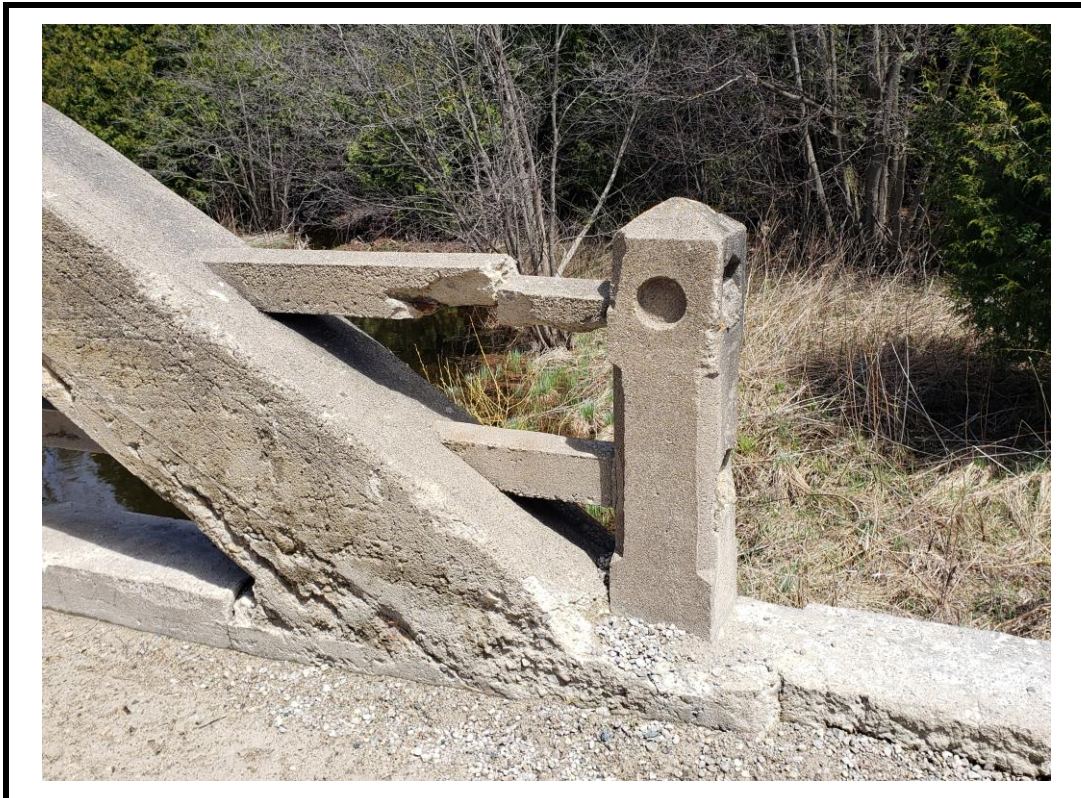
Photo 10 Spall with exposed corroded rebar and sheared railing in deck barrier at southeast corner

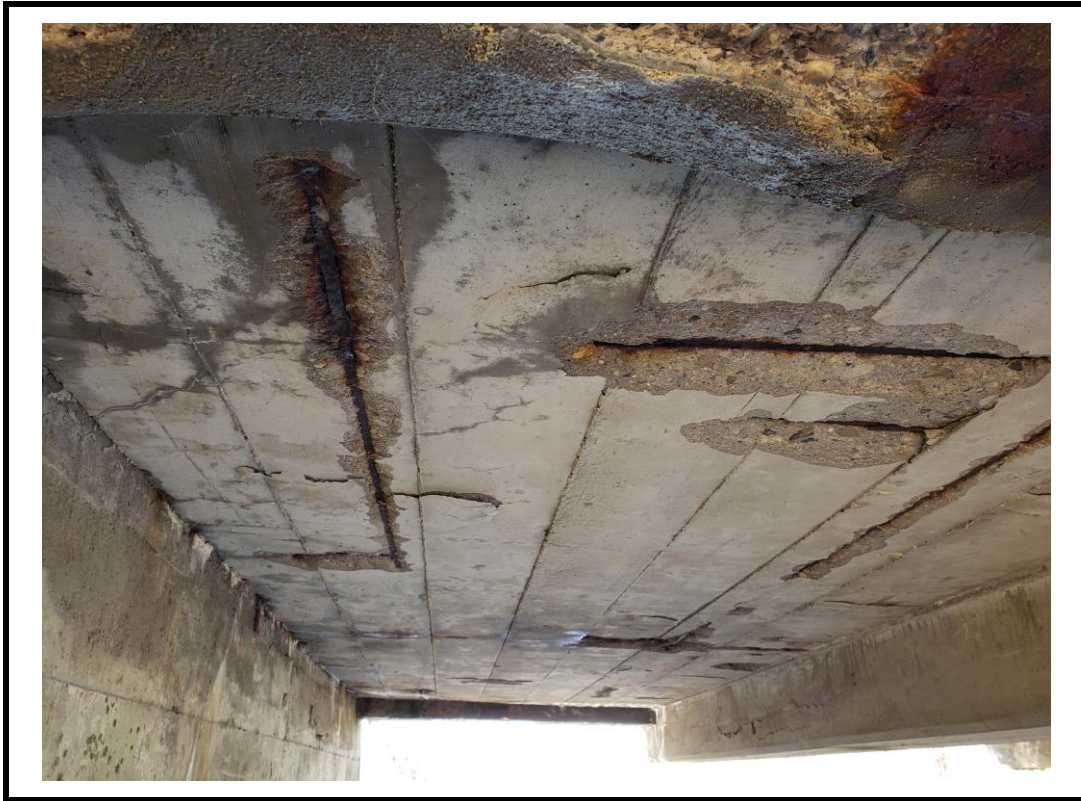
**Comments:**  
Numerous damp stains, medium & wide cracks, medium & large delaminations, and medium & large spalls with exposed corroded reinforcement noted throughout.

Photo 11 Spalls with exposed corroded rebar and delamination at soffit

**Recommended Work:** Rehab ☐ Replace ☒ Urgent ☐ 1-5 yrs ☒ 6-10 yrs ☐ Maint. Needs - - Urgent ☐ 1 year ☐

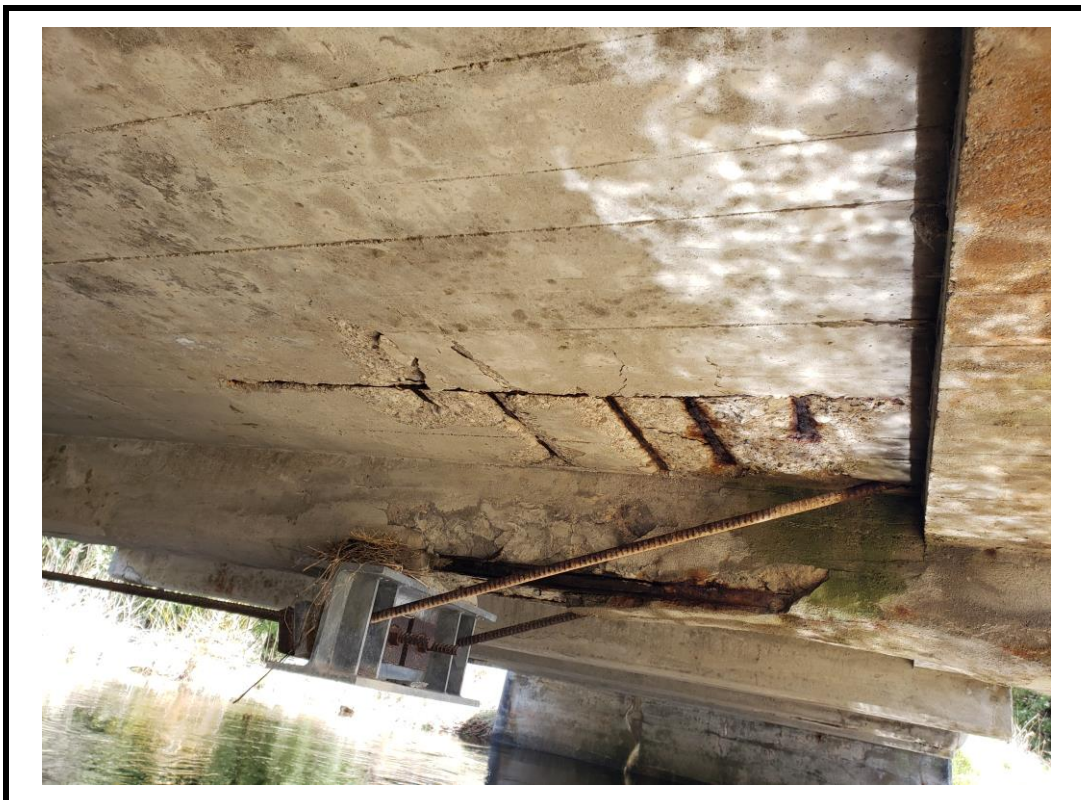
**Comments:**  
Medium and wide horizontal cracks, large delaminations, and medium to severe spalls with exposed corroded reinforcement noted throughout. Concrete patchwork noted at some beam ends. One beam has been externally post tensioned.

Photo 12 Large spalls with exposed corroder reinforcement at underside of floor beams and post tensioning system

**Recommended Work:** Rehab ☐ Replace ☒ Urgent ☐ 1-5 yrs ☒ 6-10 yrs ☐ Maint. Needs - - Urgent ☐ 1 year ☐

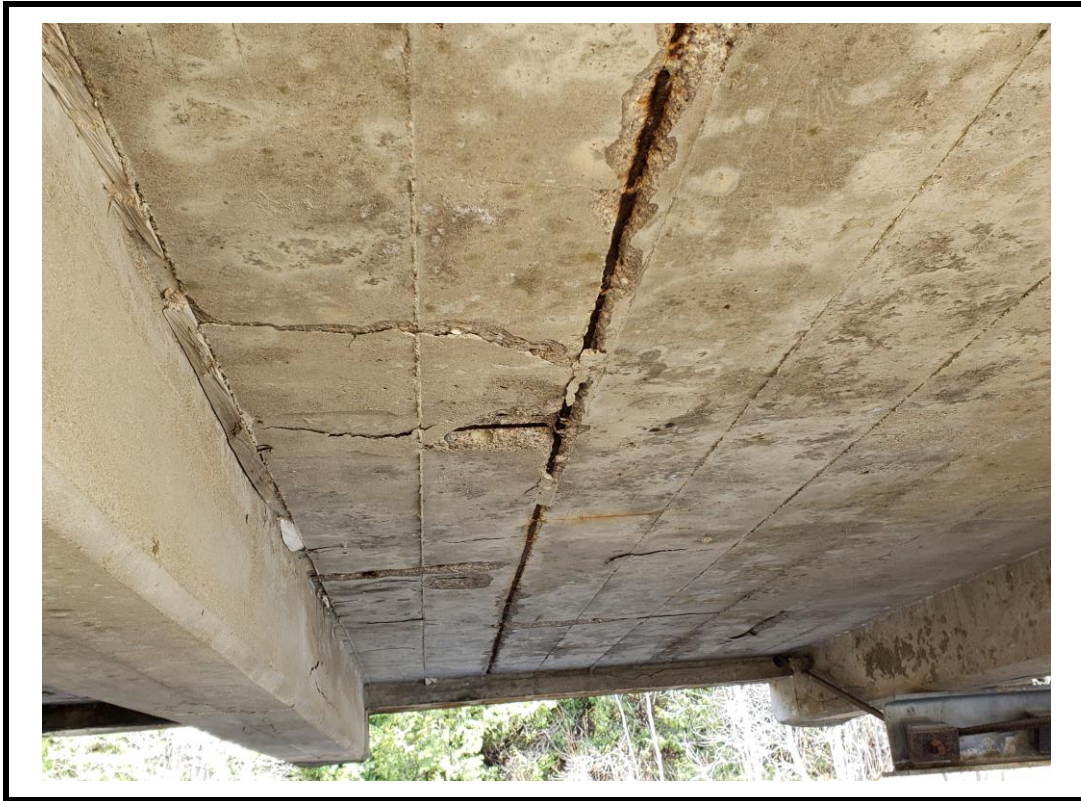
Photo 13 Large spalls with exposed corroded rebar noted at soffit in between girders

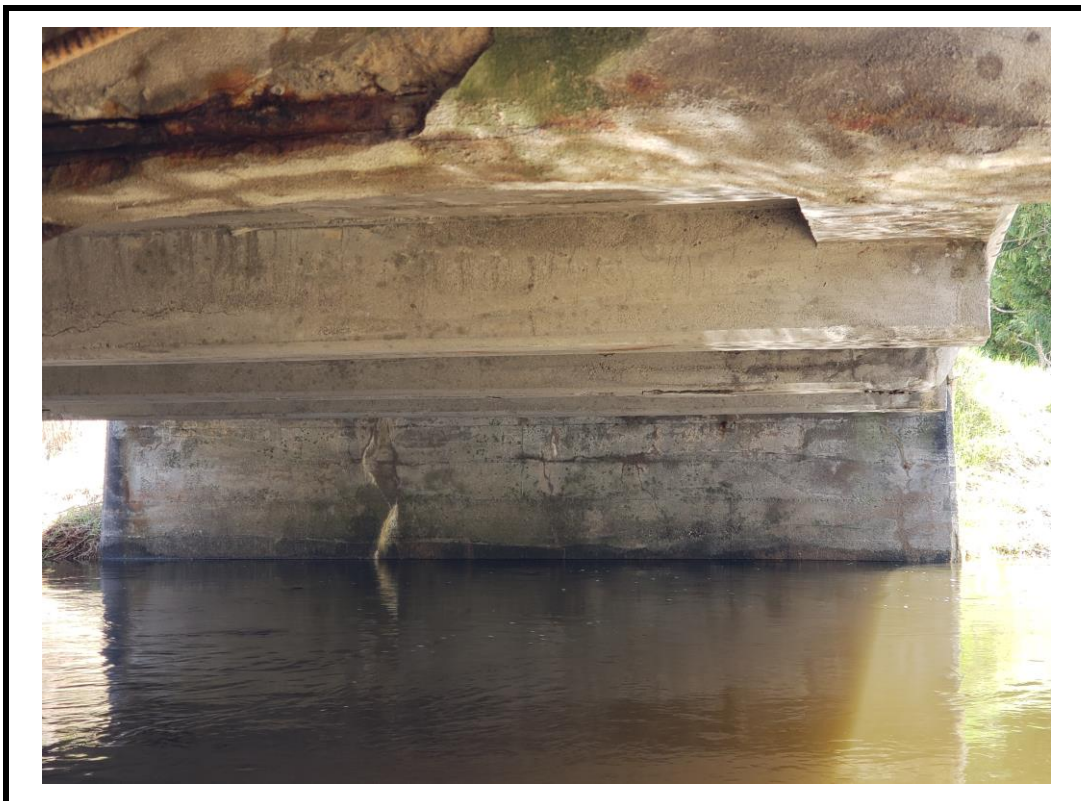
**Comments:**  
Light to moderate scaling at water level. Medium diagonal crack at upper northwest corner of north abutment wall. Medium vertical cracks with heavy efflorescence noted at south abutment wall.

Photo 14 Moderate erosion and scaling were noted at and below the waterline on north abutment wall

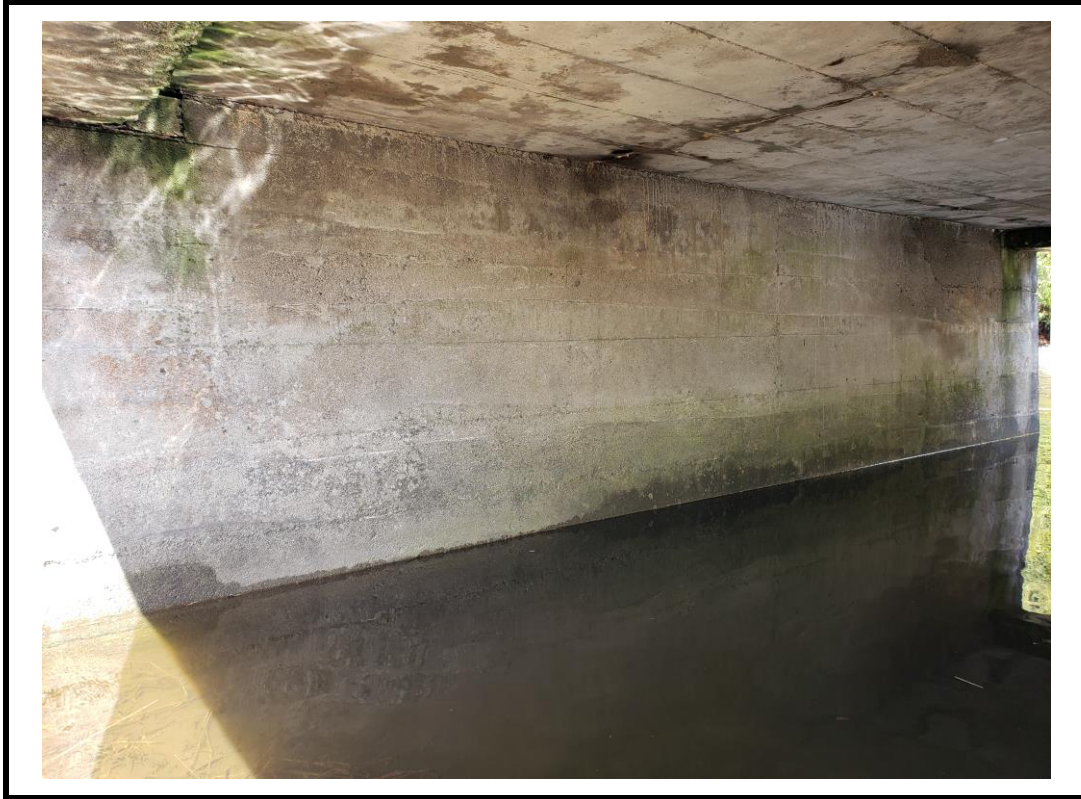
Photo 15 Moderate erosion and scaling were noted at and below the waterline on south abutment wall

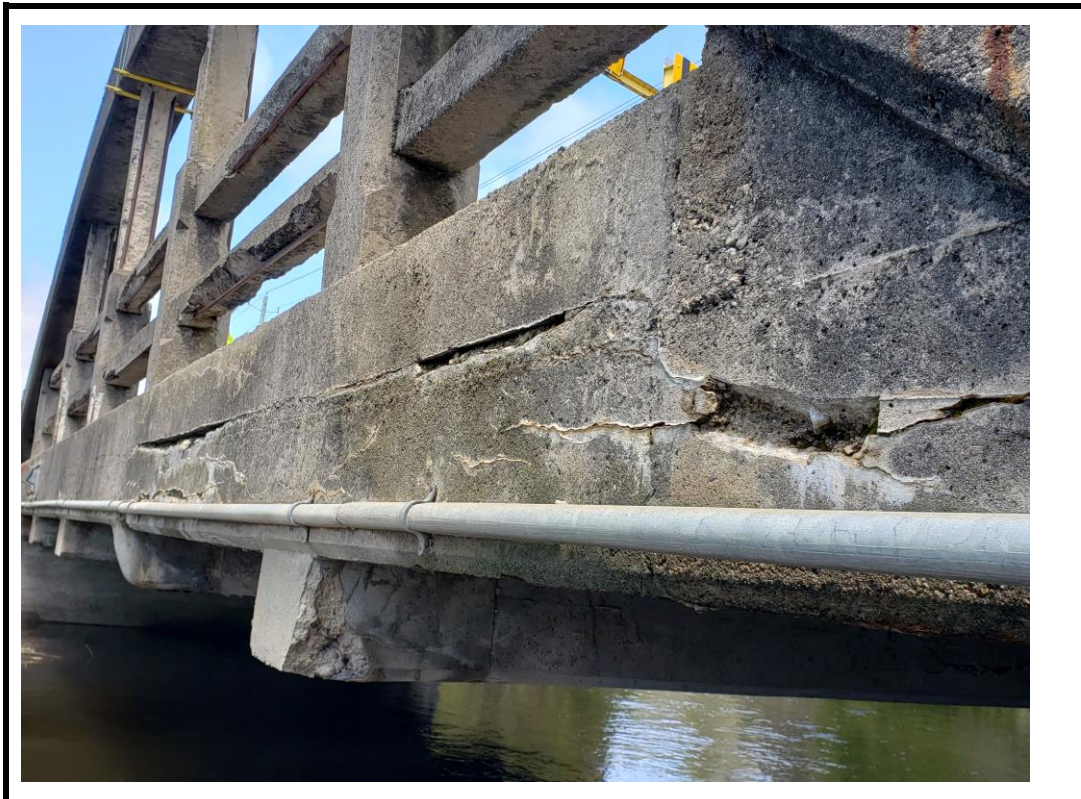
Photo 16 Wide cracks noted at underside of west chord near south end
