# Cultural Heritage Evaluation Report, Municipal Class Environmental Assessment, Bridges 2-WG, 3-E, 5-E and 7-E, Township of Centre Wellington, Ontario

**Project Number:** 2024-0053

**Report Date:** August 19, 2024

**Parslow Heritage Consultancy Inc.**

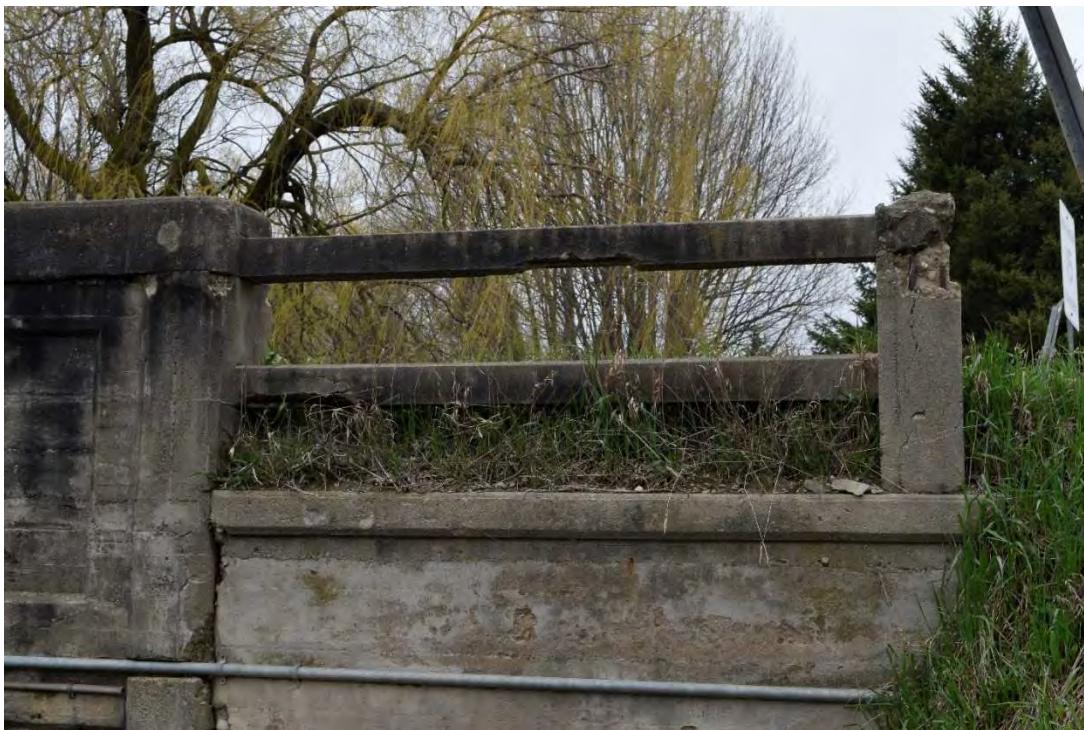
**FIGURE 6: BRIDGE 2-WG, CLOSE UP OF TYPICAL GUARD RAIL DEGRADATION**

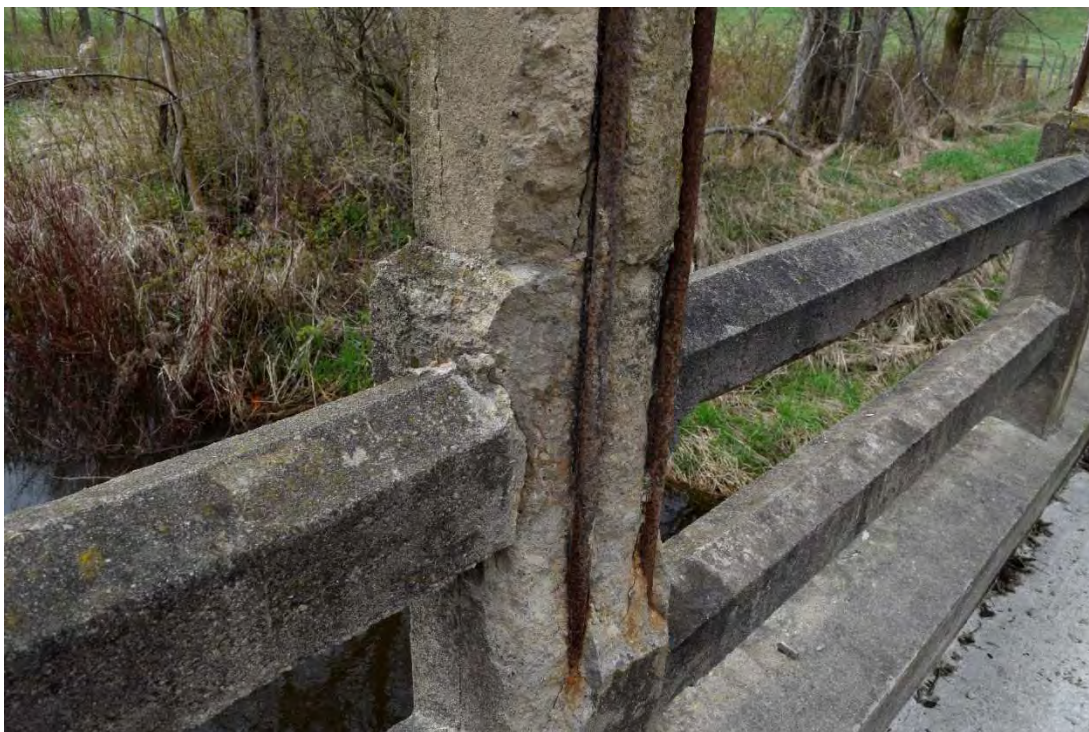
**FIGURE 16: BRIDGE 3-E, TYPICAL EXAMPLE OF DETERIORATION, EXAMPLE IS OF SUPERSTRUCTURE CENTRAL SUPPORT**

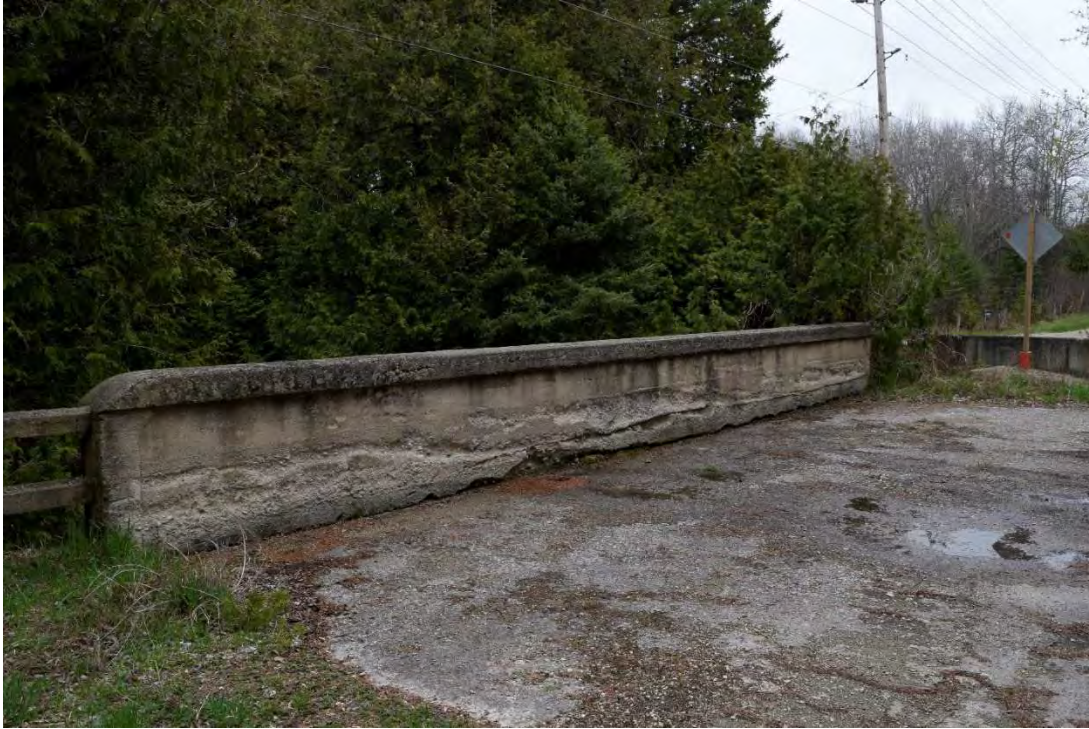
**FIGURE 23: EAST SIDE OF BRIDGE 5-E SHOWING DEGRADATION OF CONCRETE**

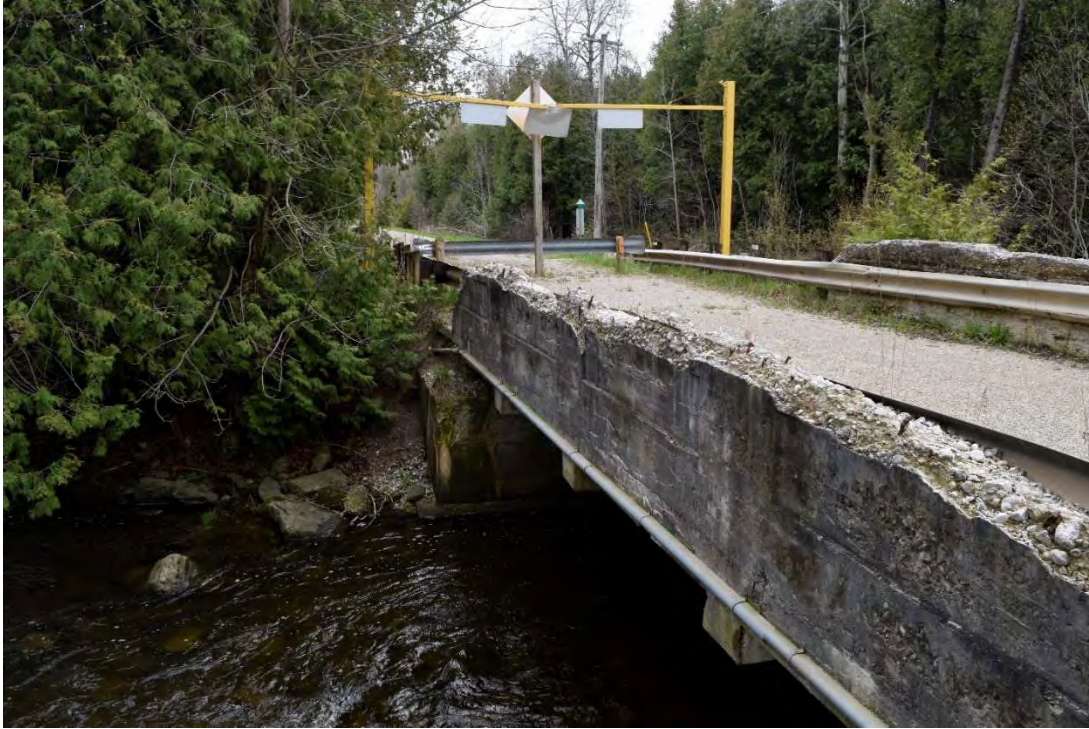
**FIGURE 25: BRIDGE 7-E, DETERIORATED UPPER SUPPORT WALLS OF EAST SIDE OF STRUCTURE**

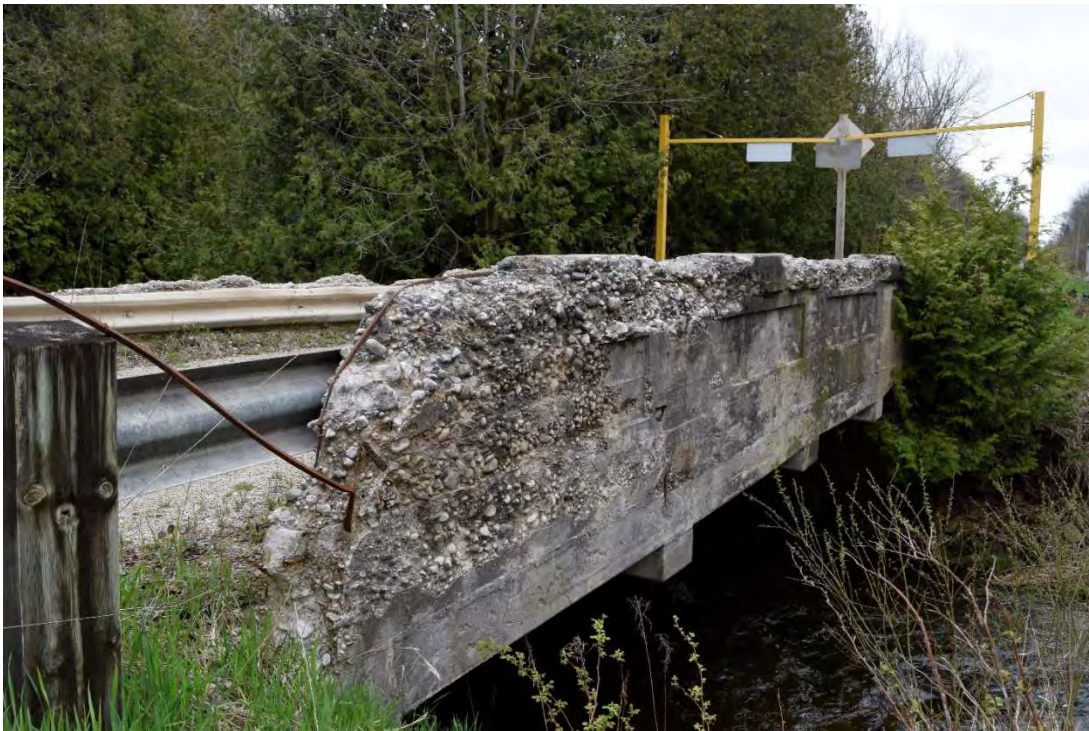
**FIGURE 26: BRIDGE 7-E, DETERIORATED UPPER SUPPORT WALLS, WEST SIDE OF STRUCTURE**

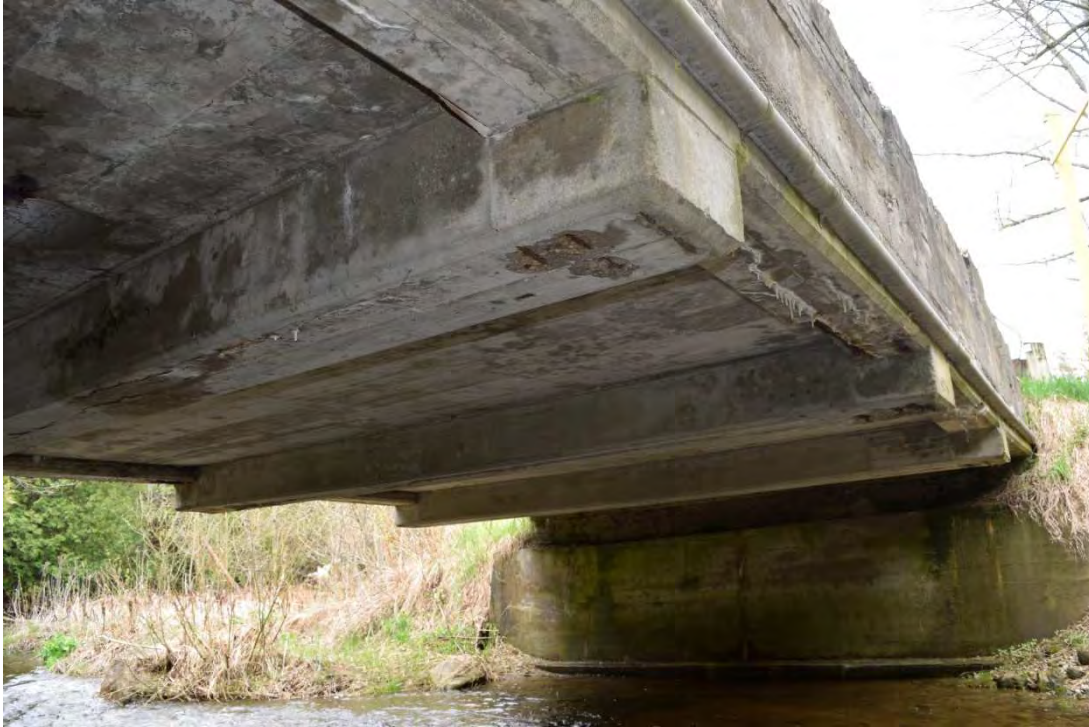
**FIGURE 29: BRIDGE 7-E, EVIDENCE OF PAST RECONDITIONING OF THE BRIDGE, WHICH IS SHOWING SIGNS OF DEGRADATION**

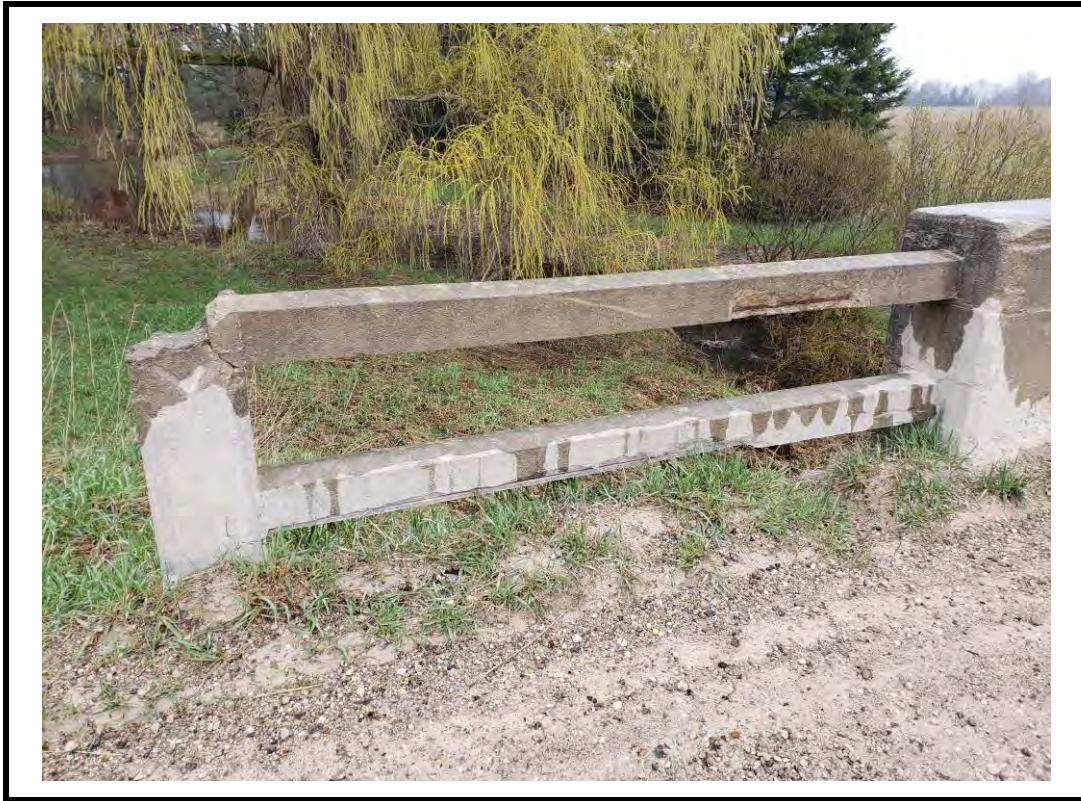
Photo 7 Spalls with exposed corroded reinforcement noted on approach barrier

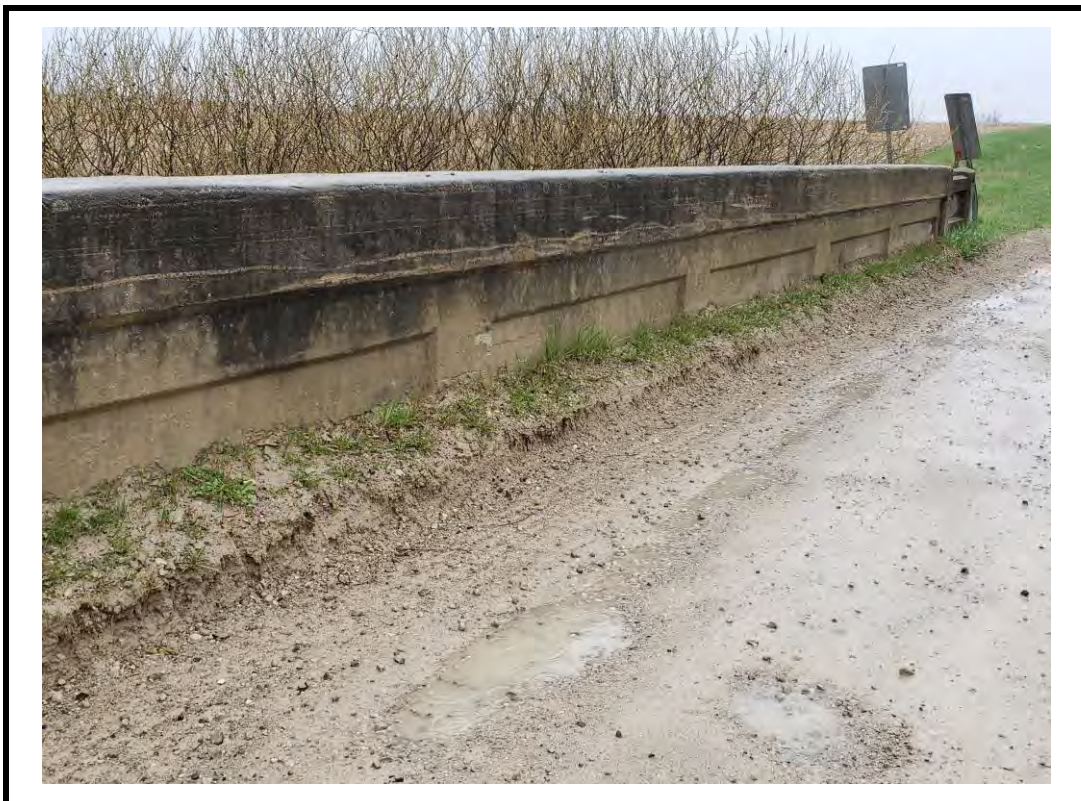
Photo 8 Disintegration with small spalls noted on east parapet wall

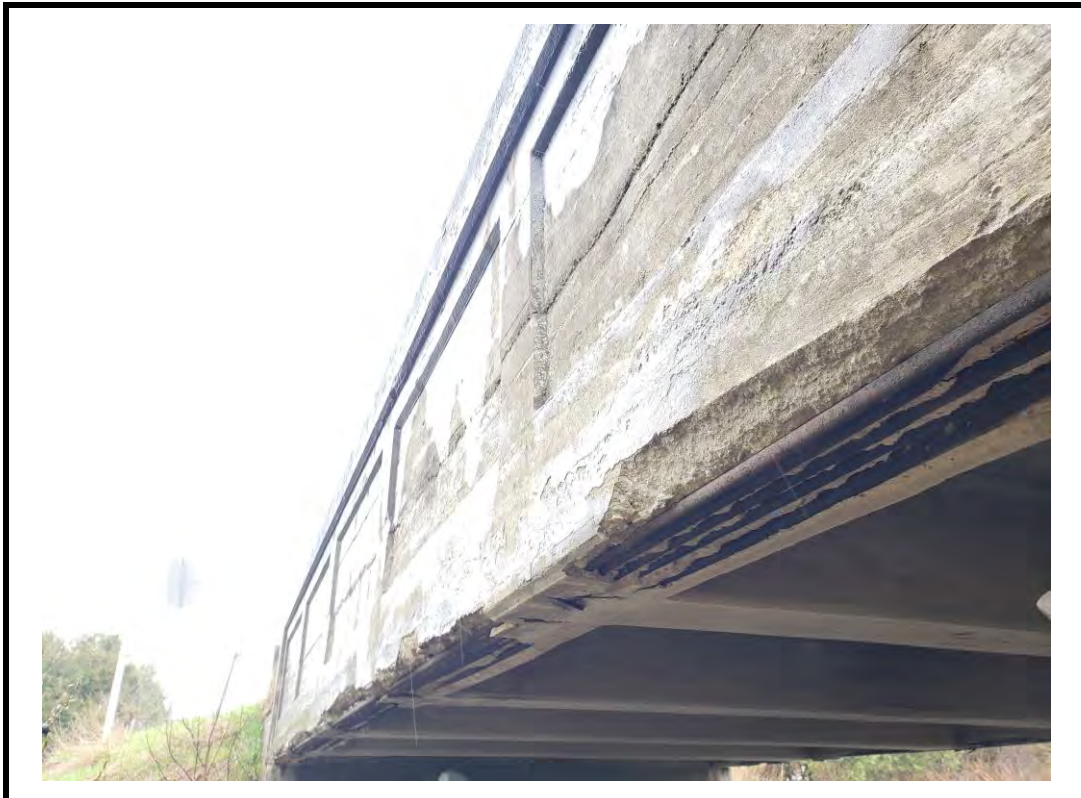
Photo 10 Severe scaling, damp stains and spalls with exposed corroded reinforcement noted on exterior parapet wall

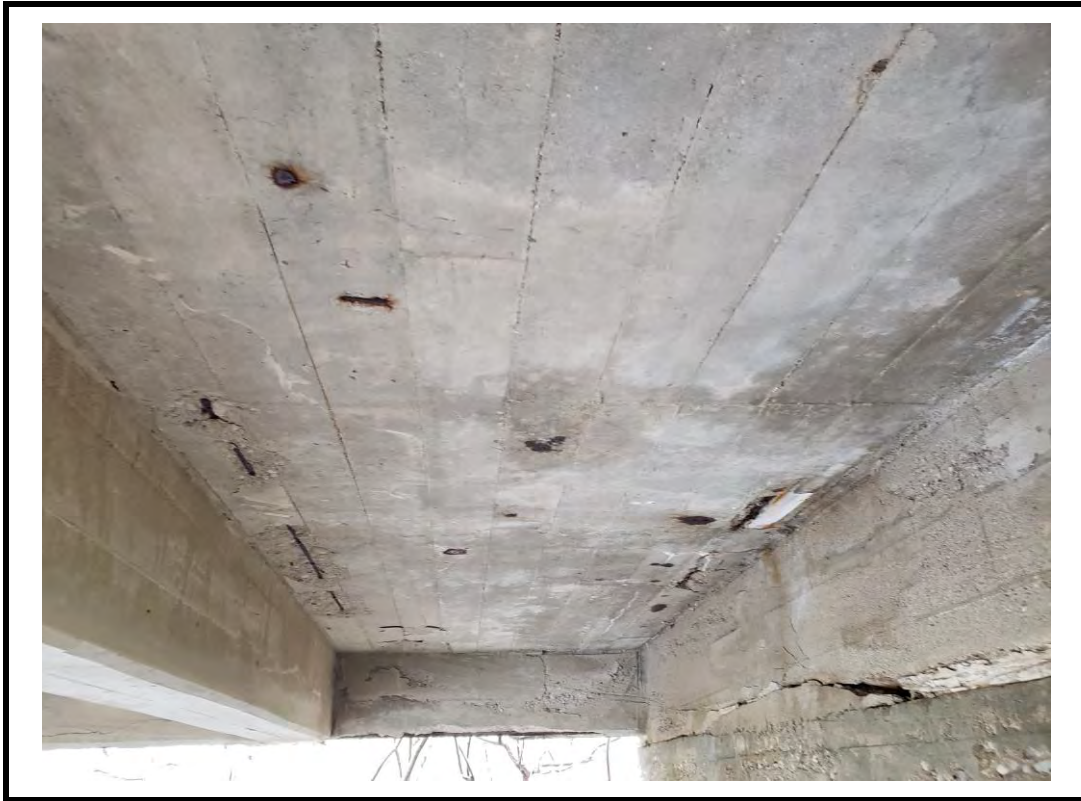
Photo 11 Medium horizontal cracks with delamination with exposed corroded reinforcement noted at soffit

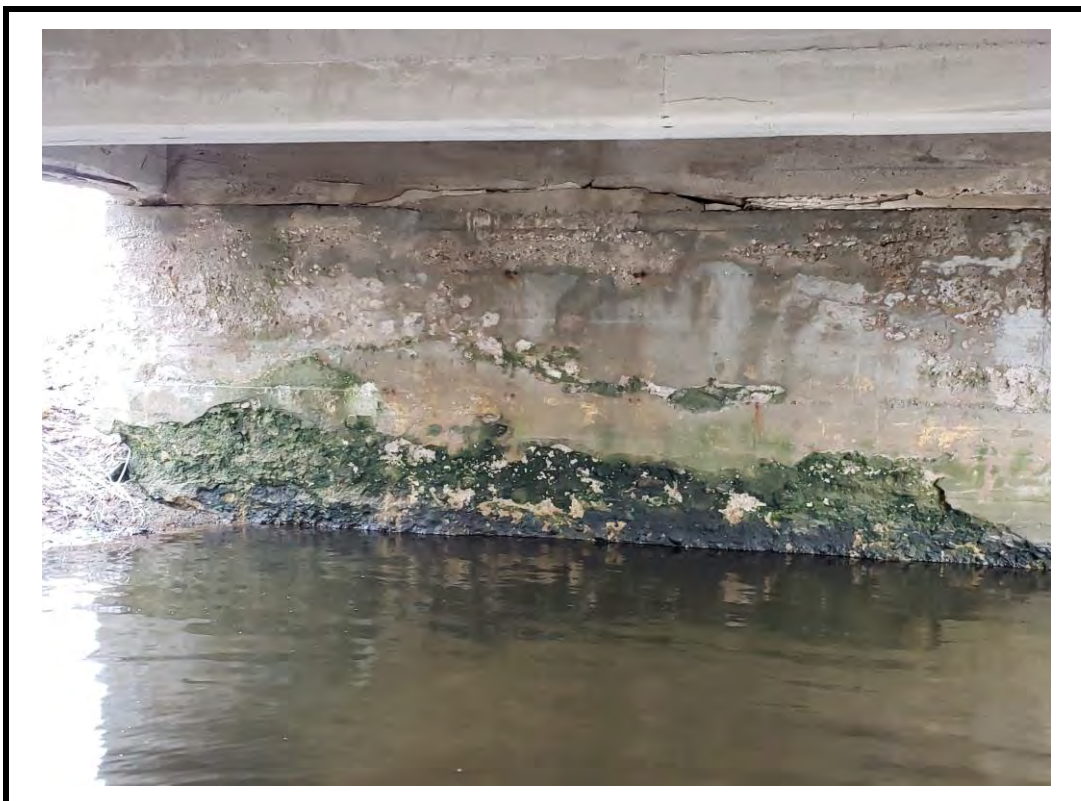
Photo 12 Sever scaling and erosion with horizontal cracks noted on north abutment wall

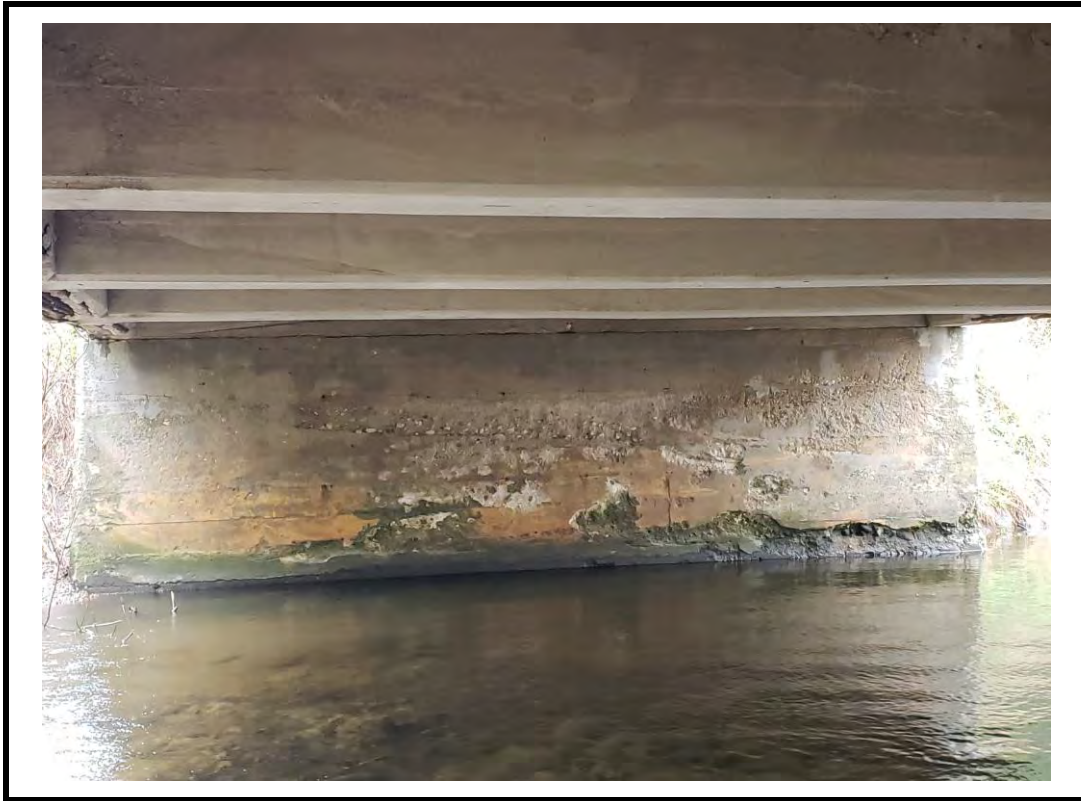
Photo 13 Severe spalls with concrete disintegration noted on south abutment wall

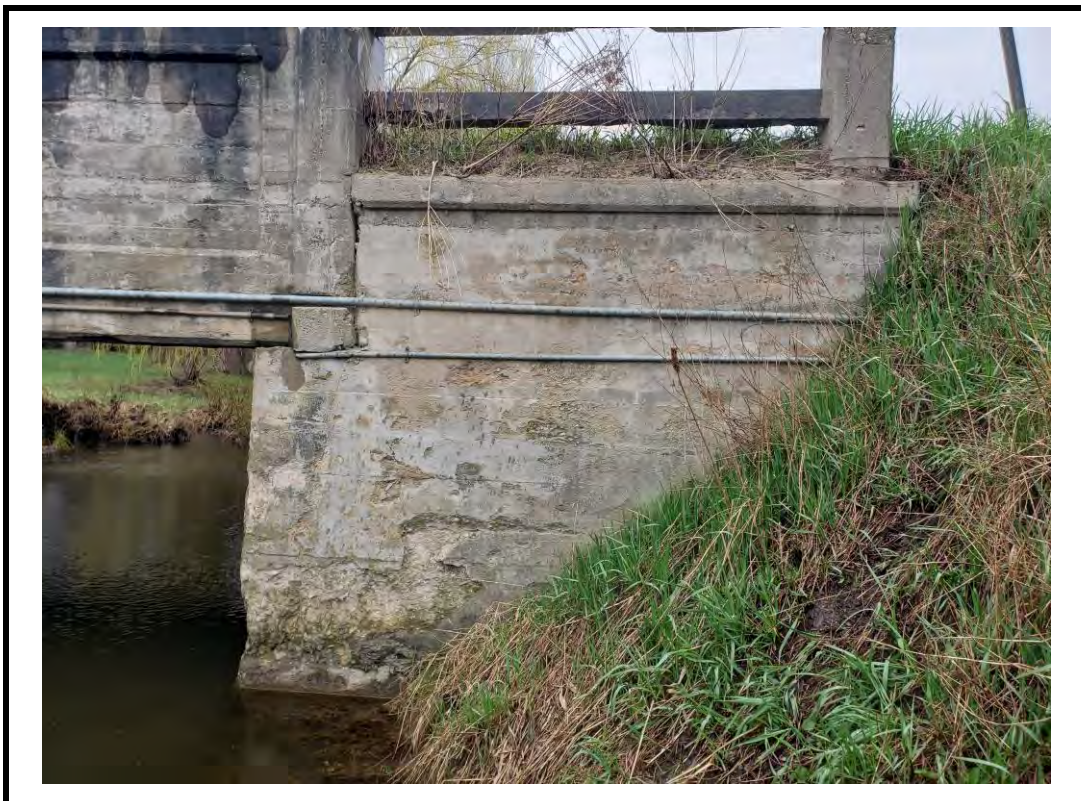
Photo 14 Concrete disintegration and spalls observed on wingwalls

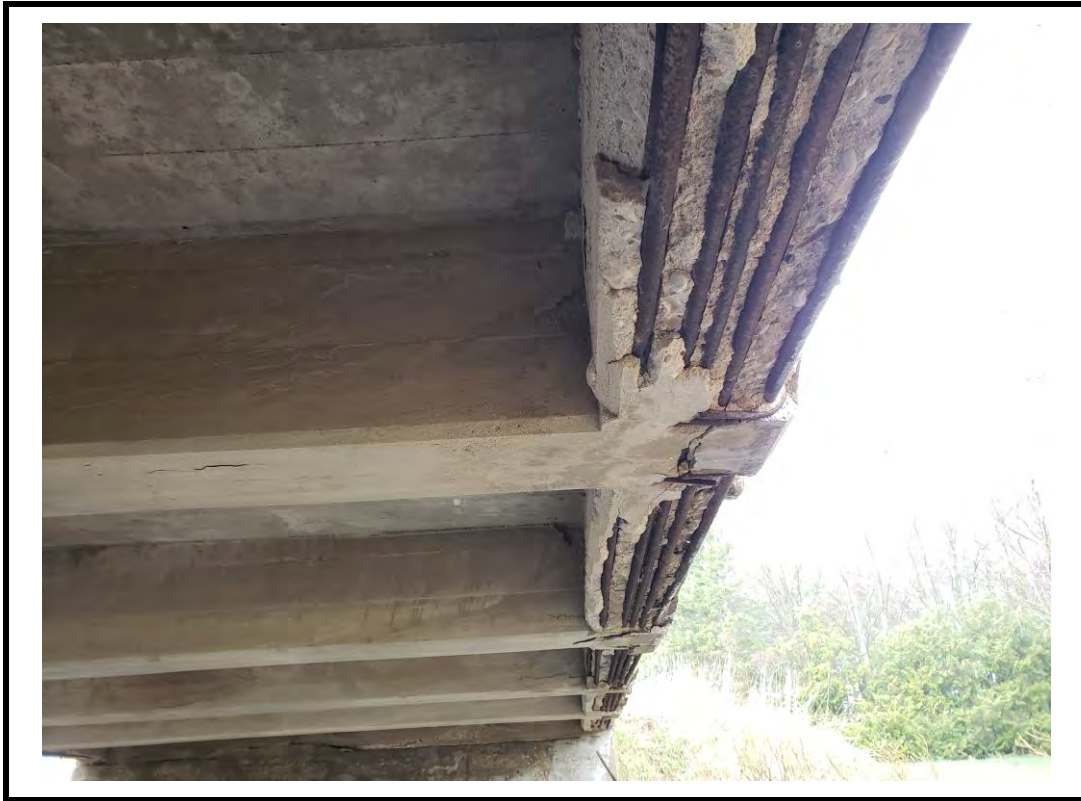
Photo 15      Sever spalling with exposed corroded reinforcement noted over the full length of west exterior beams

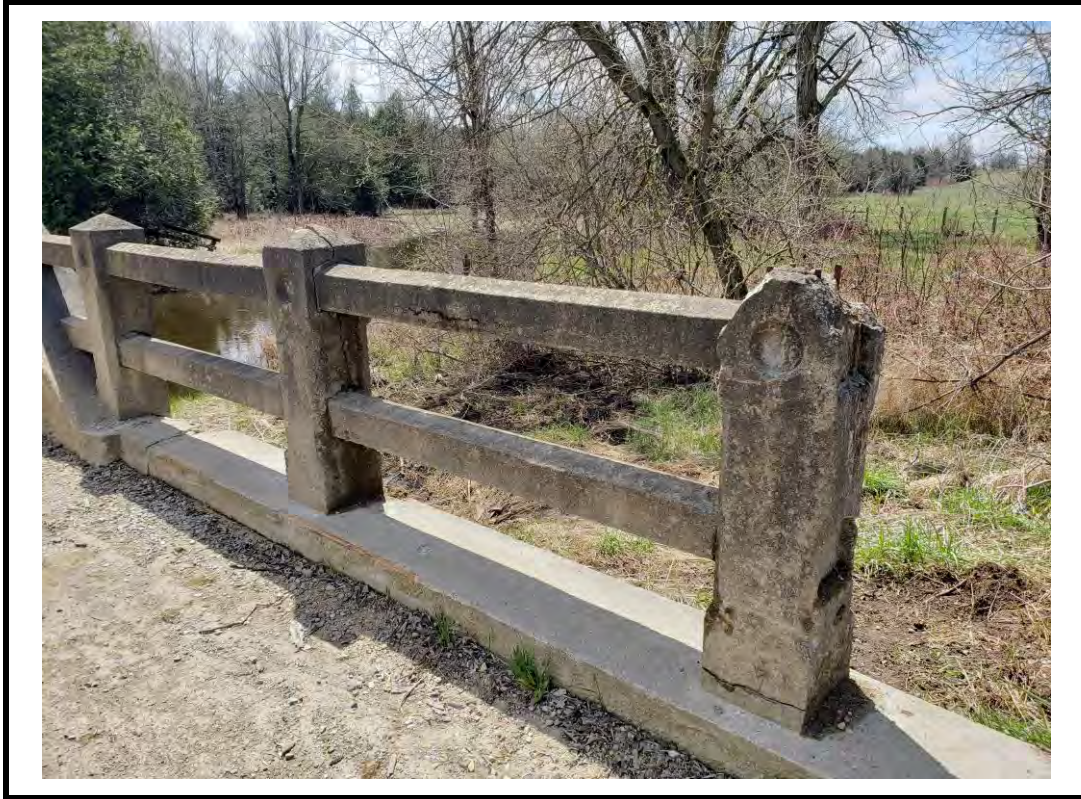
Photo 7 Concrete disintegration with exposed corroded rebar at northwest of deck barrier post

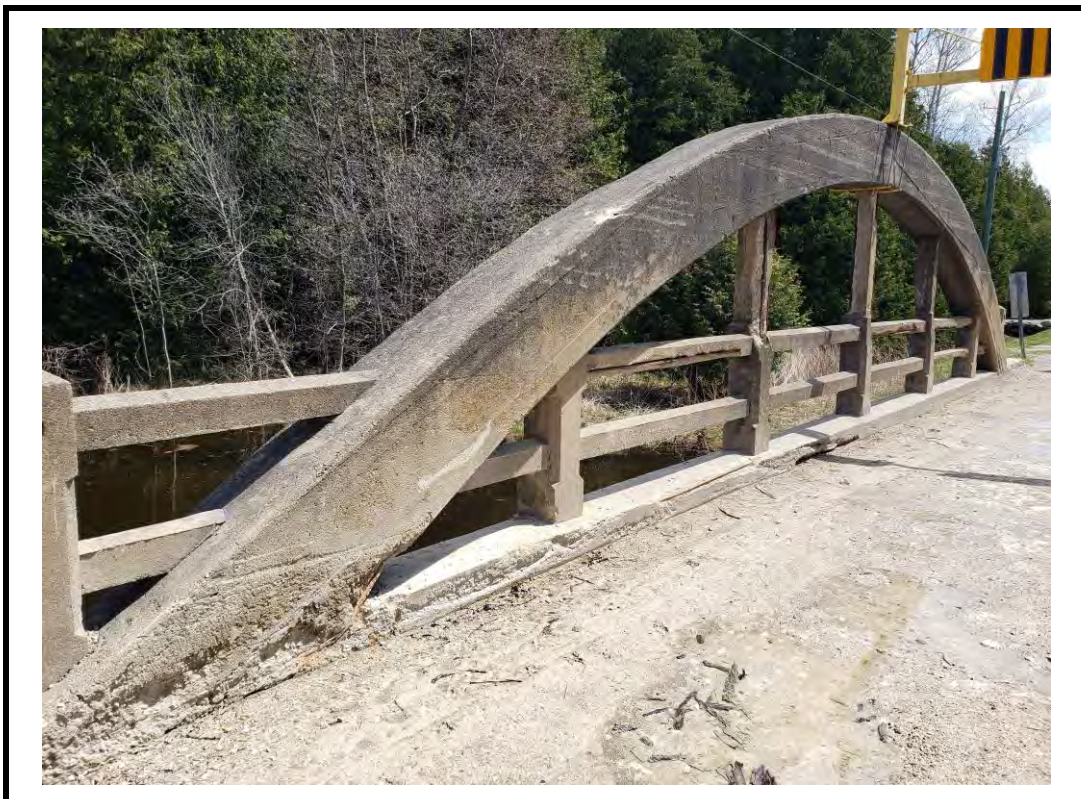
Photo 8 Severe spalling with exposed corroded rebar at rail in deck barrier

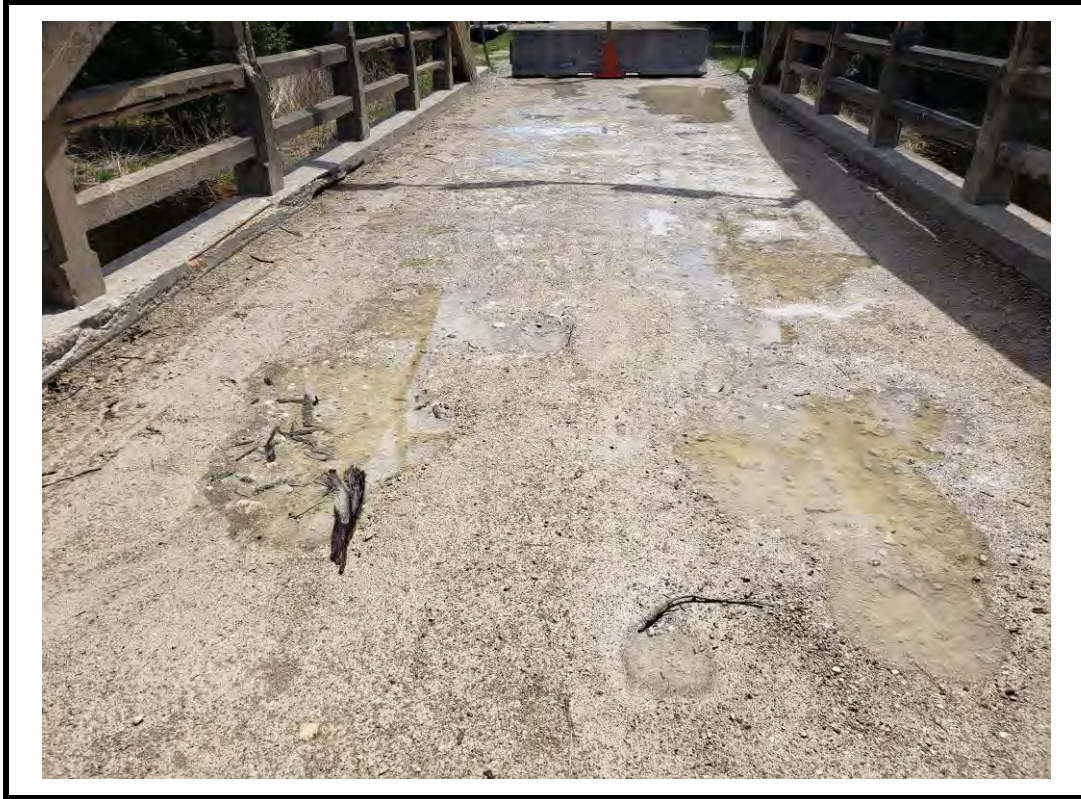
Photo 9 Spalls in exposed concrete deck top

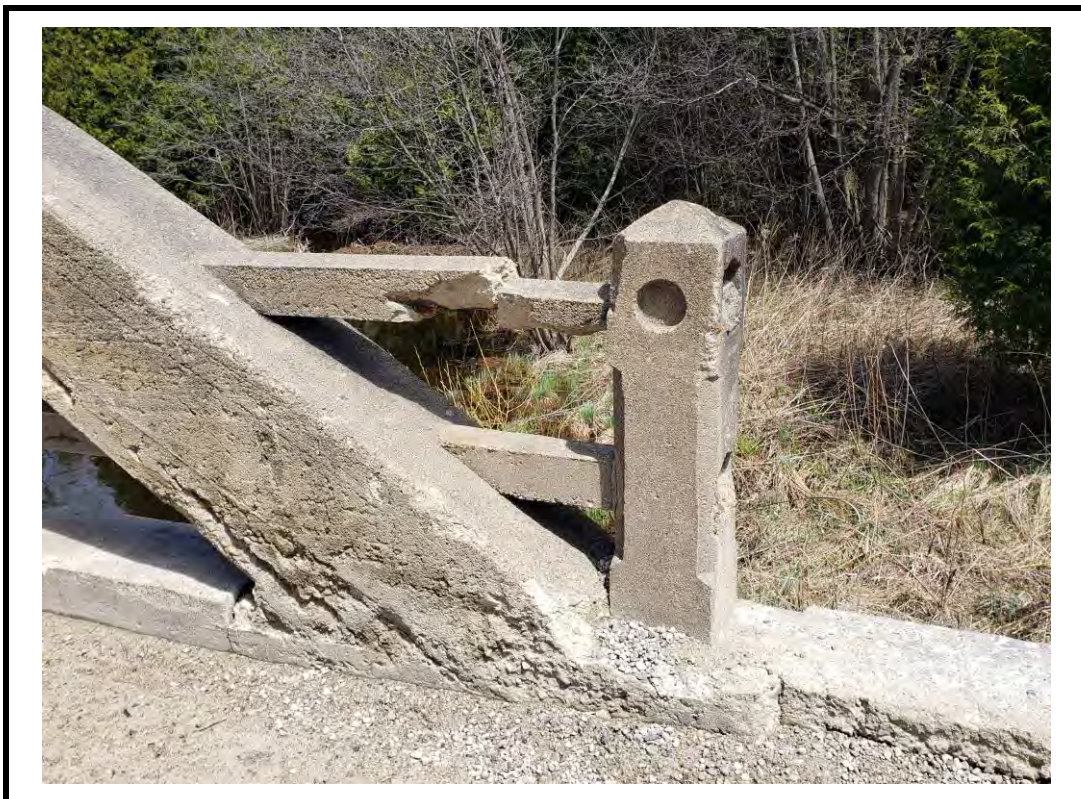
Photo 10 Spall with exposed corroded rebar and sheared railing in deck barrier at southeast corner

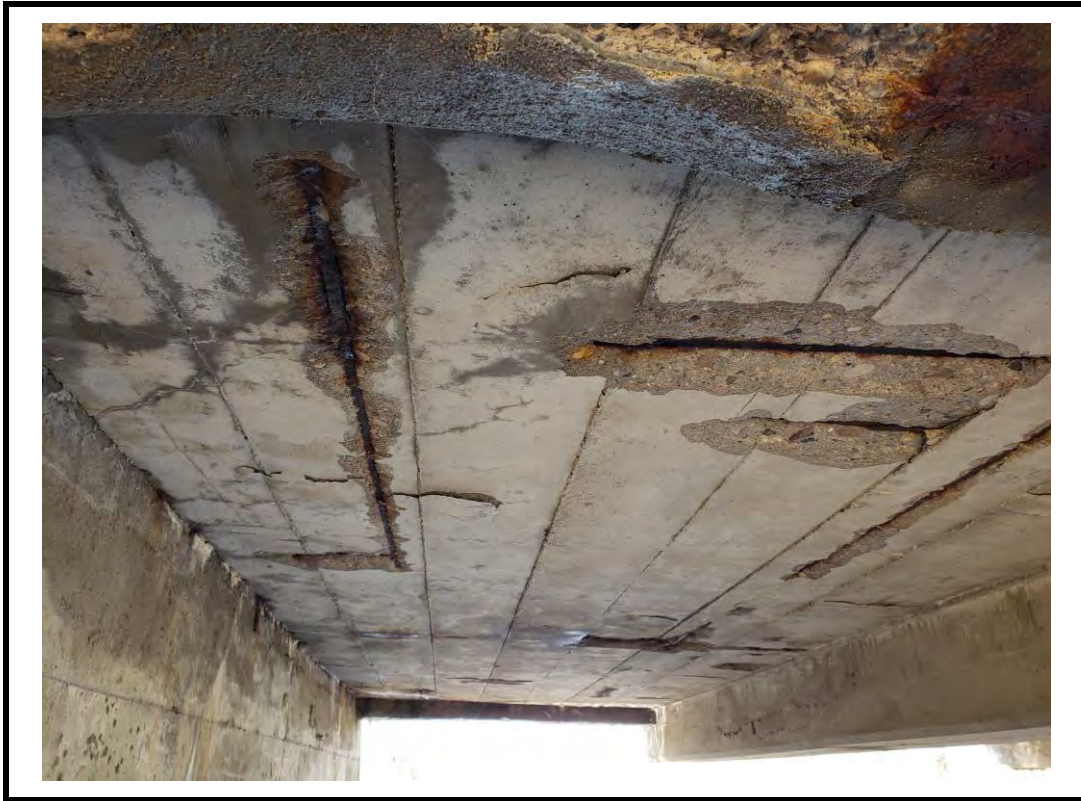
Photo 11 Spalls with exposed corroded rebar and delamination at soffit

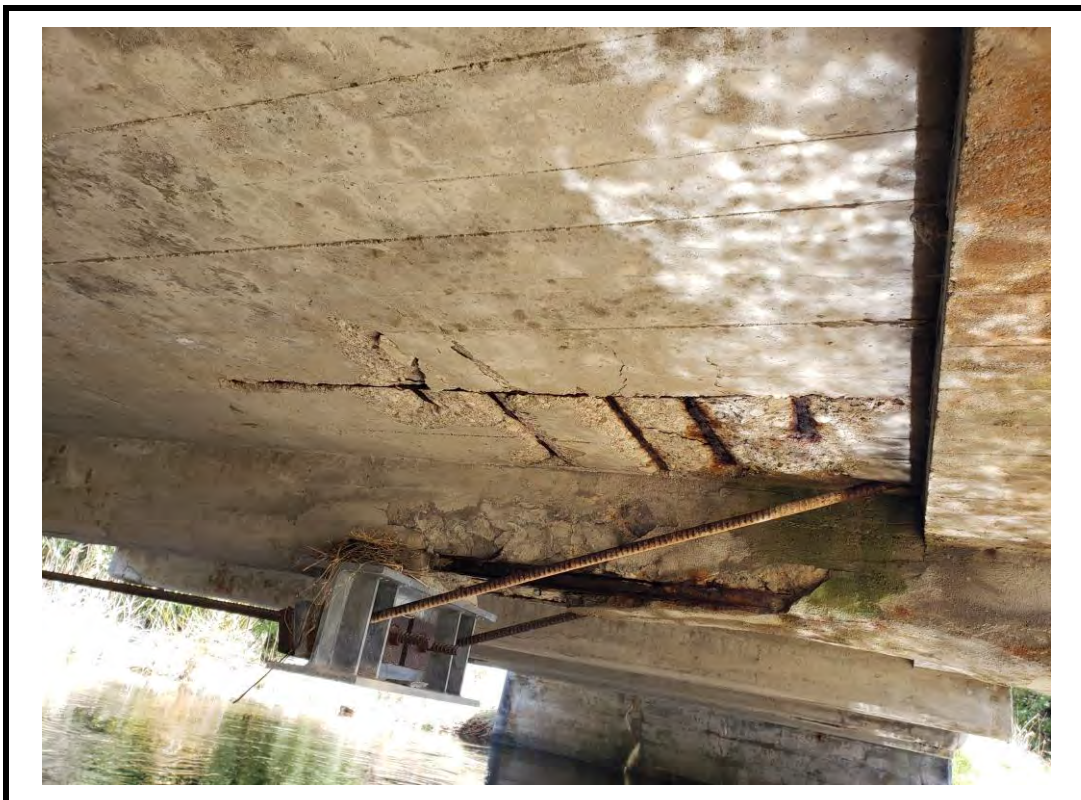
Photo 12 Large spalls with exposed corroder reinforcement at underside of floor beams and post tensioning system

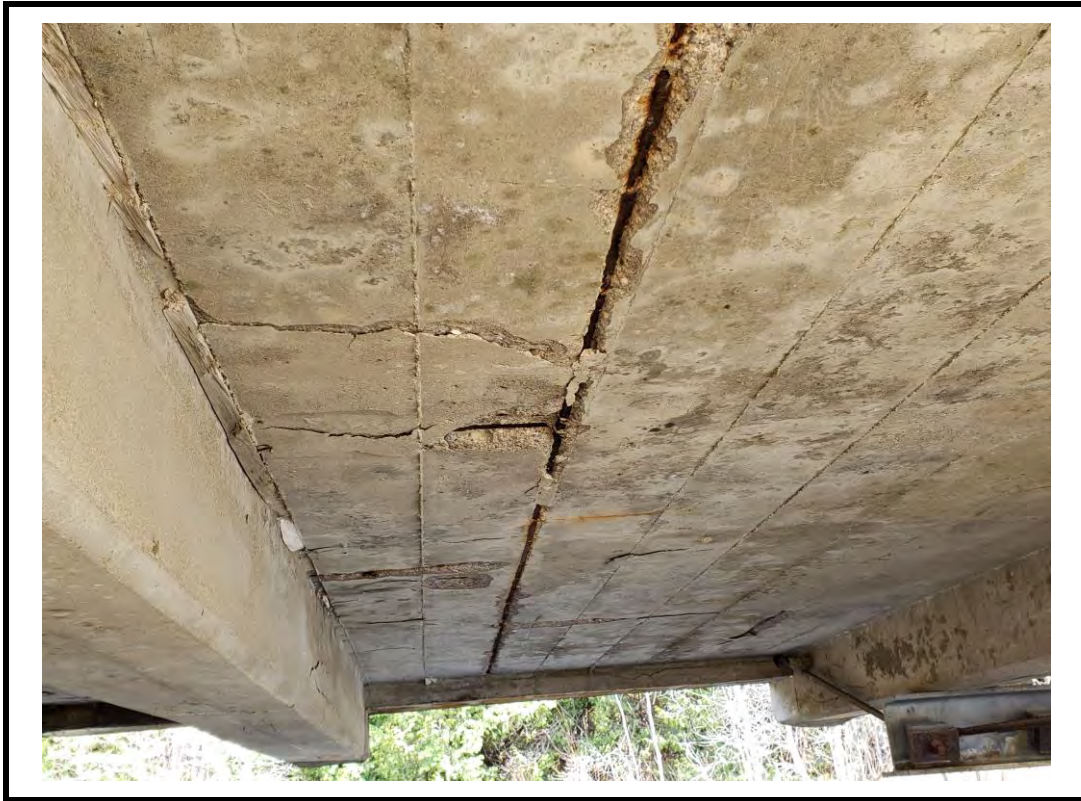
Photo 13 Large spalls with exposed corroded rebar noted at soffit in between girders

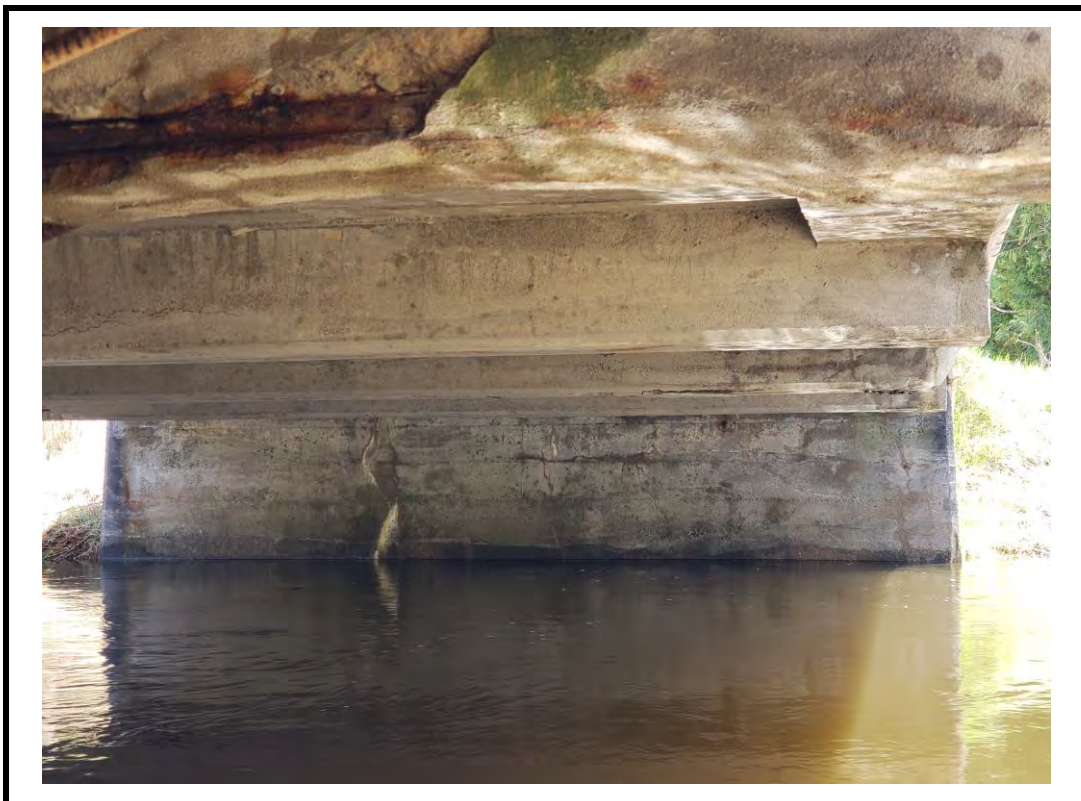
Photo 14 Moderate erosion and scaling were noted at and below the waterline on north abutment wall

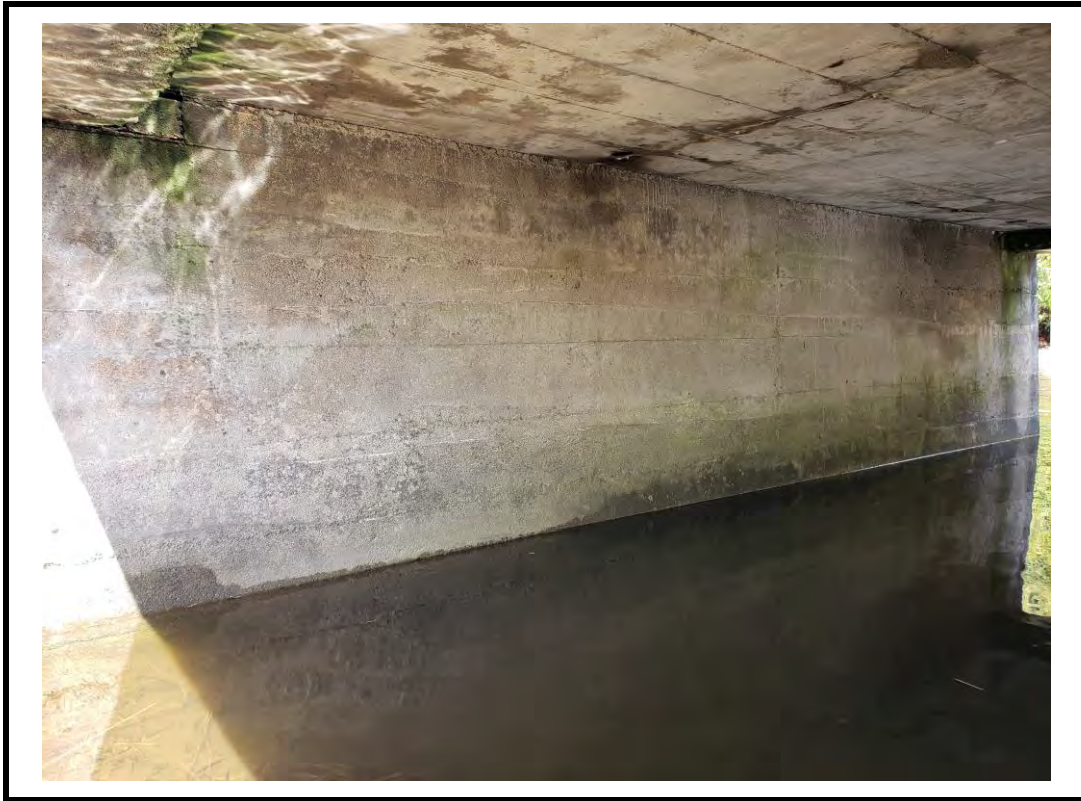
Photo 15 Moderate erosion and scaling were noted at and below the waterline on south abutment wall

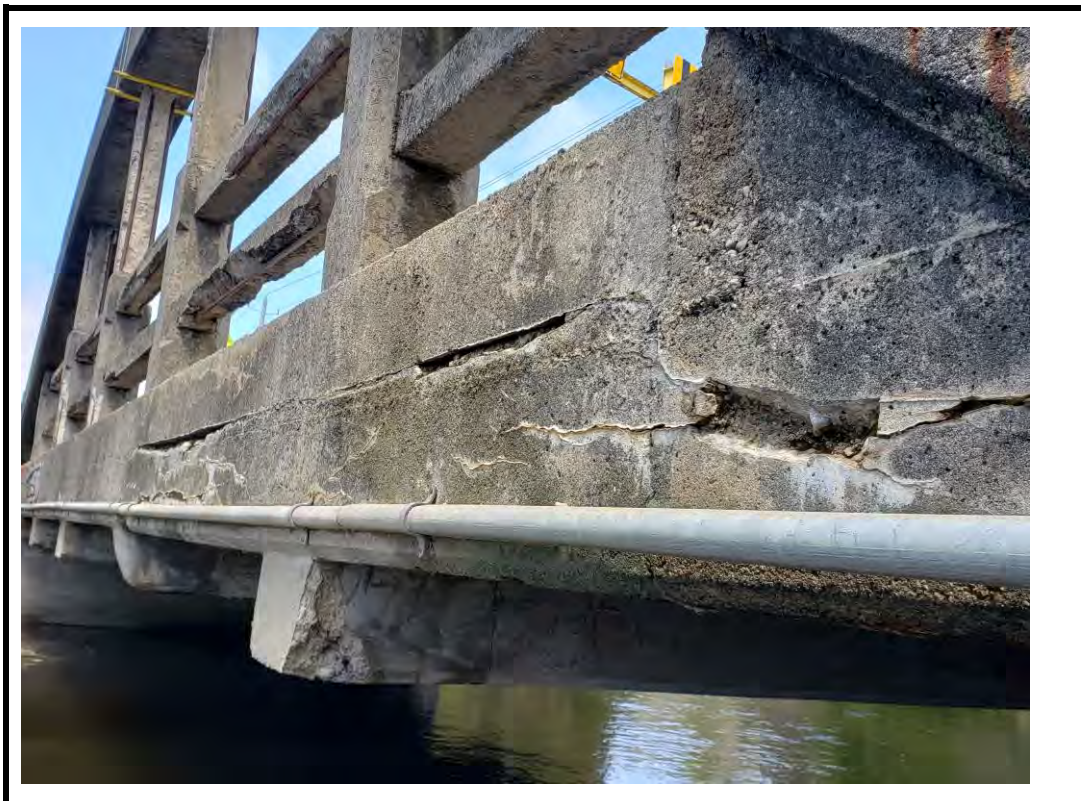
Photo 16 Wide cracks noted at underside of west chord near south end

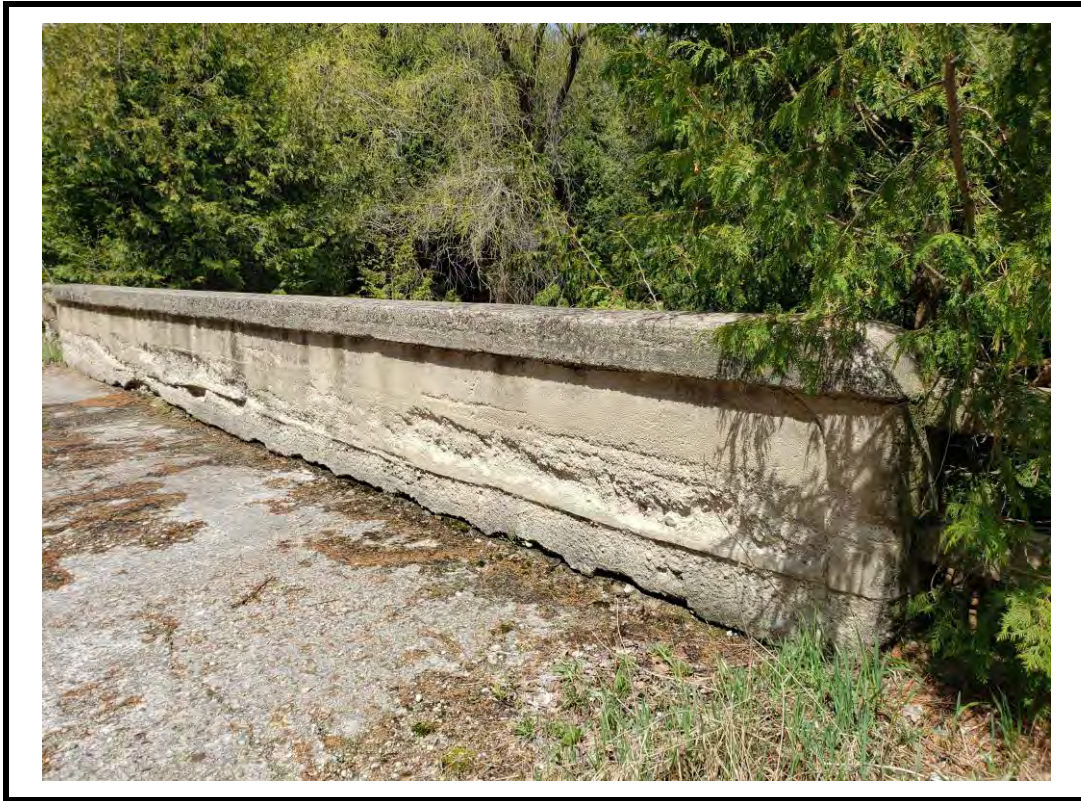
Photo 7 Severe concrete deterioration at base of deck barrier

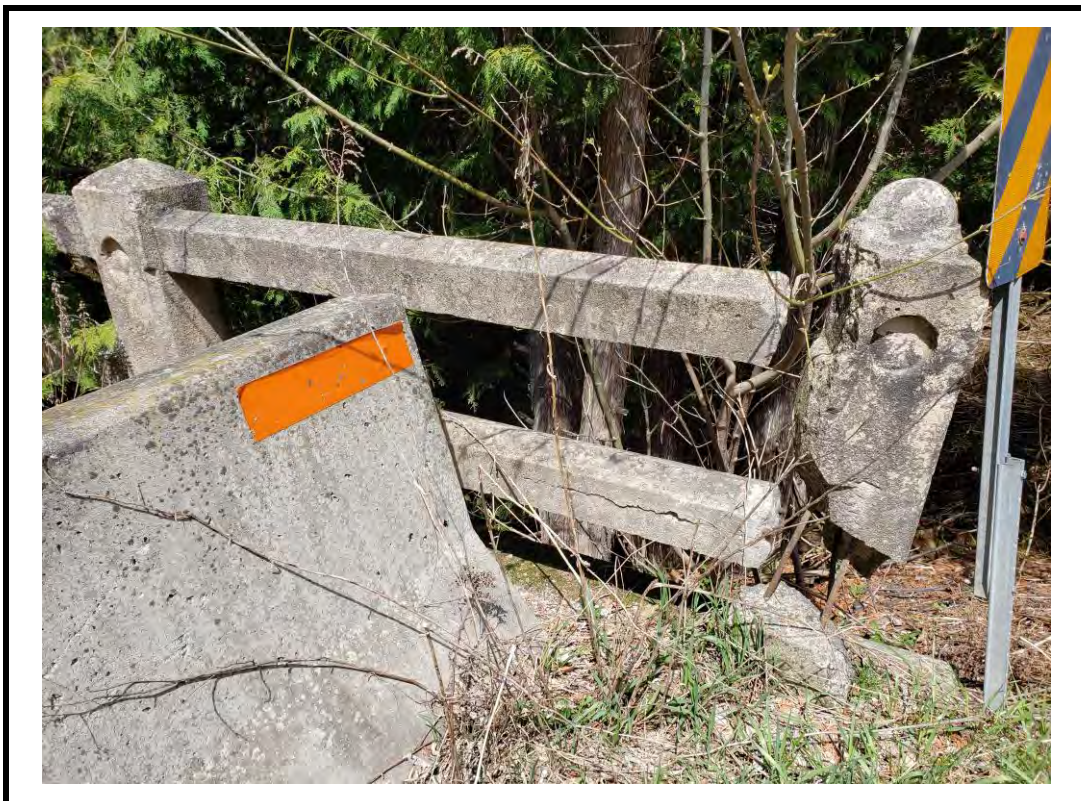
Photo 8 Full depth disintegration of concrete post in approach barrier system
