# Cultural Heritage Evaluation Report, Municipal Class Environmental Assessment, Bridges 2-WG, 3-E, 5-E and 7-E, Township of Centre Wellington, Ontario

**Project Number:** 2024-0053

**Report Date:** August 19, 2024

**Parslow Heritage Consultancy Inc.**

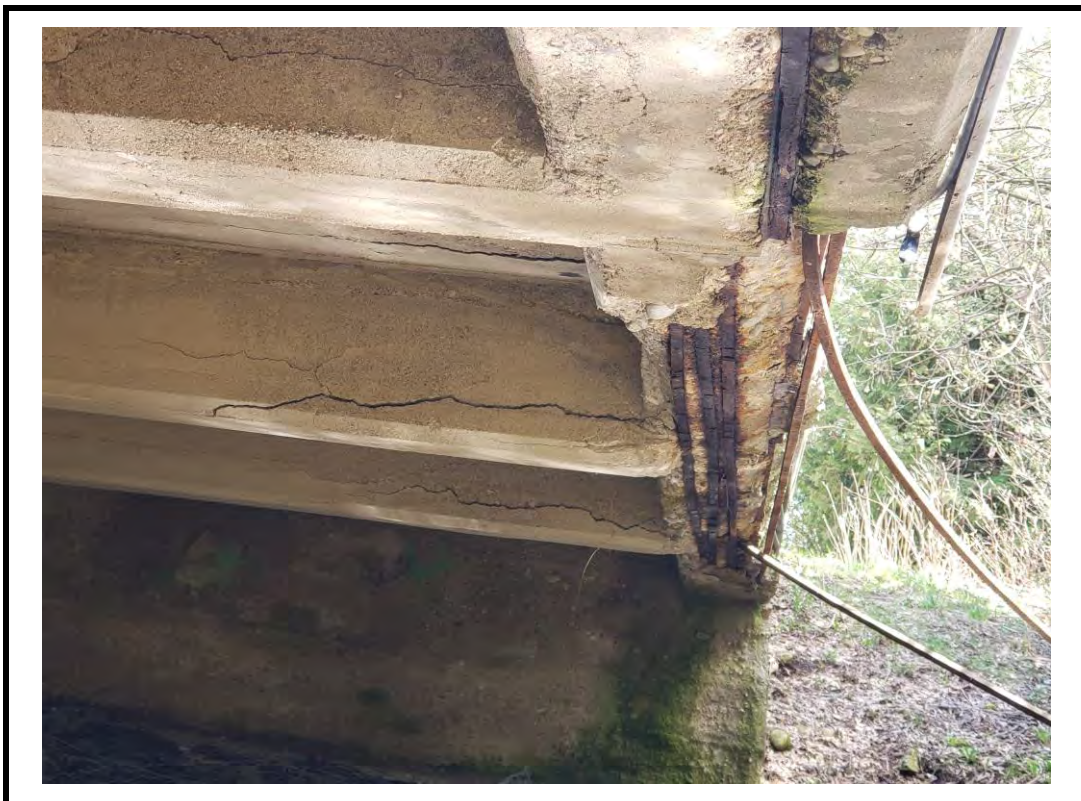
Photo 10 Severe spalling with exposed corroded rebar at underside of girder

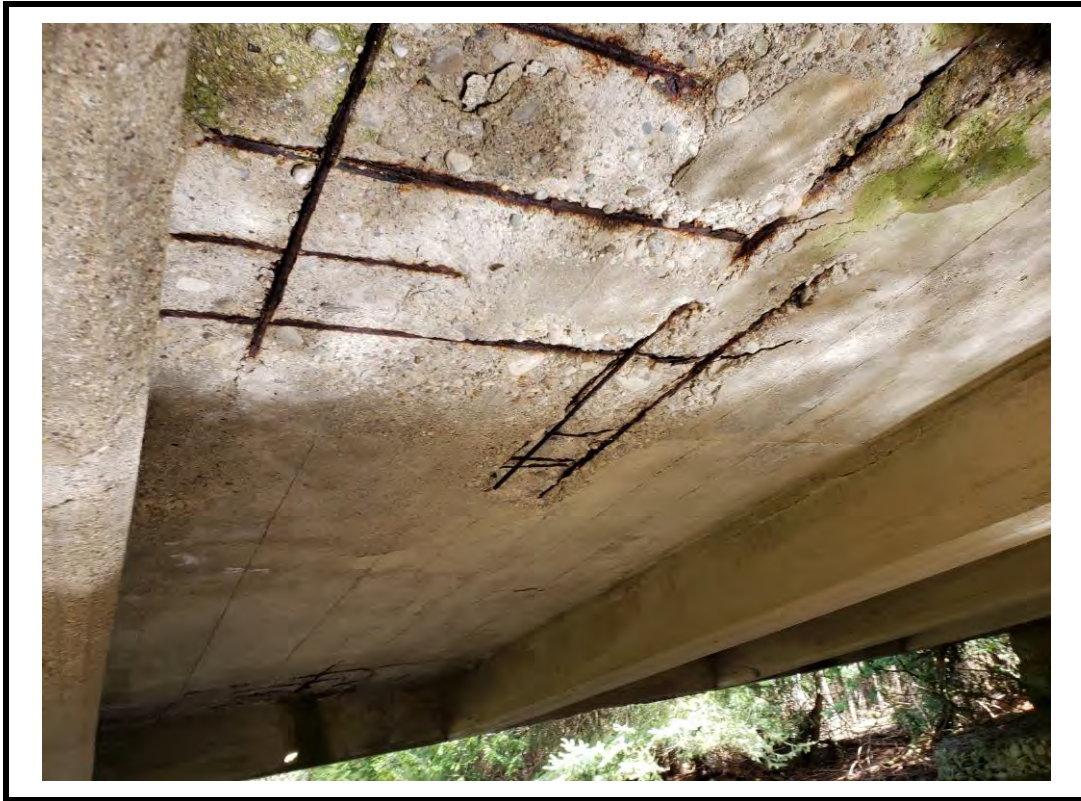
Photo 11 Spalling with exposed corroded rebar at soffit

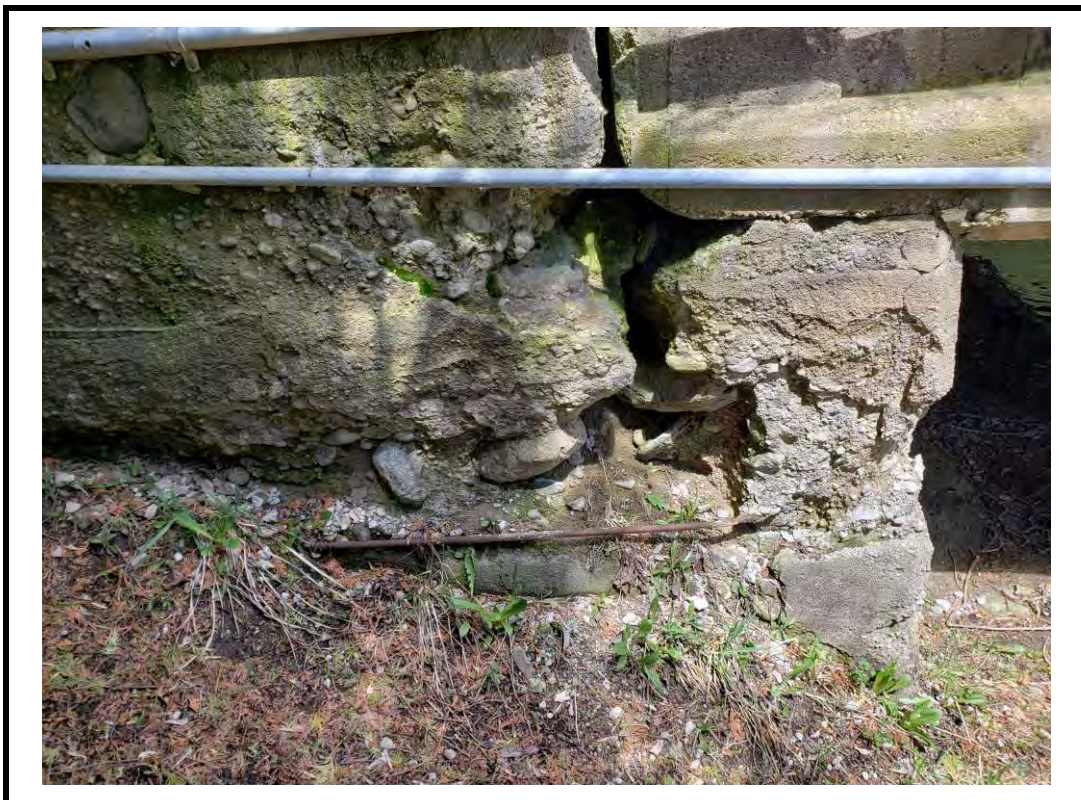
Photo 12 Severe concrete disintegration at NE wingwall

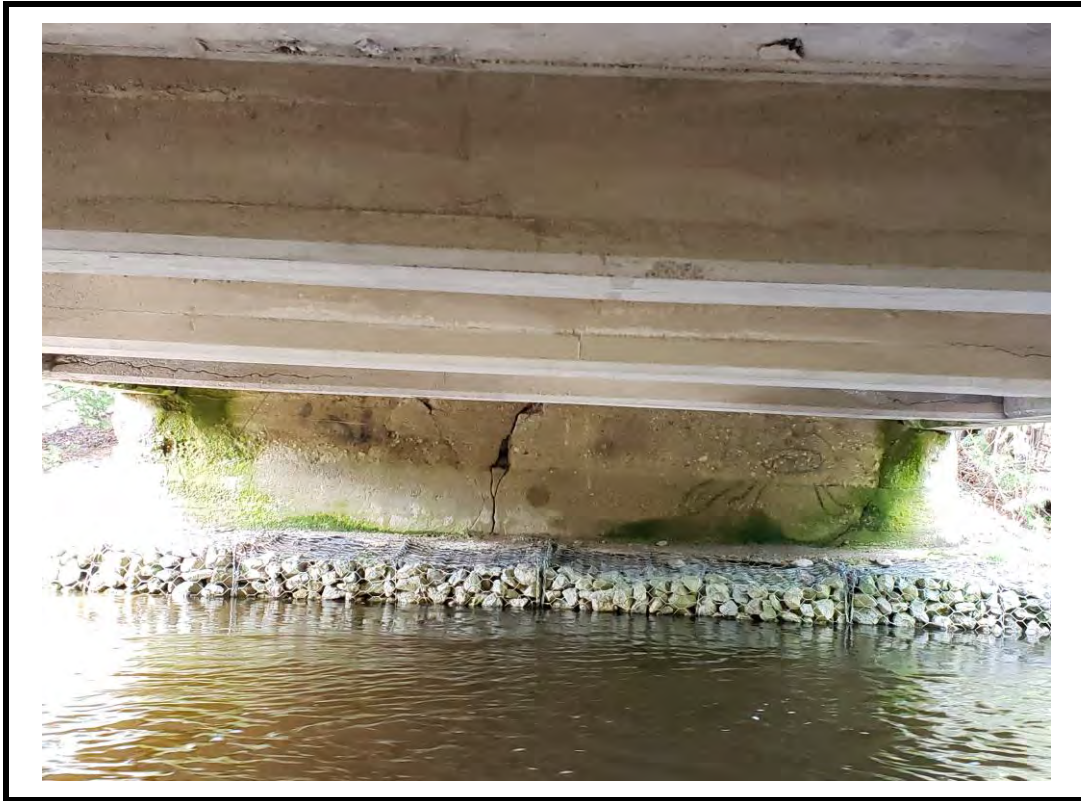
Photo 13 Wide crack, scaling and spall at north abutment wall

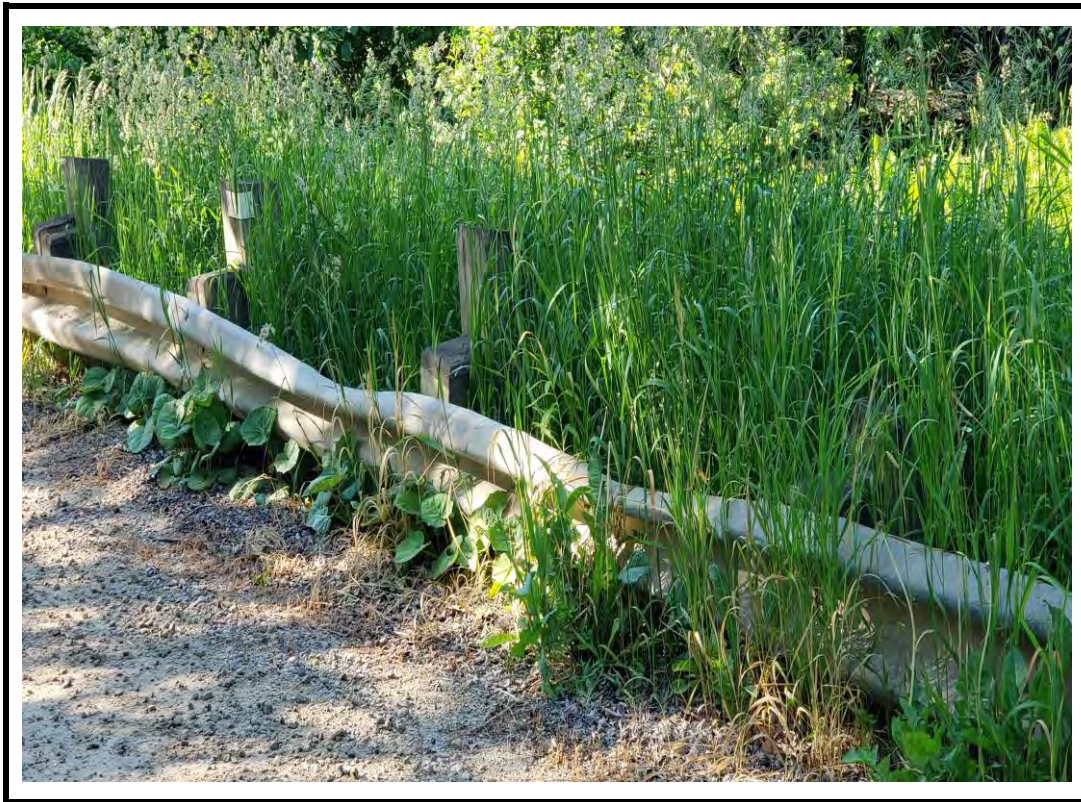
Photo 7 Collision damage noted at west approach barrier

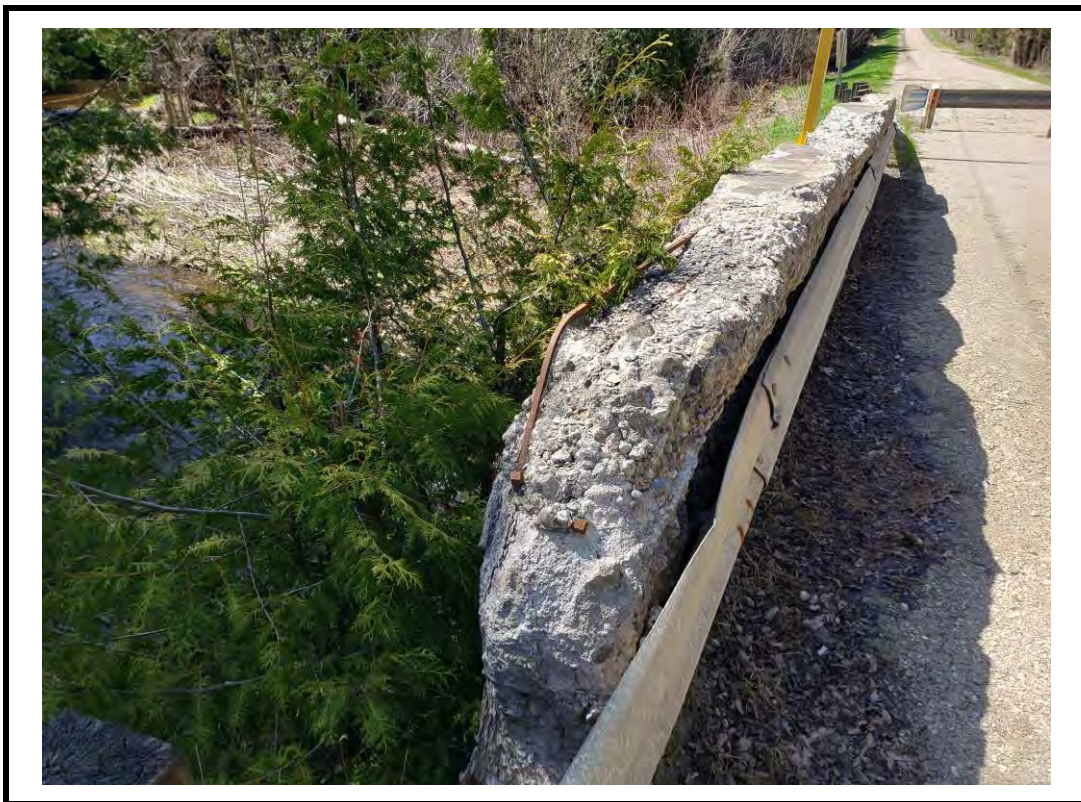
Photo 8 Traffic Barrier Disintegration with exposed corroded reinforcing

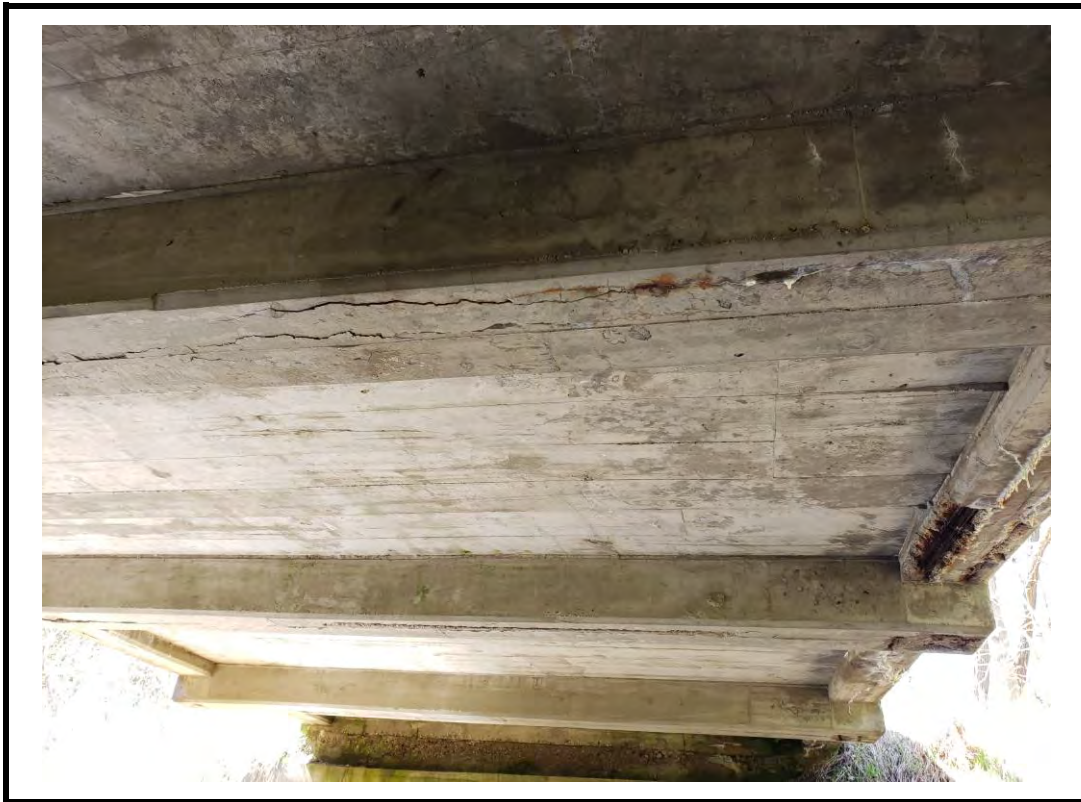
Photo 9 Delamination and spalls with exposed corroded reinforcing on soffit

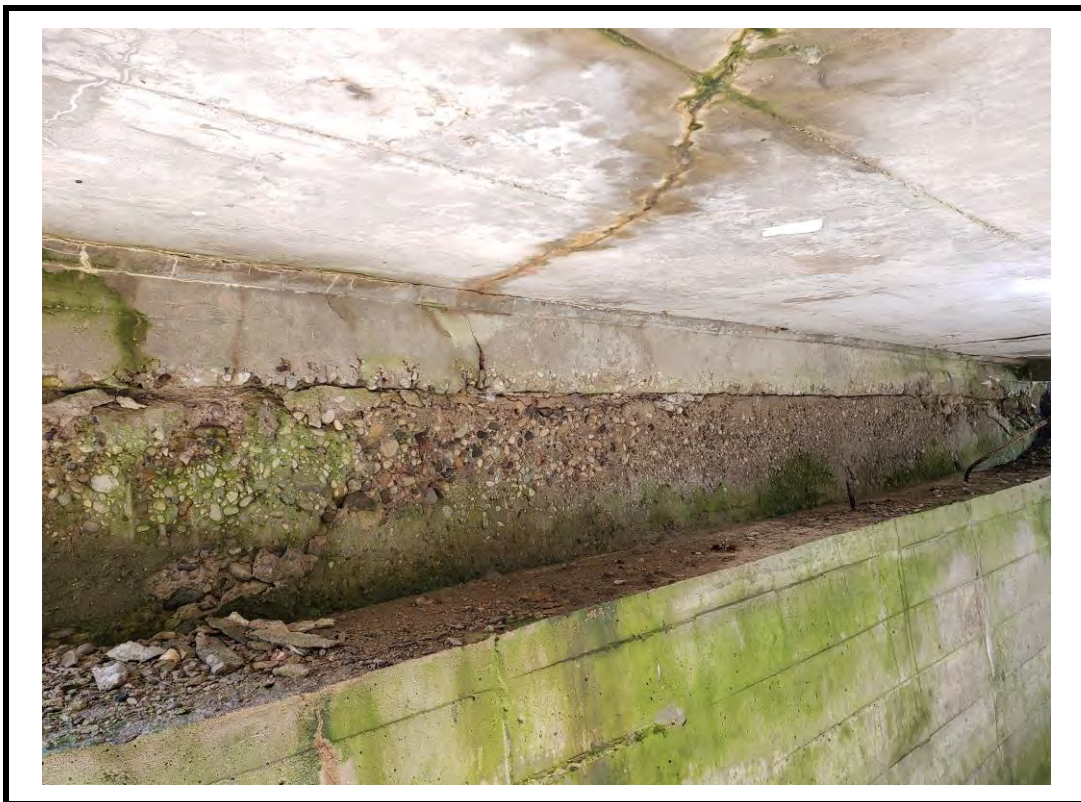
Photo 10 Medium cracks and map cracks with efflorescence

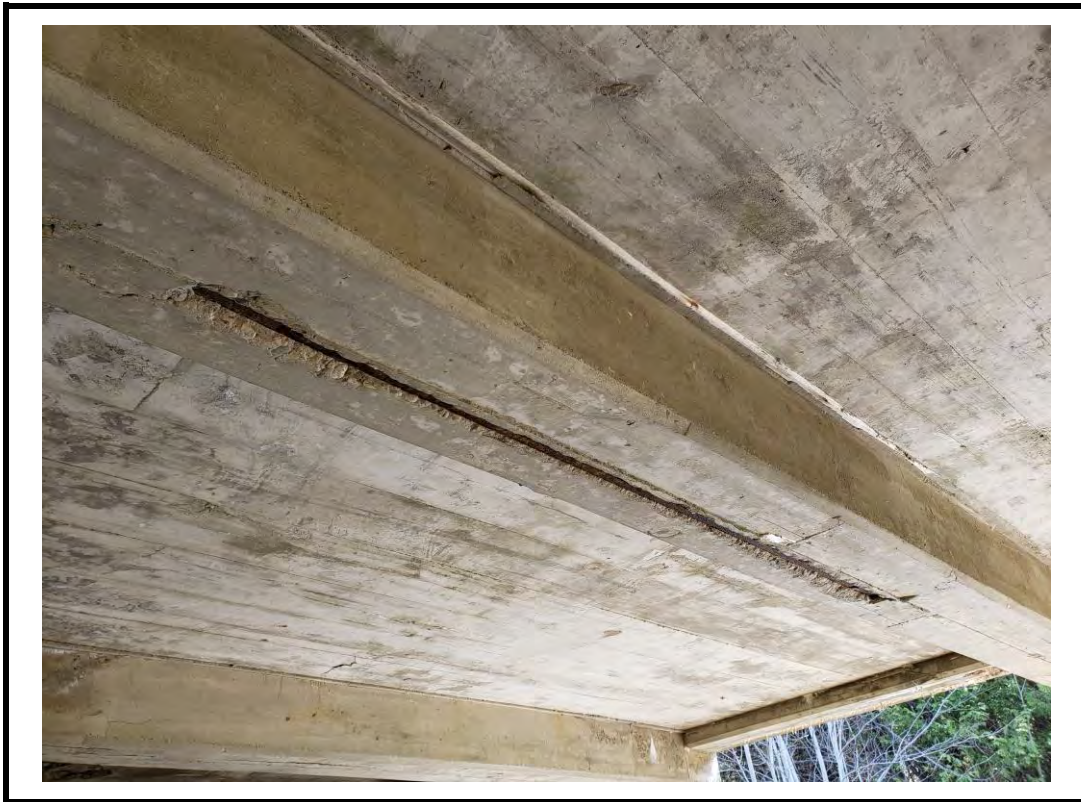
Photo 11 Spall with exposed corroded reinforcing and efflorescence on girder & floor beam

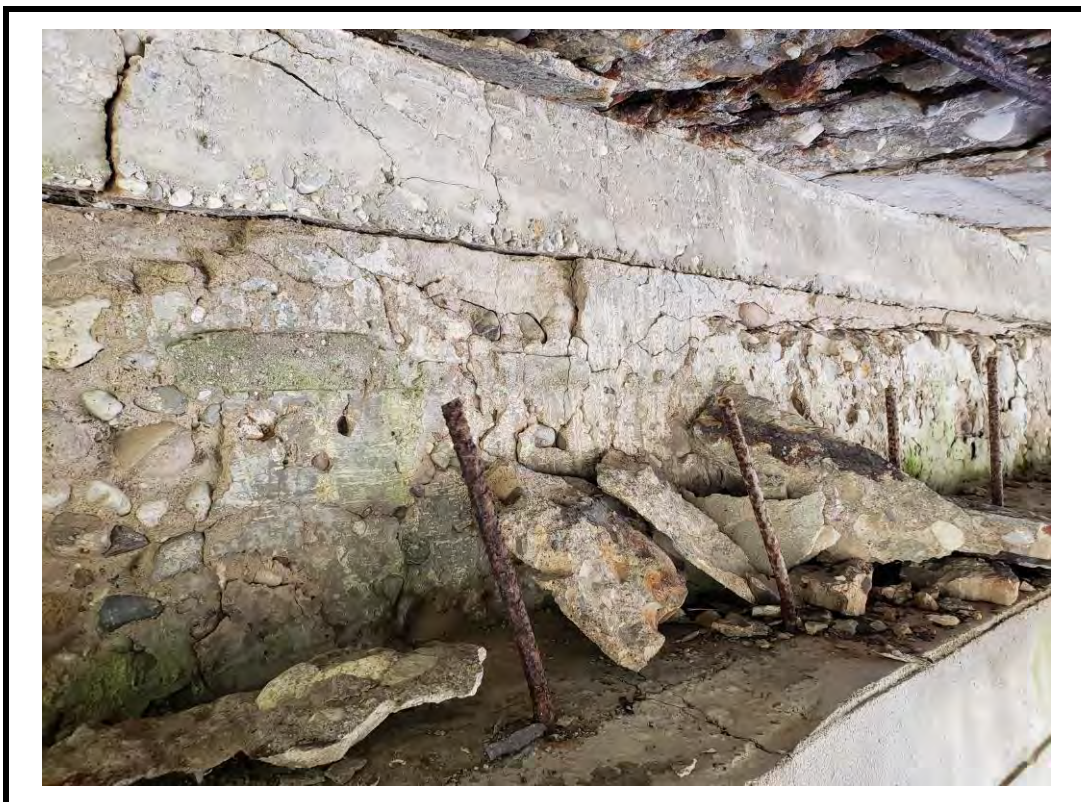
Photo 12 Exposed corroded reinforcement with severe scaling noted at ballast wall

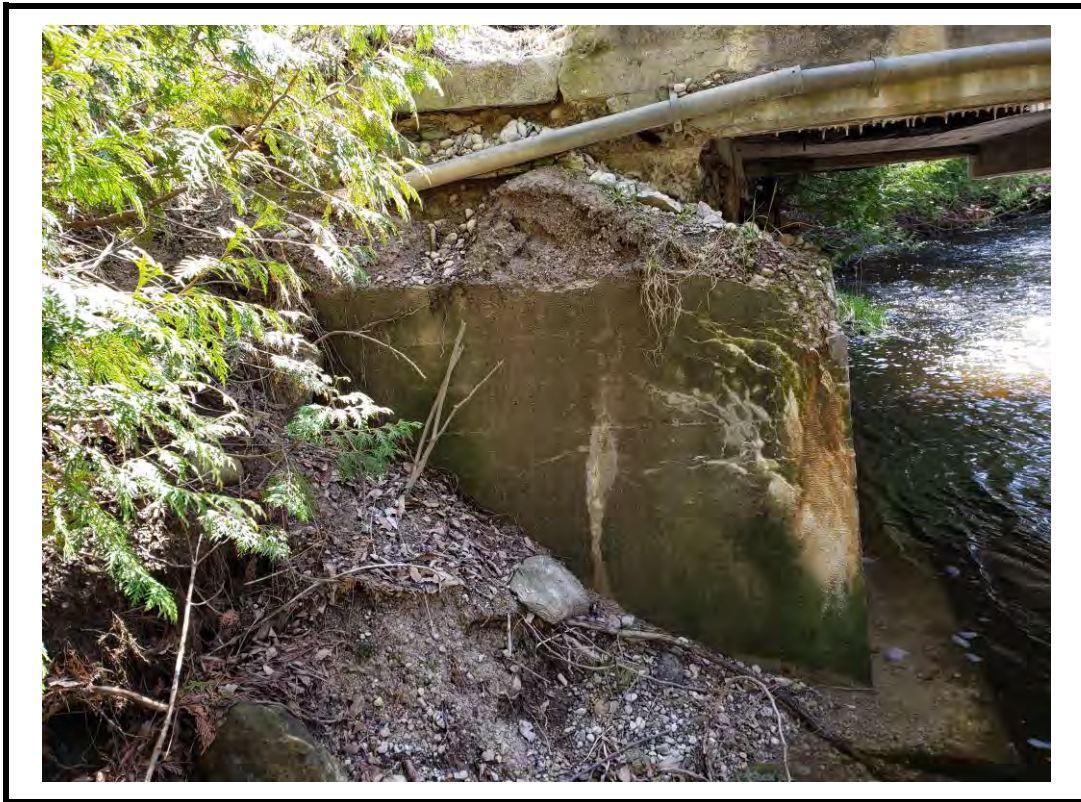
Photo 13 Spalls noted at south abutment and southeast wingwall interface.
