# Cultural Heritage Evaluation Report, Municipal Class Environmental Assessment, Bridges 2-WG, 3-E, 5-E and 7-E, Township of Centre Wellington, Ontario

**Project Number:** 2024-0053

**Report Date:** August 19, 2024

**Parslow Heritage Consultancy Inc.**

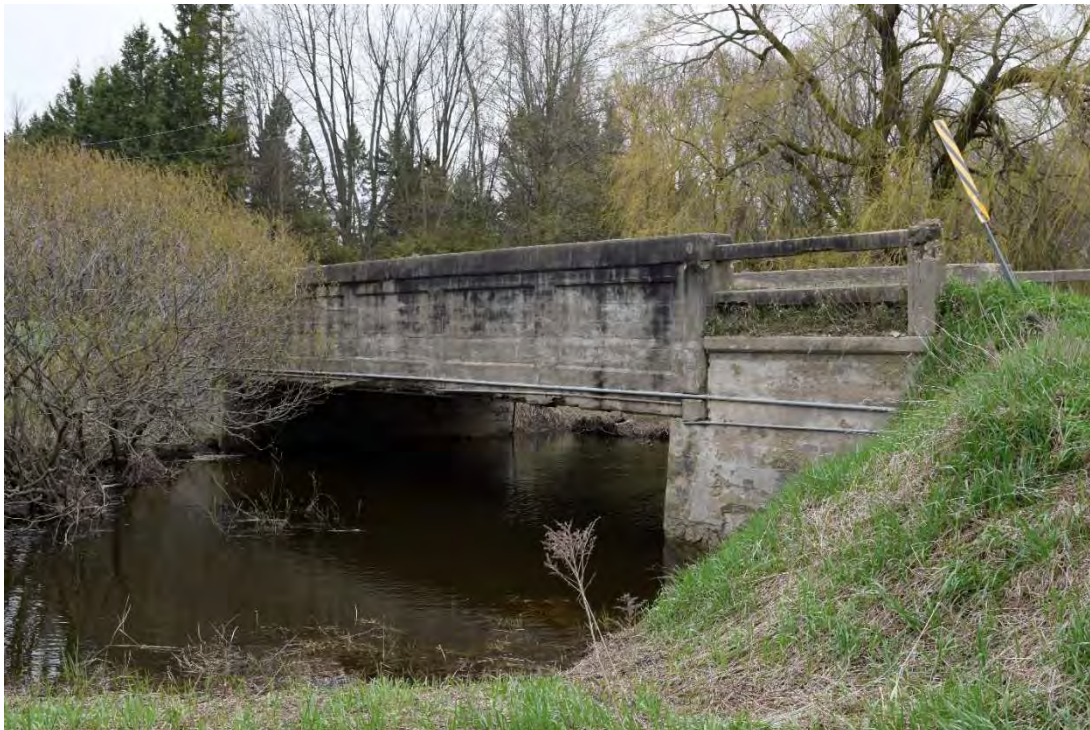
**FIGURE 1: BRIDGE 2-WG, SOUTH SIDE FACING NORTH**

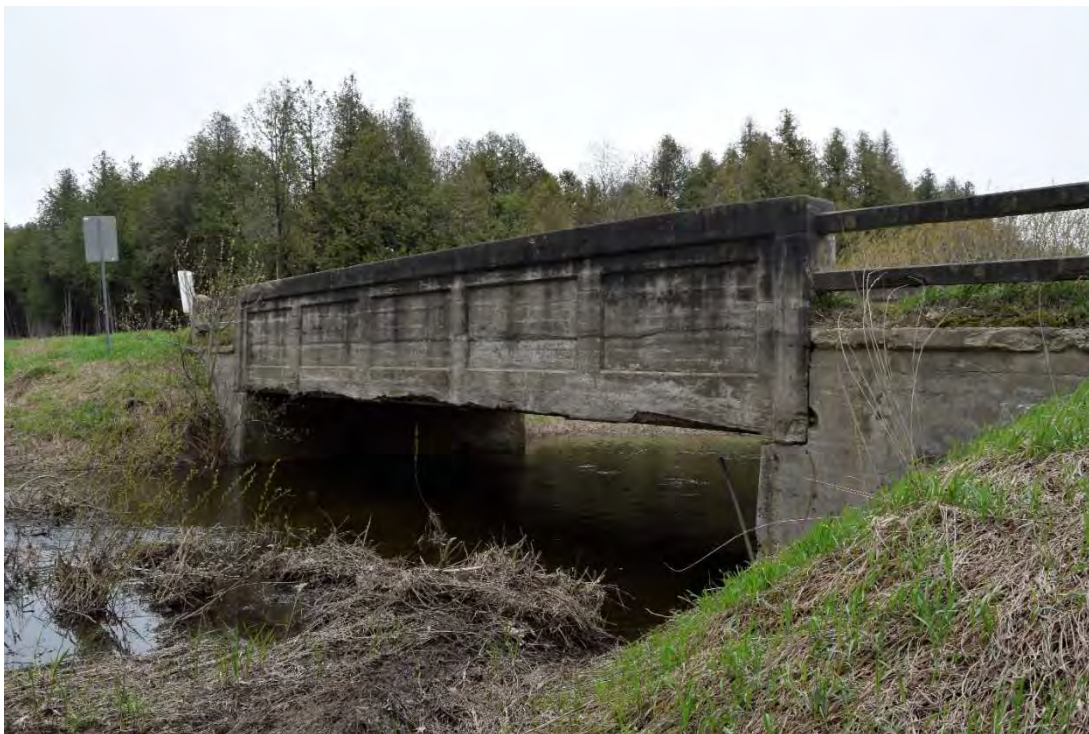
**FIGURE 2: BRIDGE 2-WG, NORTH FACE, FACING SOUTH**

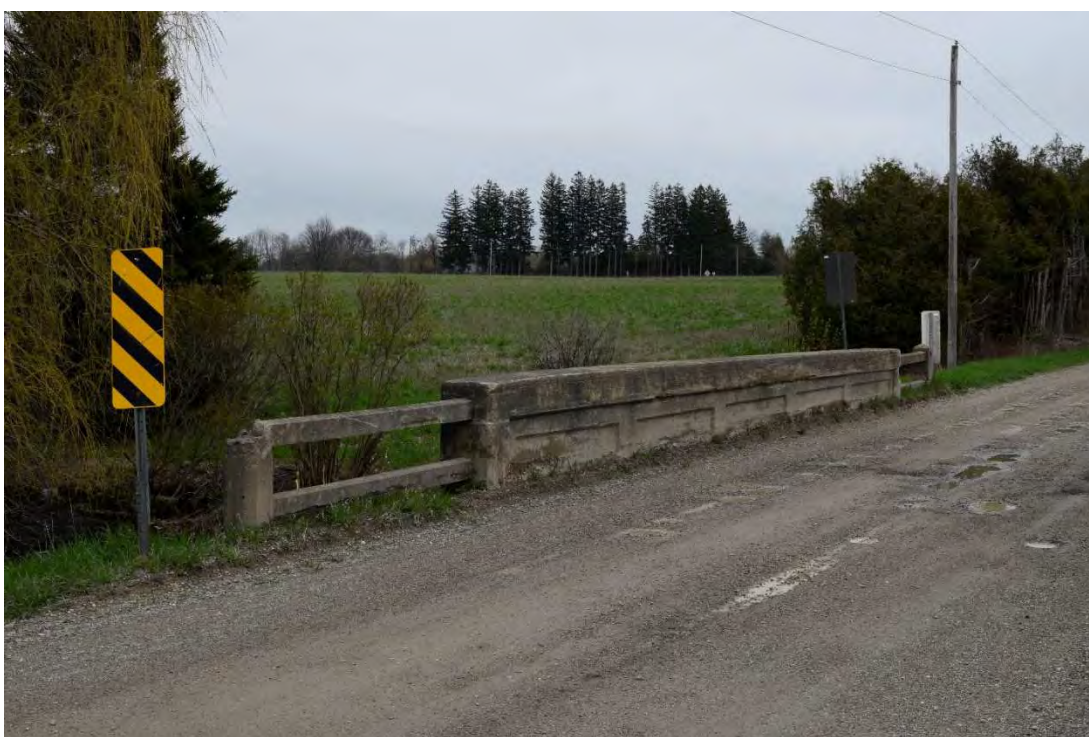
**FIGURE 3: BRIDGE 2-WG, SUPERSTRUCTURE ABUTTING ROADWAY**

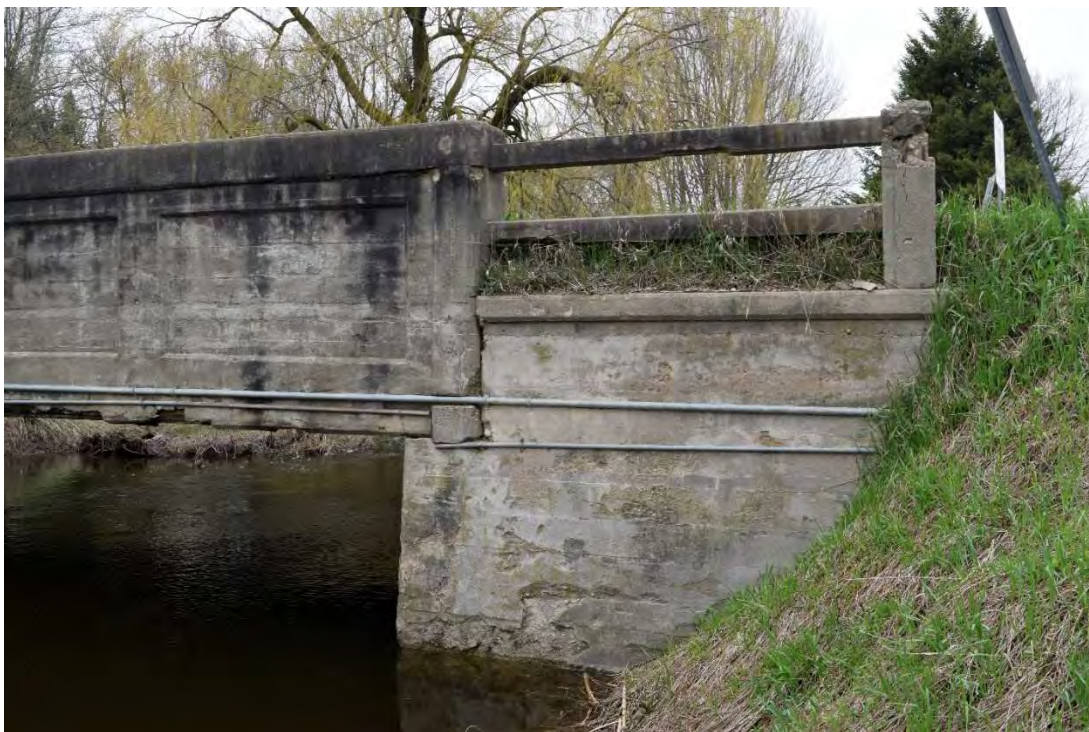
**FIGURE 4: BRIDGE 2-WG, REPRESENTATIVE ABUTMENT, BRIDGE DECK AND GUARDRAIL**

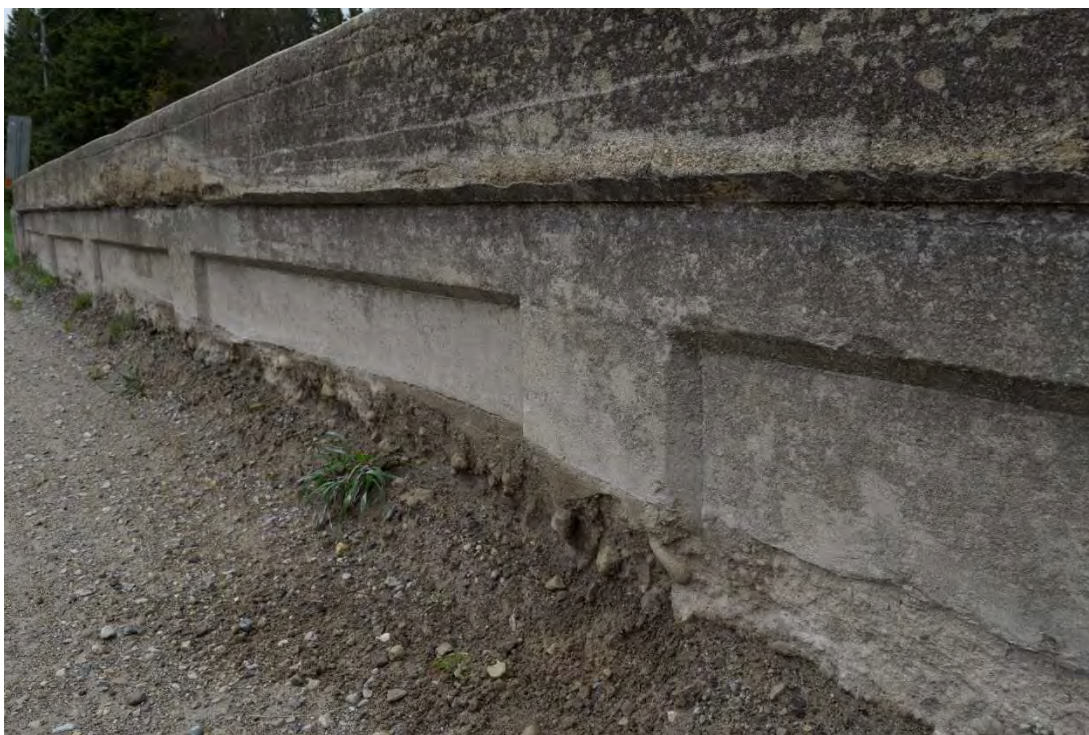
**FIGURE 5: BRIDGE 2-WG, CLOSE UP OF SUPERSTRUCTURE**

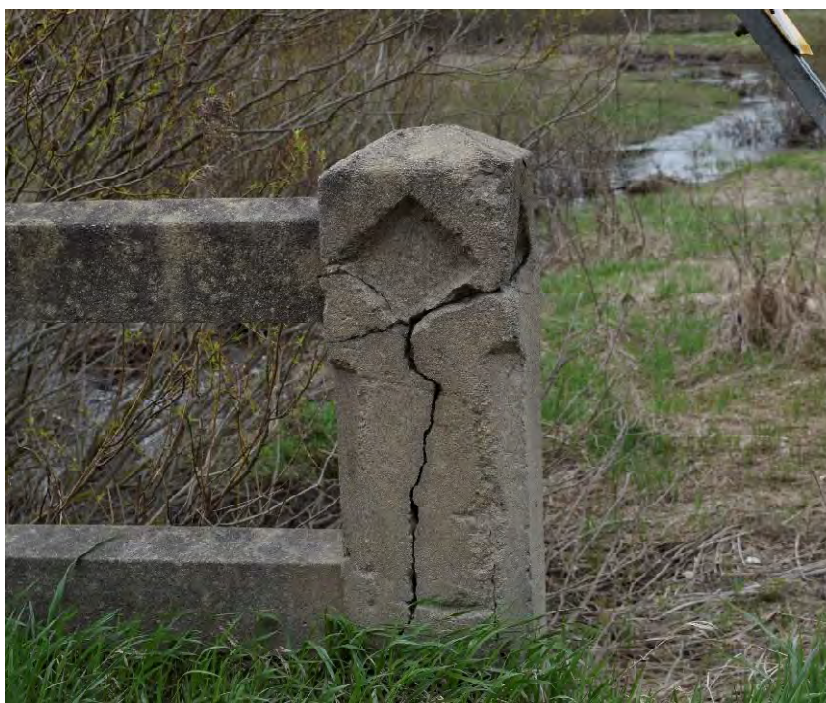
**FIGURE 7: BRIDGE 2-WG, CLOSEUP OF GUARD RAIL SUPPORT WITH CHAMFERED CORNERS, CAST DIAMOND INSET AND TAPERED UPPER SURFACE**

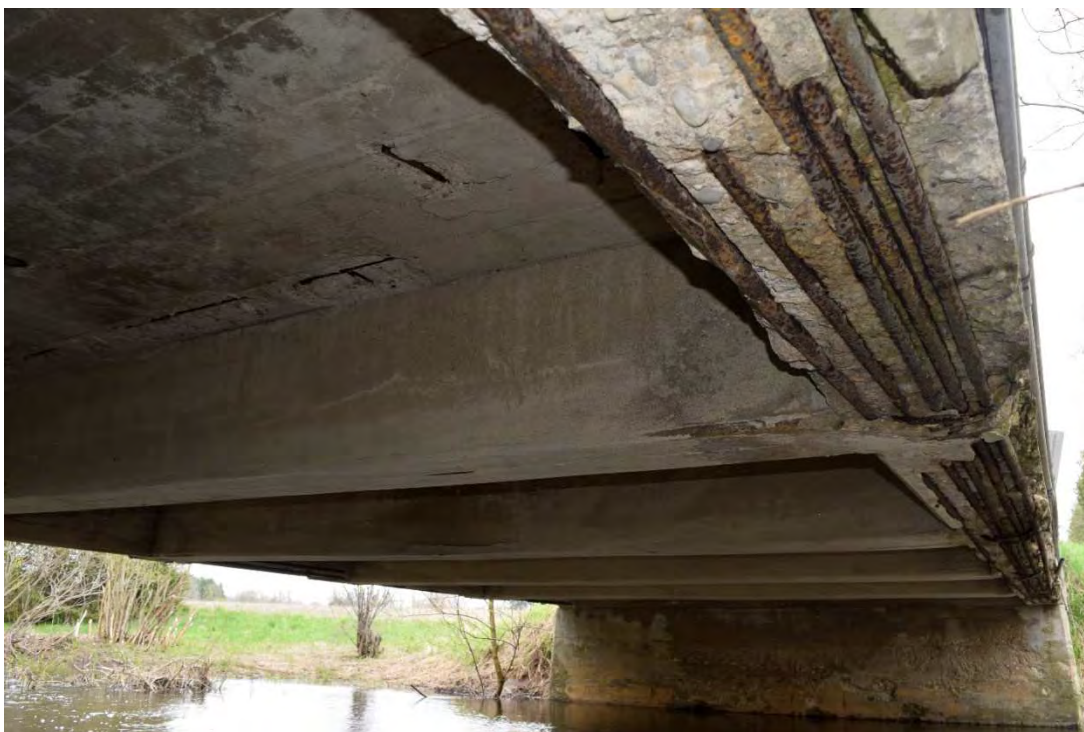
Bridge 2-WG, located on 3<sup>rd</sup> Line, appears to be in fair condition. The bridge shows ample signs of degradation and exhibits signs of past structural repairs consistent with previous maintenance. The underside of the bridge presents as being in the best overall structural condition, but this may be the result of previous repairs as the concrete exhibits a different colour then the remainder of the structure. The guard rails exhibit signs of significant degradation and the walls of the superstructure of the bridge adjacent to the road deck show signs of significant degradation resulting from prolonged exposure to road salt. Bridge 2-WG is narrow and is not suited to modern two lane traffic or modern agricultural equipment. Bridge 2-WG remains open to vehicular traffic. A 2022 Ontario Structure Inspection Manual (OSIM) report recommended the bridge be replaced within 1-5 years (Appendix D).

**FIGURE 8: BRIDGE 2-WG, UNDERSIDE OF BRIDGE**

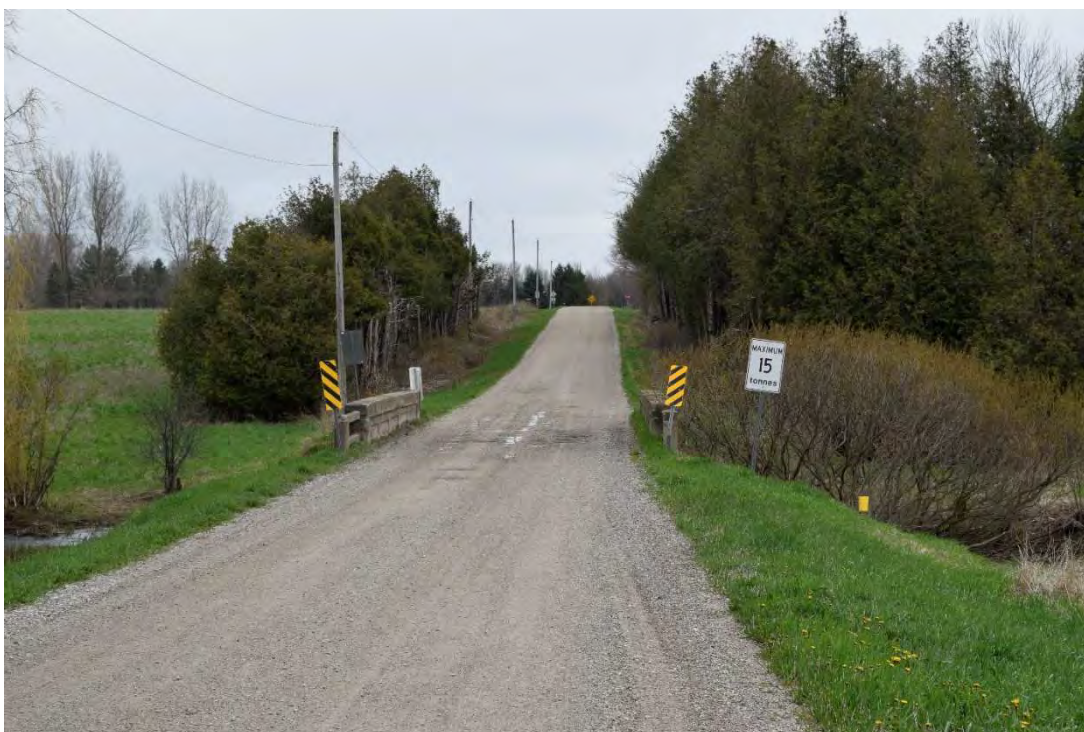
**FIGURE 9: BRIDGE 2-WG, APPROACH TO BRIDGE 2-WG FACING SOUTHEAST**

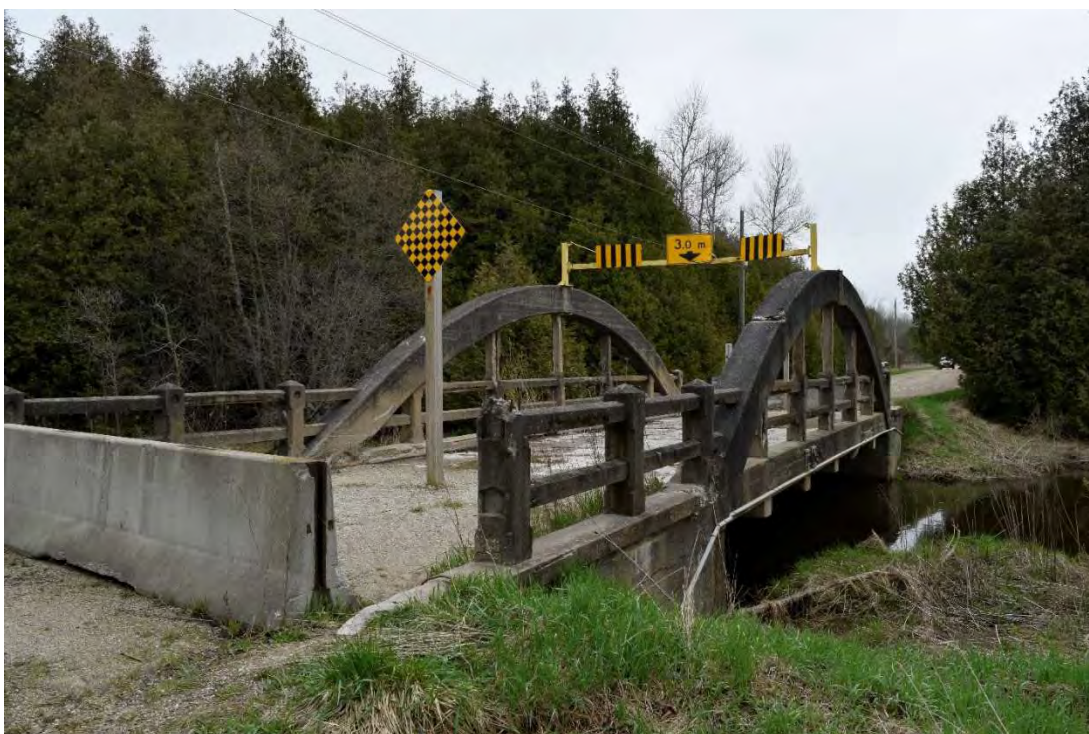
**FIGURE 11: BRIDGE 3-E, SOUTH SIDE OF BRIDGE, FACING NORTH**

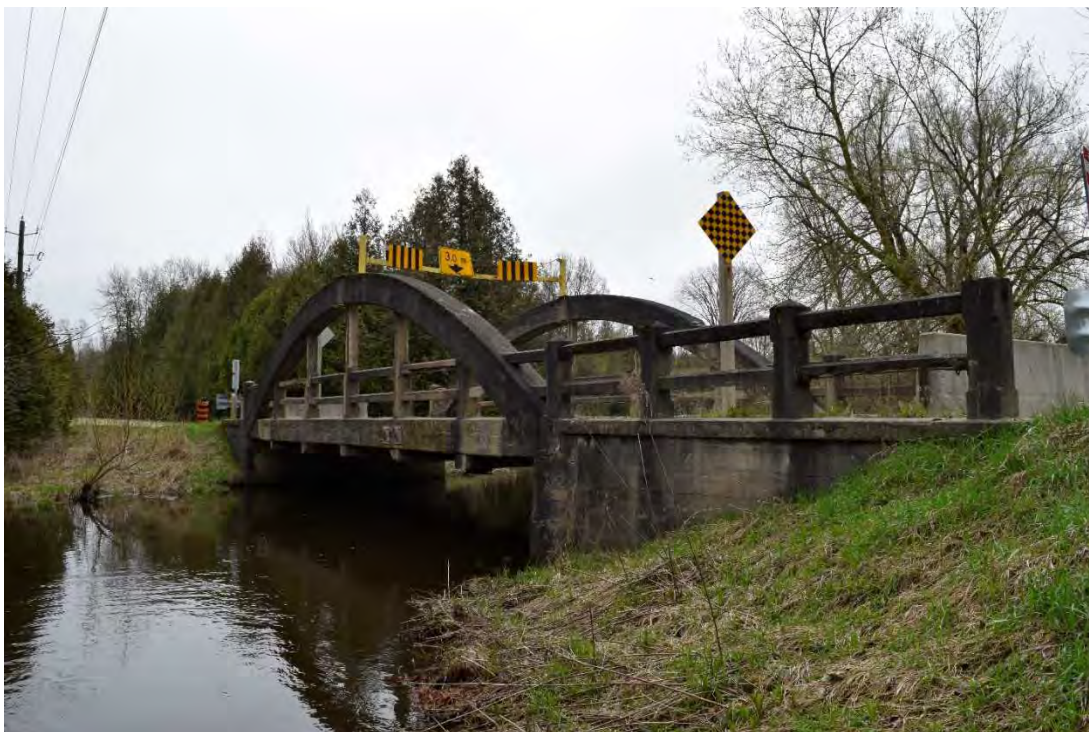
**FIGURE 12: BRIDGE 3-E, SOUTHSIDE OF BRIDGE, FACING NORTH**

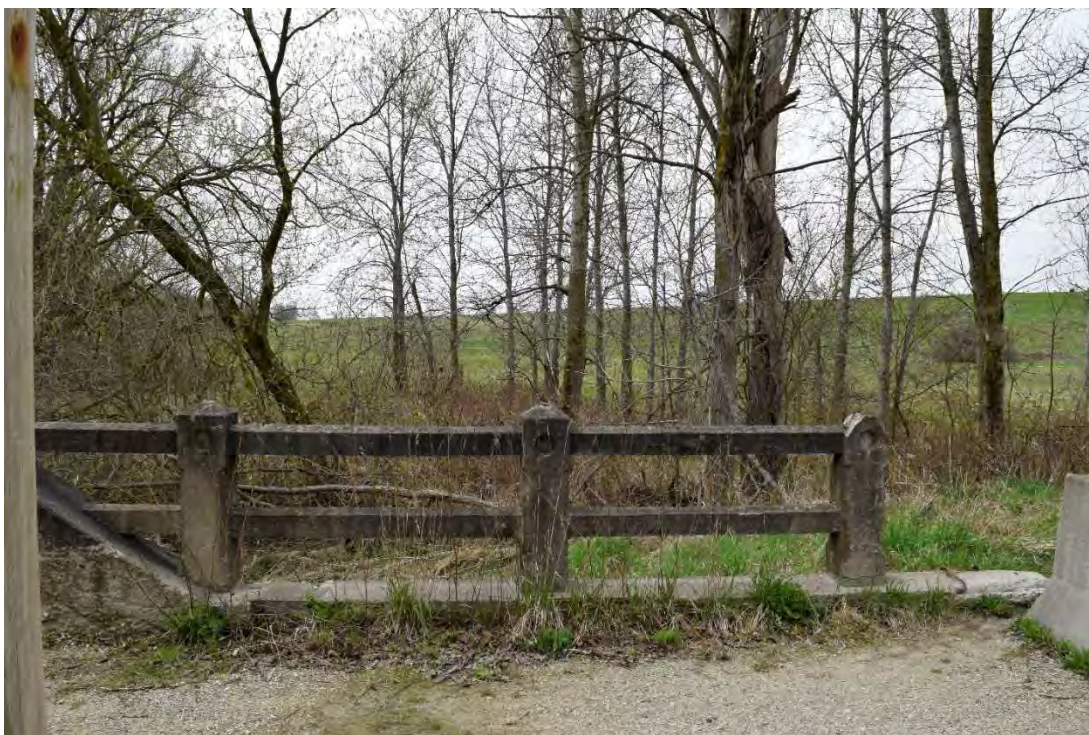
**FIGURE 13: BRIDGE 3-E, TYPICAL GUARDRAIL, SOUTH SIDE**

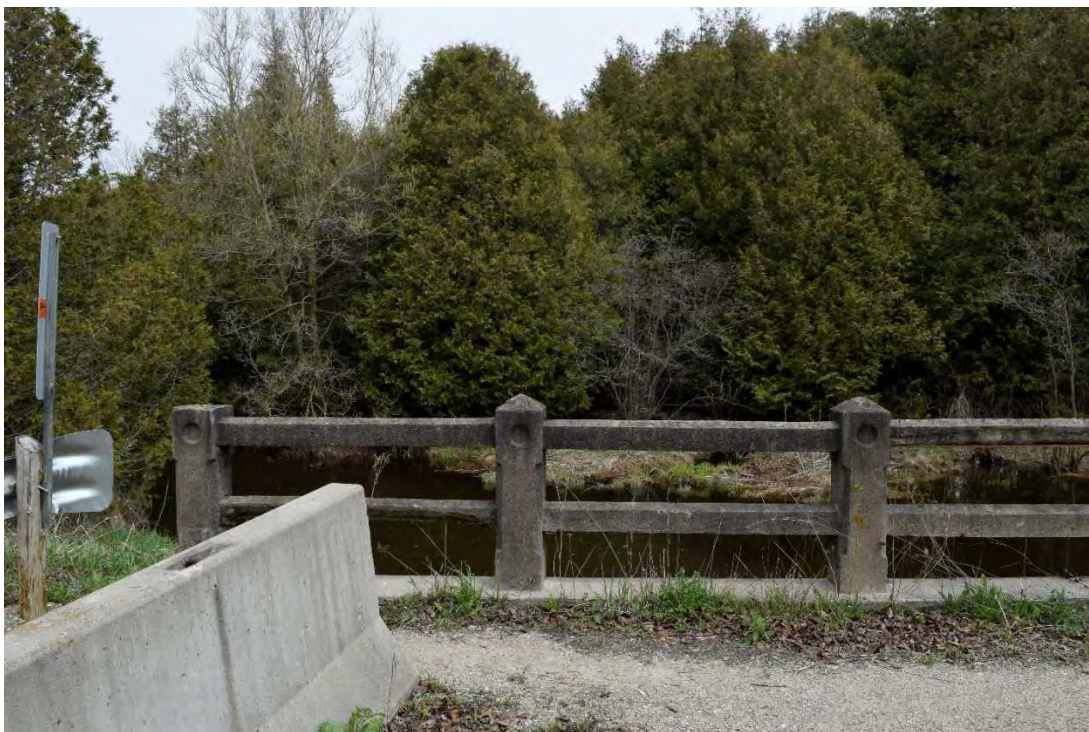
**FIGURE 14: BRIDGE 3-E, TYPICAL GUARDRAIL NORTH SIDE**

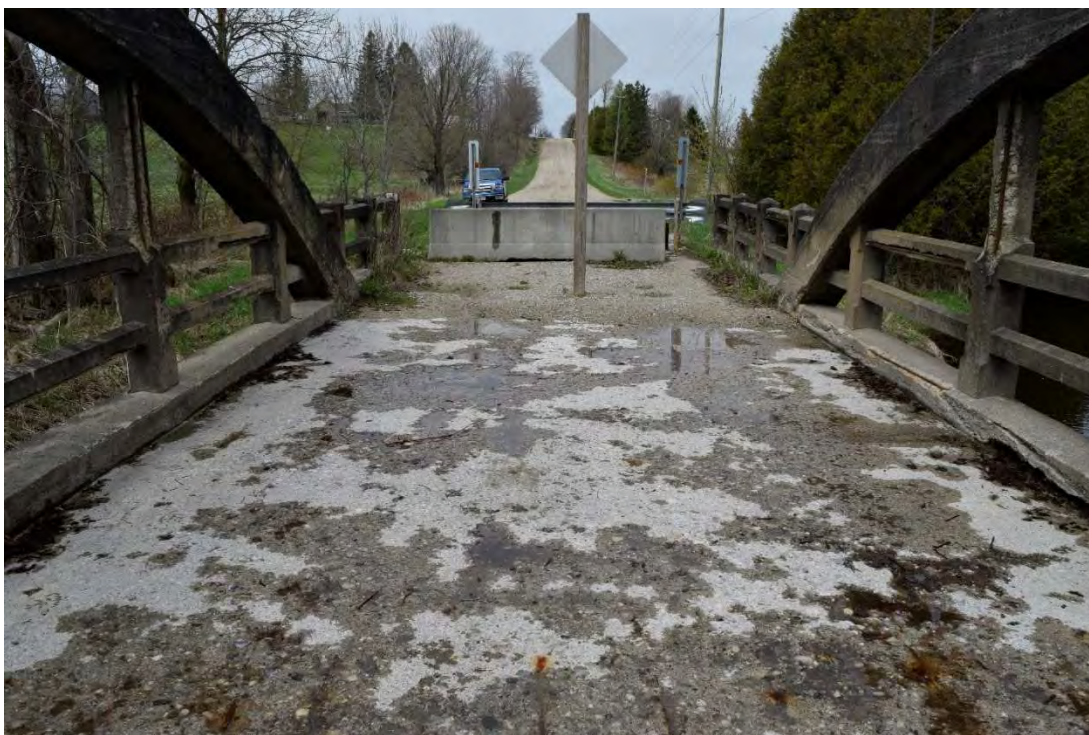
**FIGURE 15: BRIDGE 3-E, BRIDGE DECK, FACING NORTHWEST**

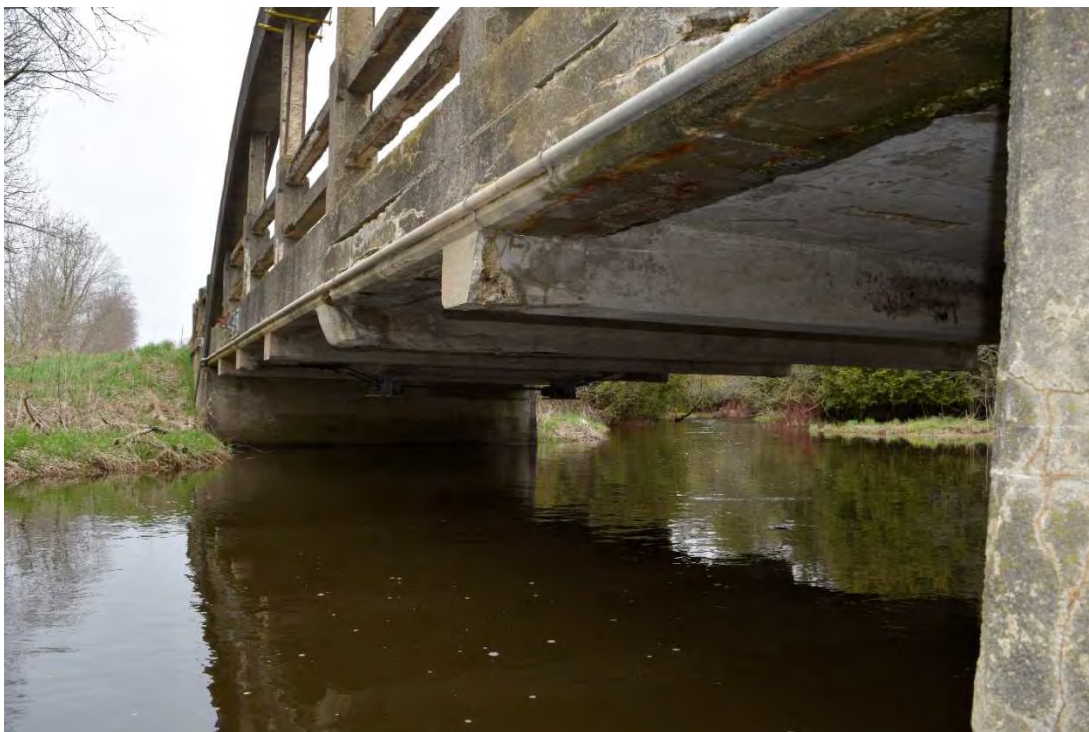
**FIGURE 17: BRIDGE 3-E, UNDERSIDE OF BRIDGE DECK**

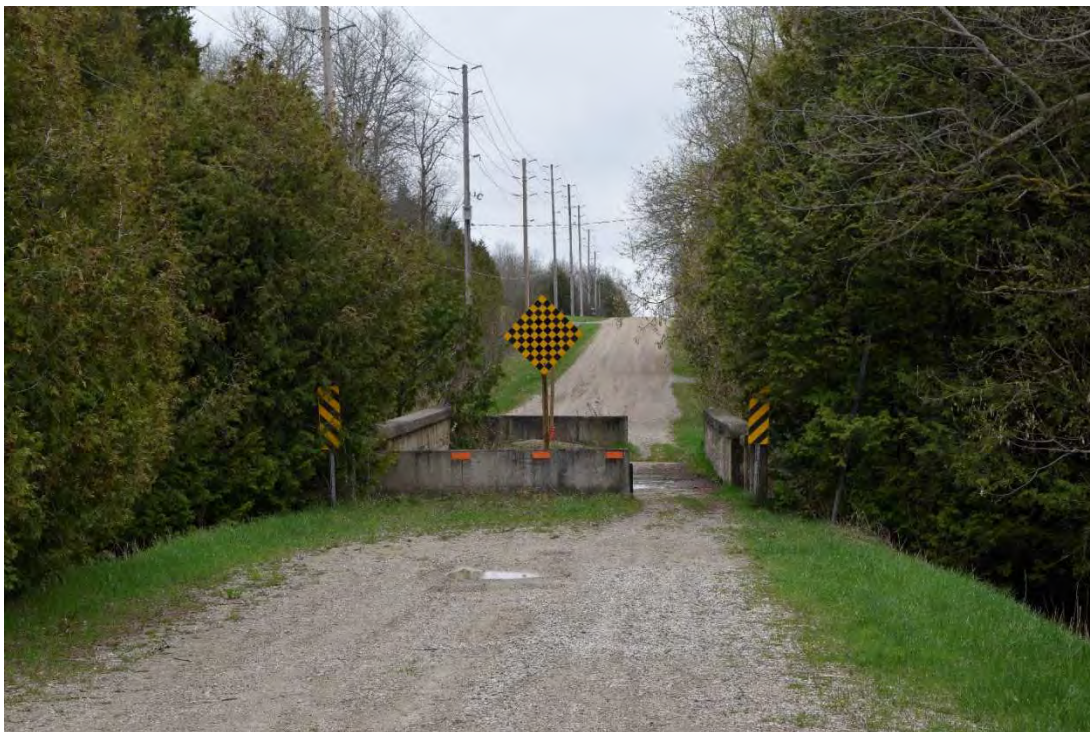
FIGURE 18: BRIDGE 5-E, LOOKING SOUTHEAST FROM APPROACH

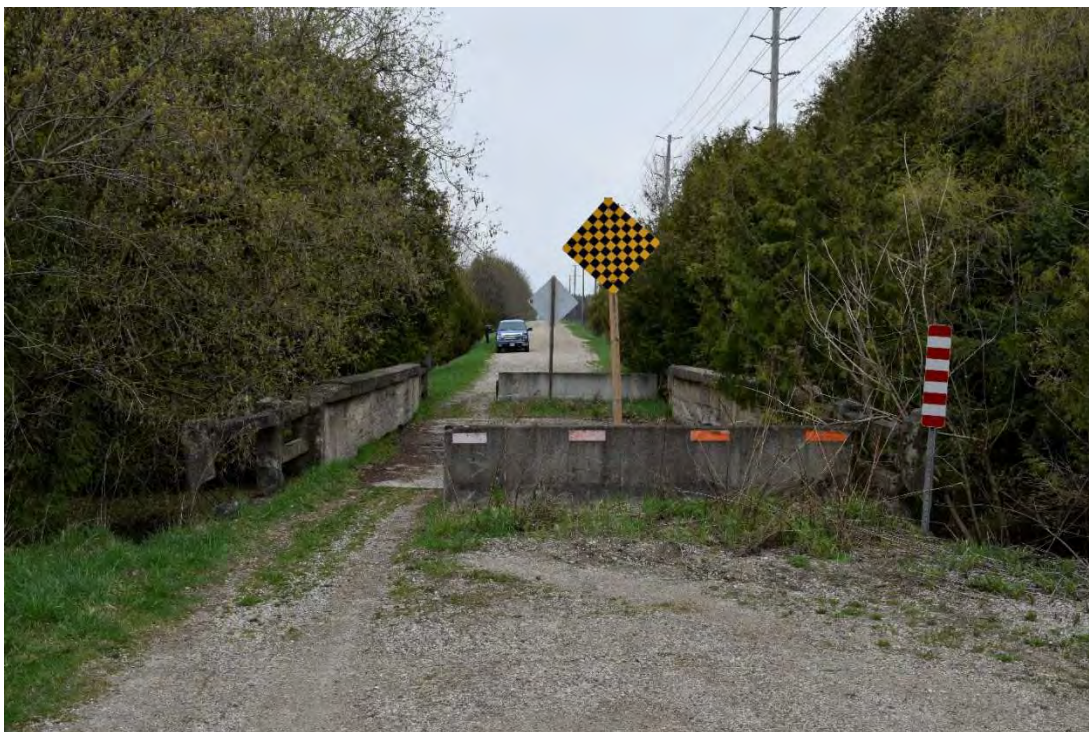
**FIGURE 19: BRIDGE 5-E, LOOKING NORTHWEST FROM APPROACH**

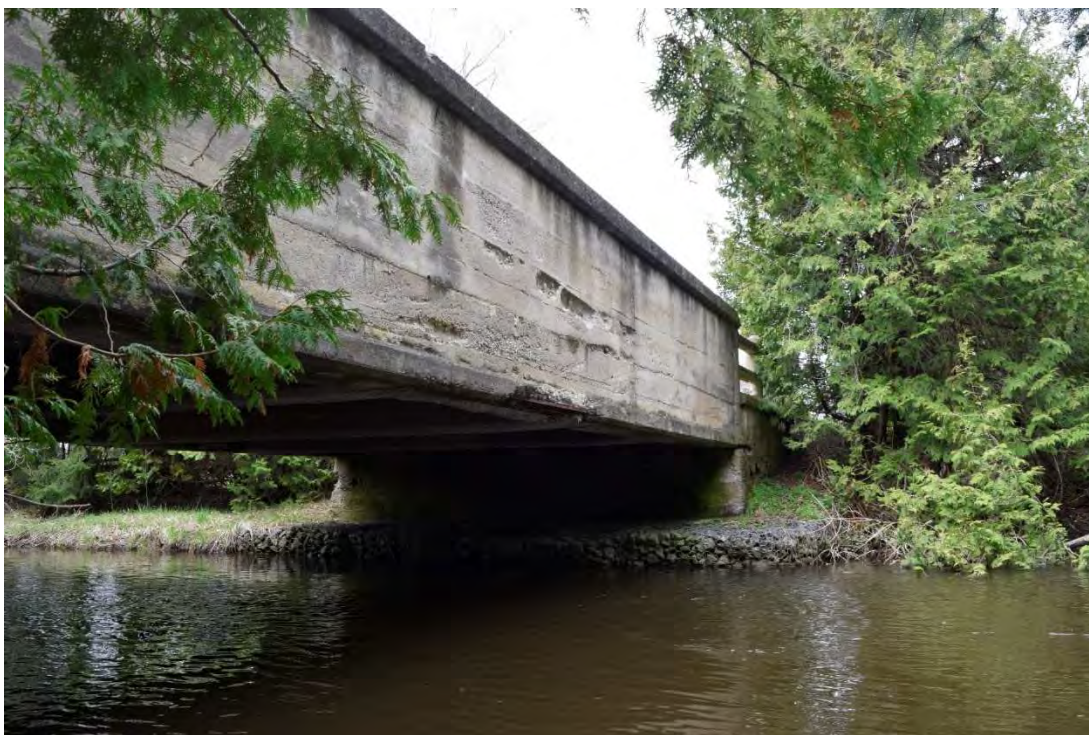
**FIGURE 20: EAST SIDE OF BRIDGE 5-E**

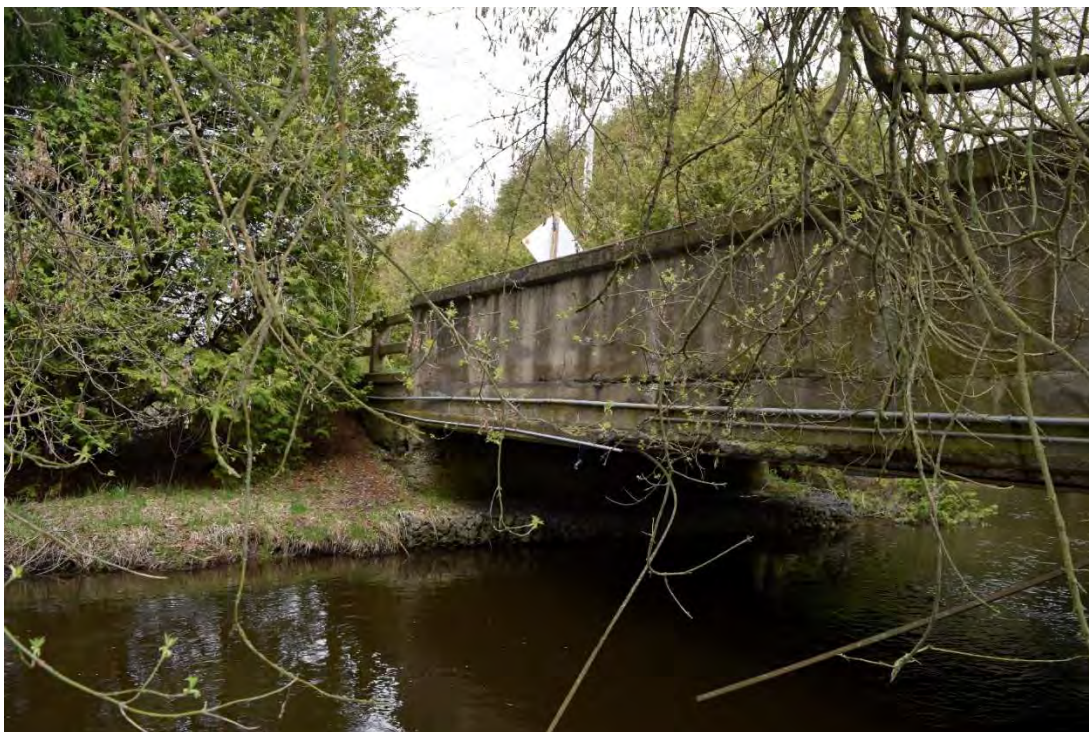
**FIGURE 21: WEST SIDE OF BRIDGE 5-E**

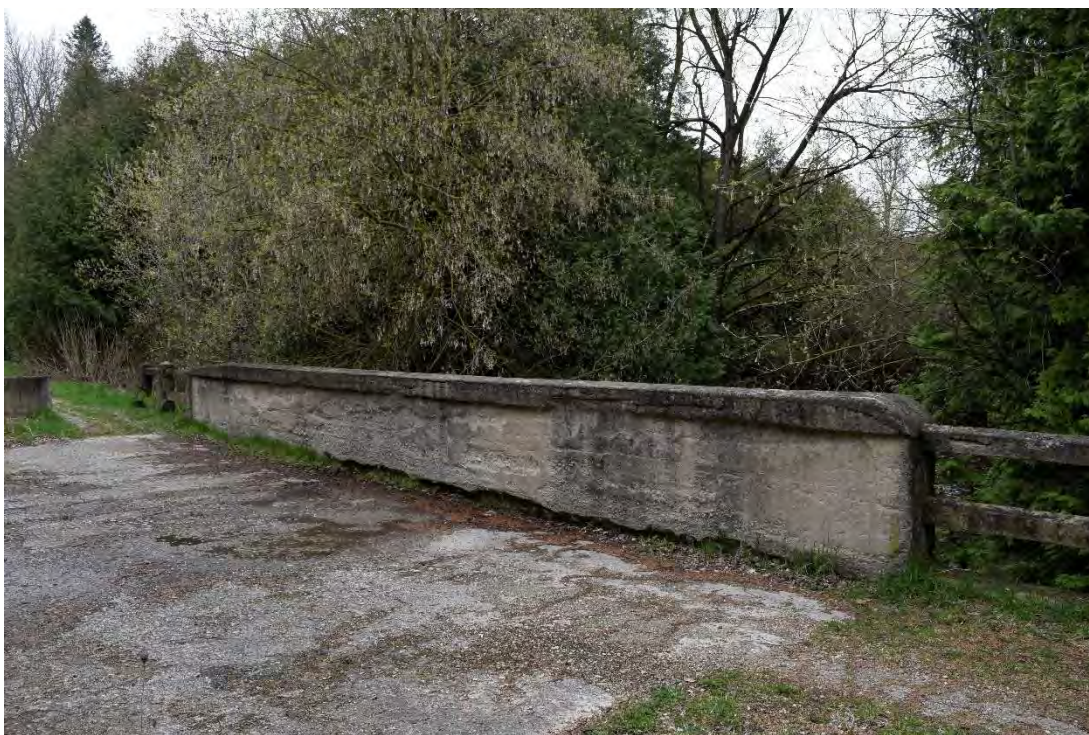
**FIGURE 22: WEST SIDE OF BRIDGE 5-E WITH ROAD DECK**

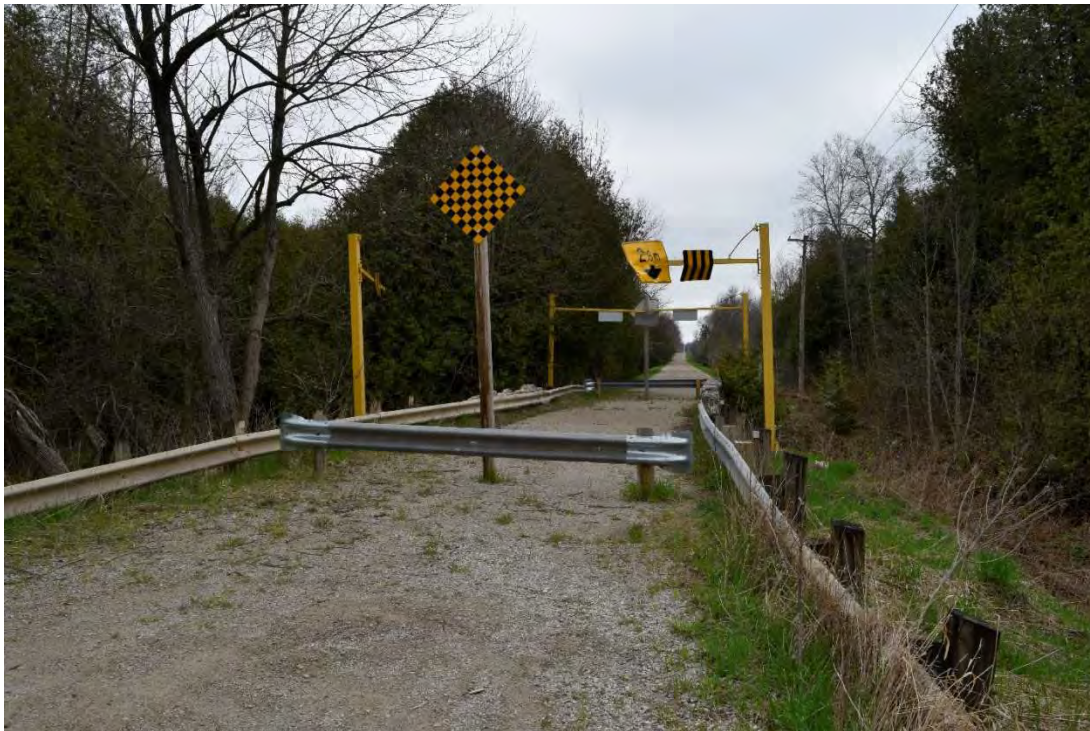
**FIGURE 24: BRIDGE 7-E, NORTH APPROACH TO BRIDGE, FACING SOUTH**

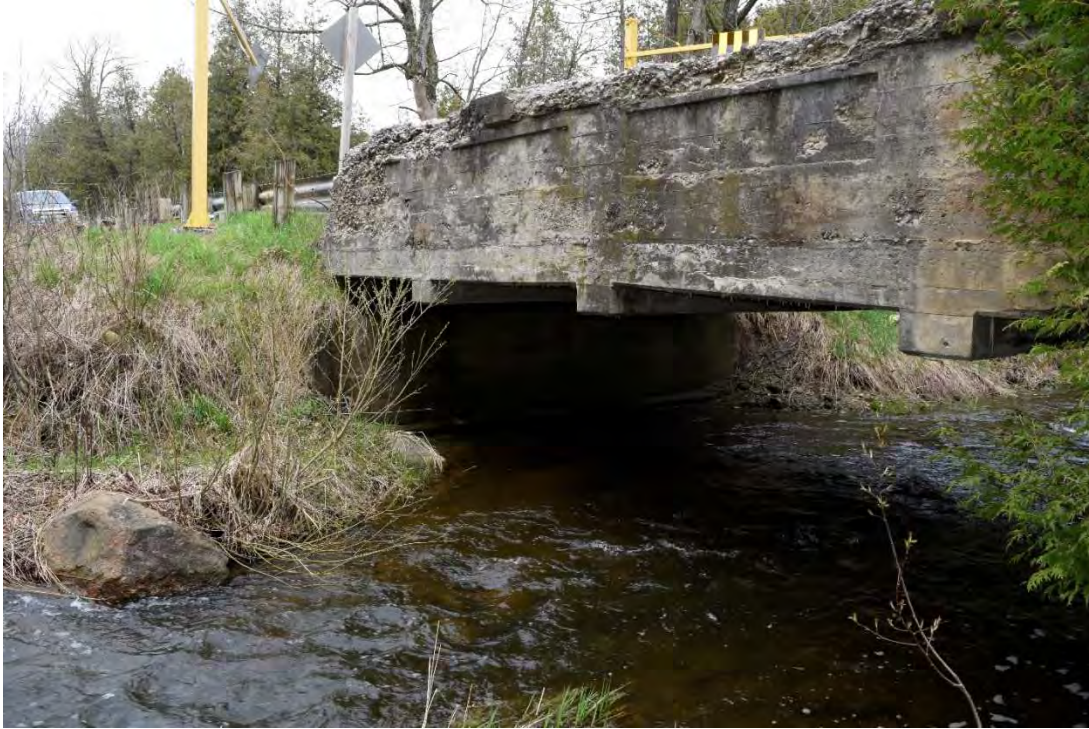
**FIGURE 27: BRIDGE 7-E, OVERVIEW OF THE WEST SIDE OF BRIDGE, FACING NORTH**

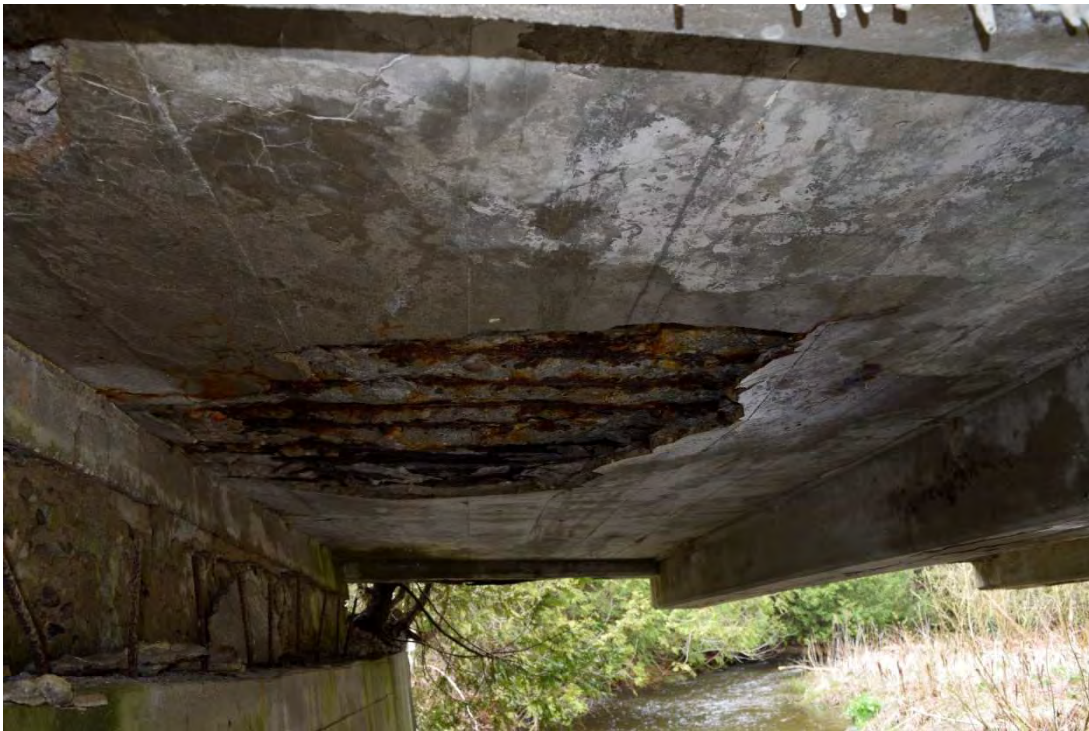
**FIGURE 28: BRIDGE 7-E, EXAMPLE OF THE UNDERSIDE OF STRUCTURE, SHOWING EXPOSED AND UNSUPPORTED REBAR IN BOTH THE BRIDGE DECK AND THE ABUTMENT WALL**

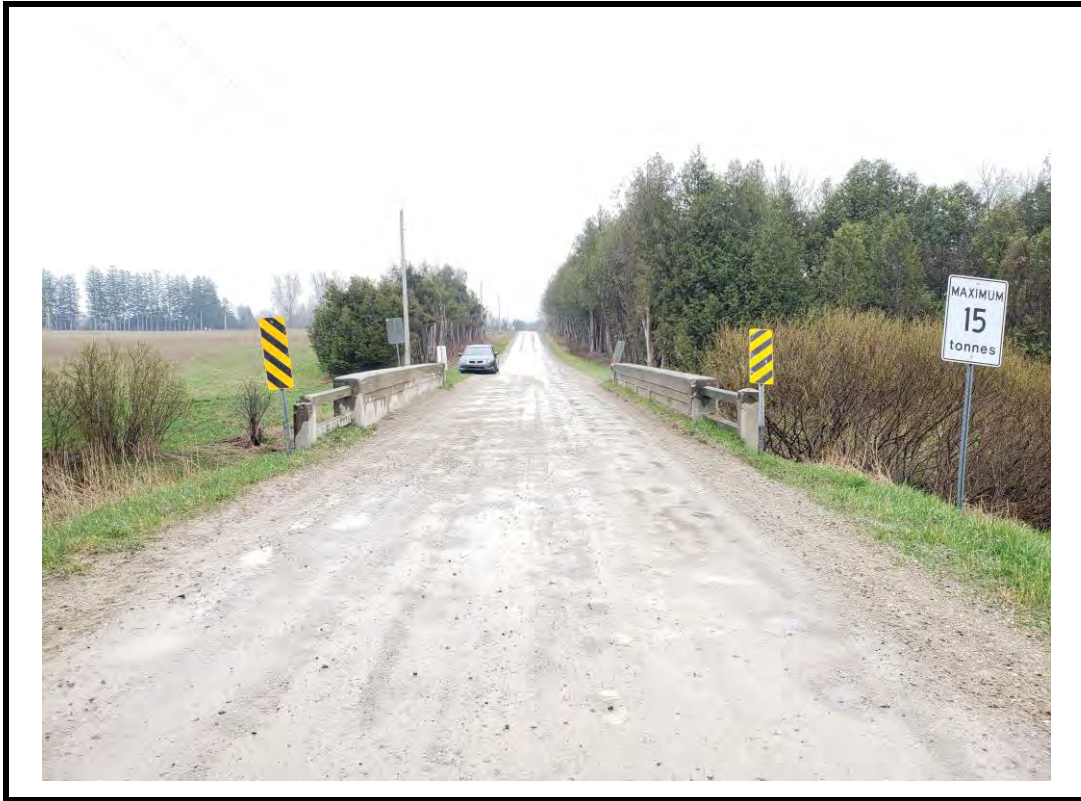
Photo 1 Structure from north approach

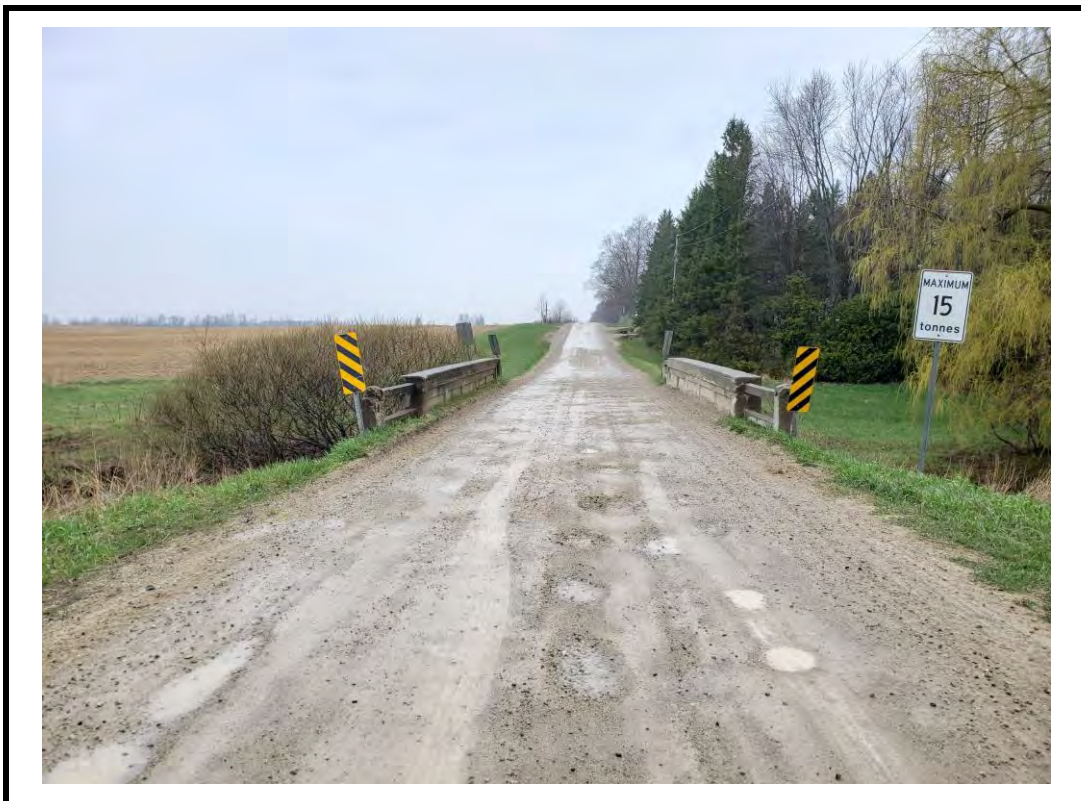
Photo 2 Structure from south approach

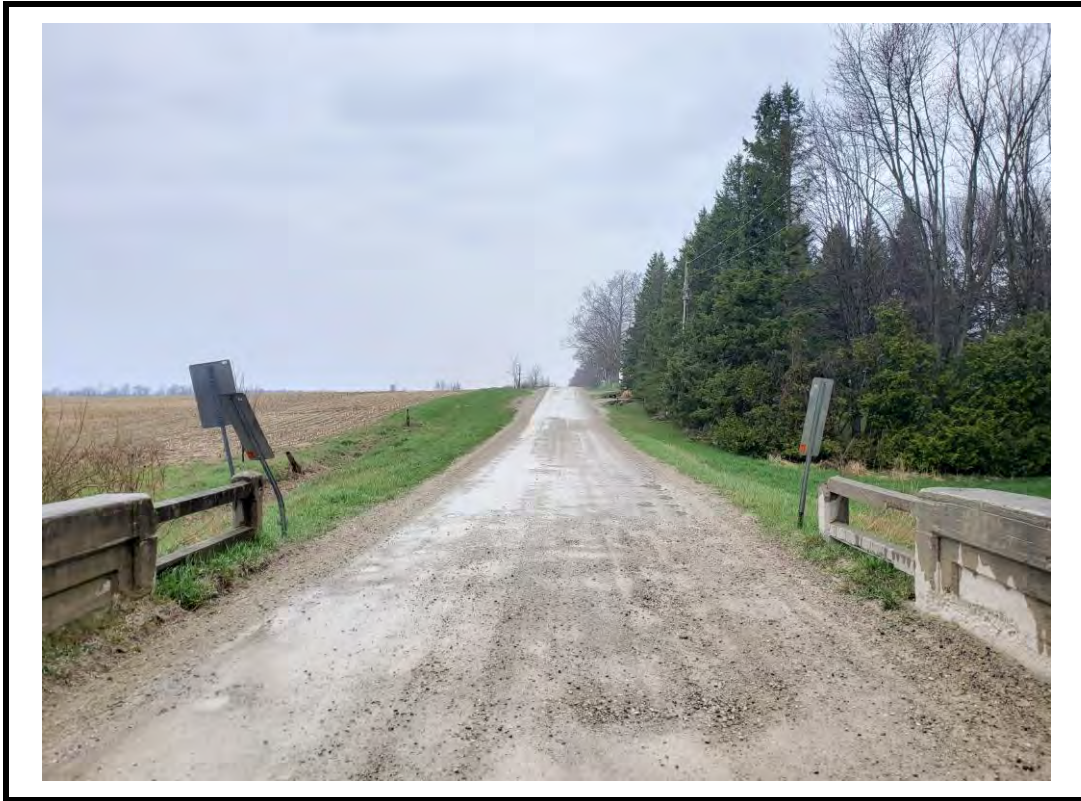
Photo 3 North approach from centre of structure

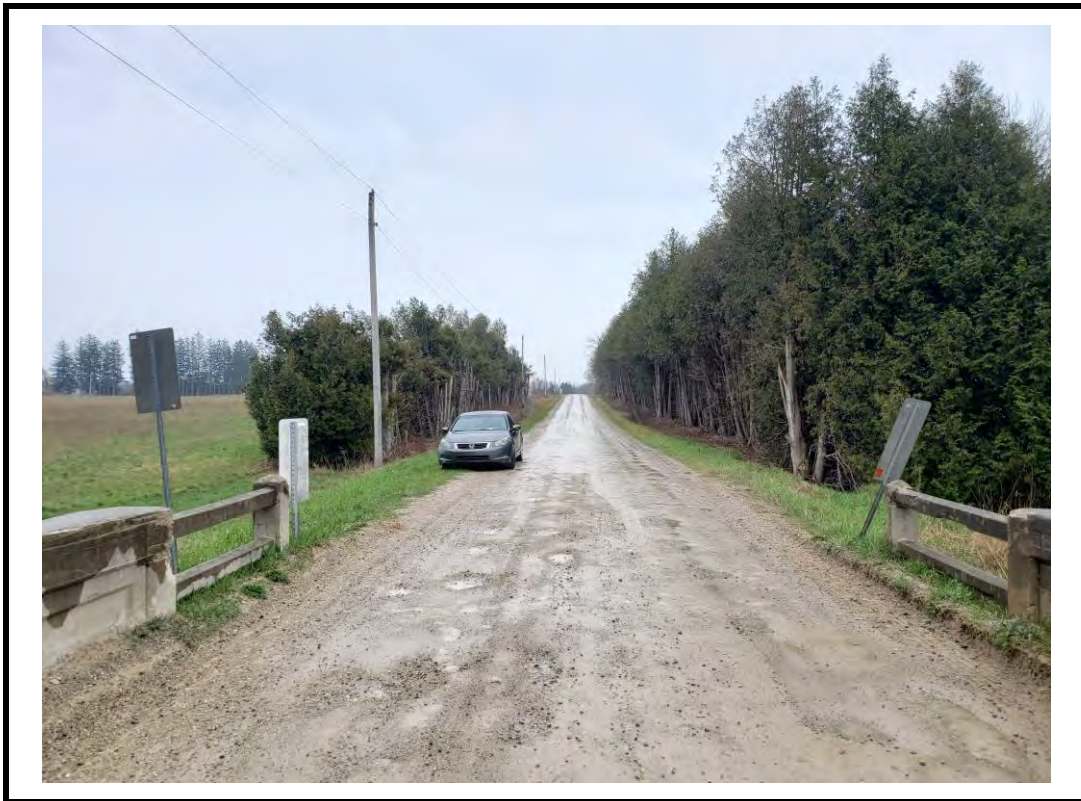
Photo 4 South approach from centre of structure

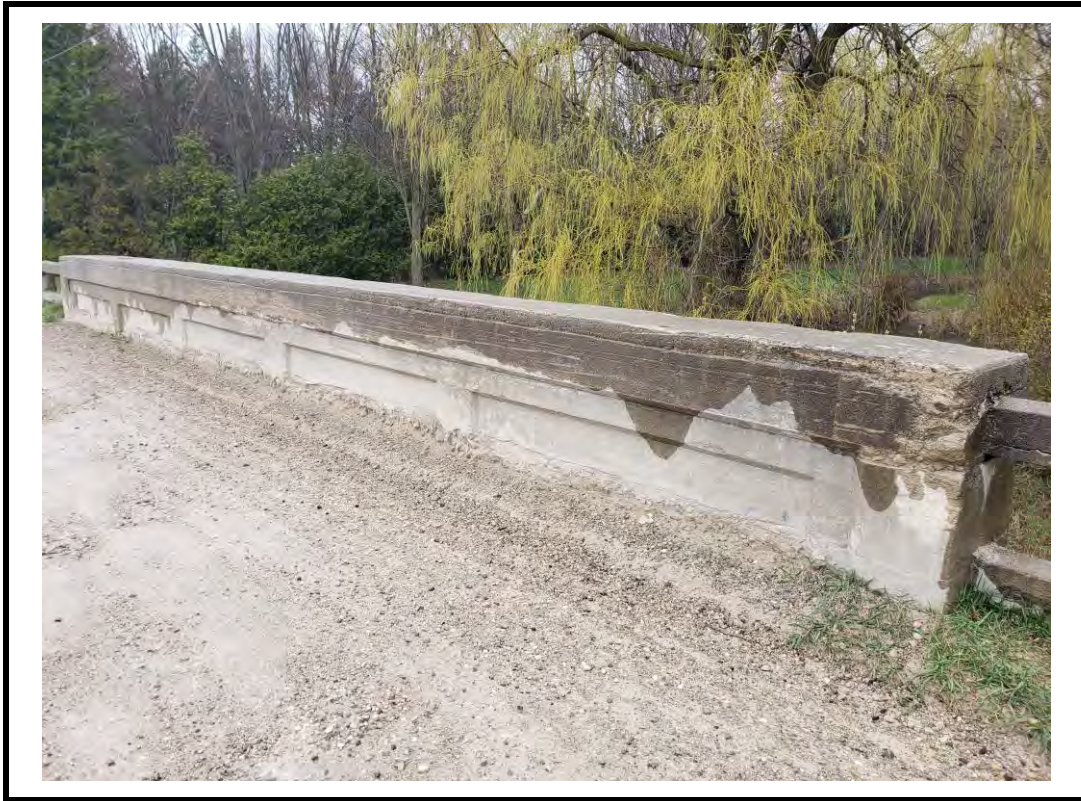
Photo 9 Interior face of west parapet wall

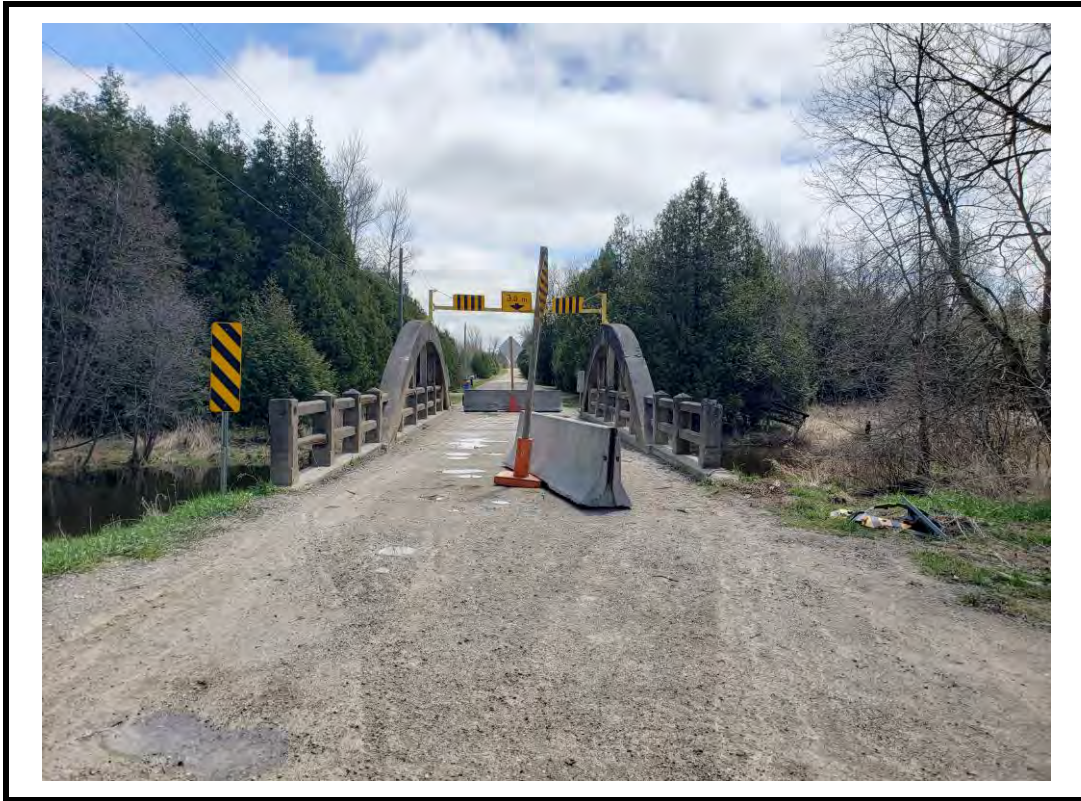
Photo 1 Structure from north approach
