# Cultural Heritage Evaluation Report, Municipal Class Environmental Assessment, Bridges 2-WG, 3-E, 5-E and 7-E, Township of Centre Wellington, Ontario

**Project Number:** 2024-0053

**Report Date:** August 19, 2024

**Parslow Heritage Consultancy Inc.**

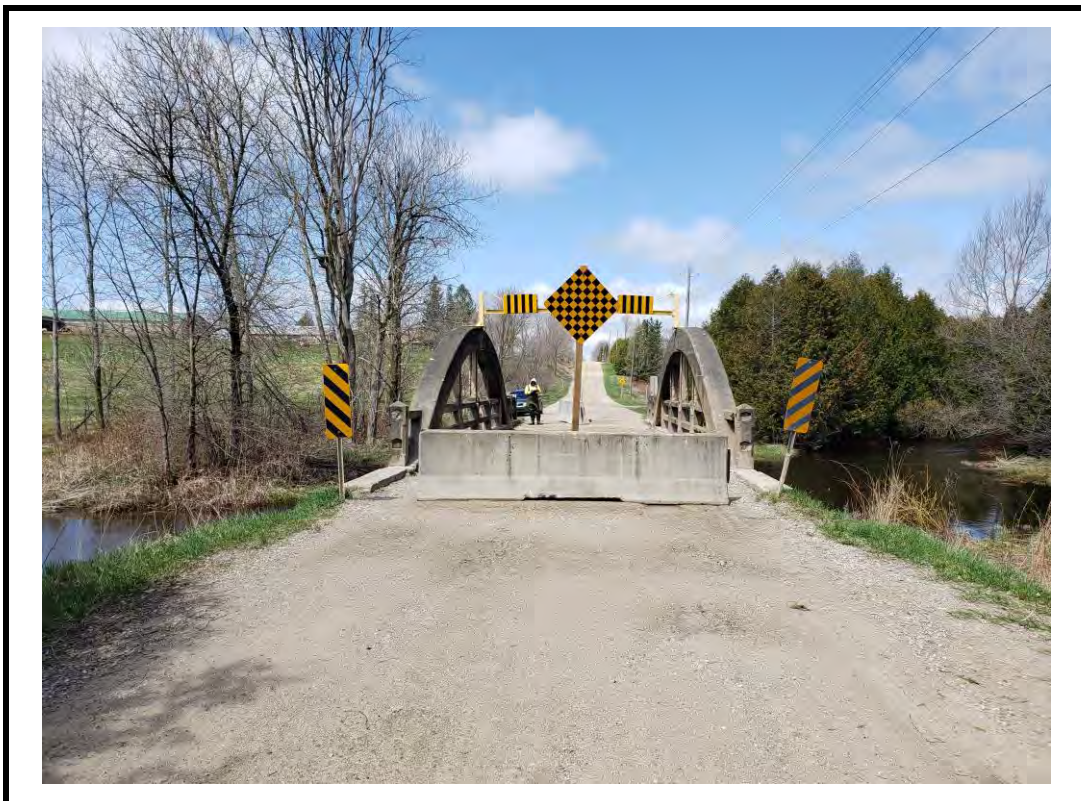
Photo 2 Structure from south approach

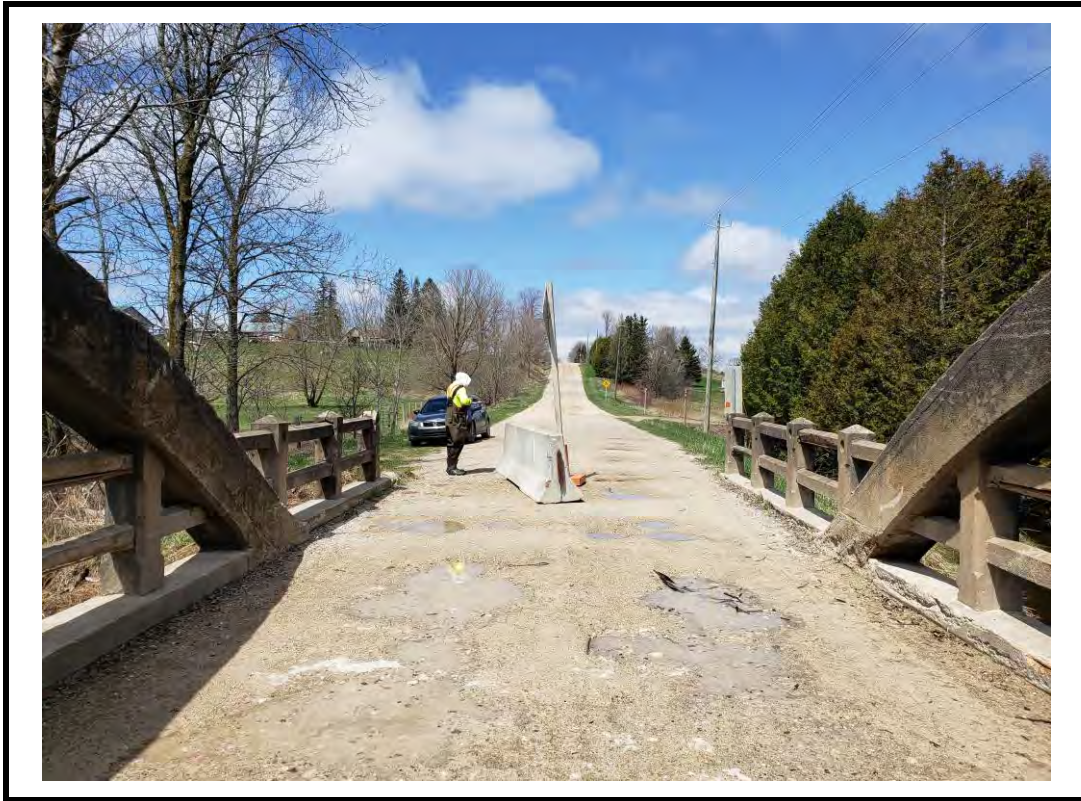
Photo 3 North approach from centre of structure

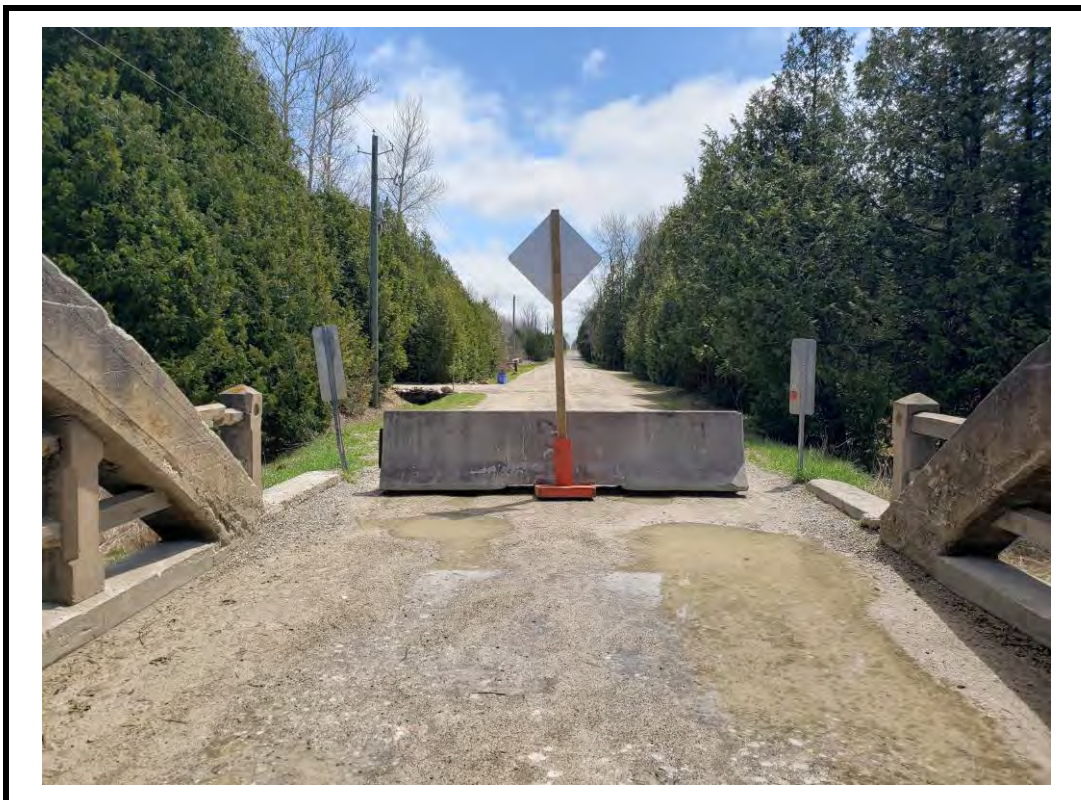
Photo 4 South approach from centre of structure

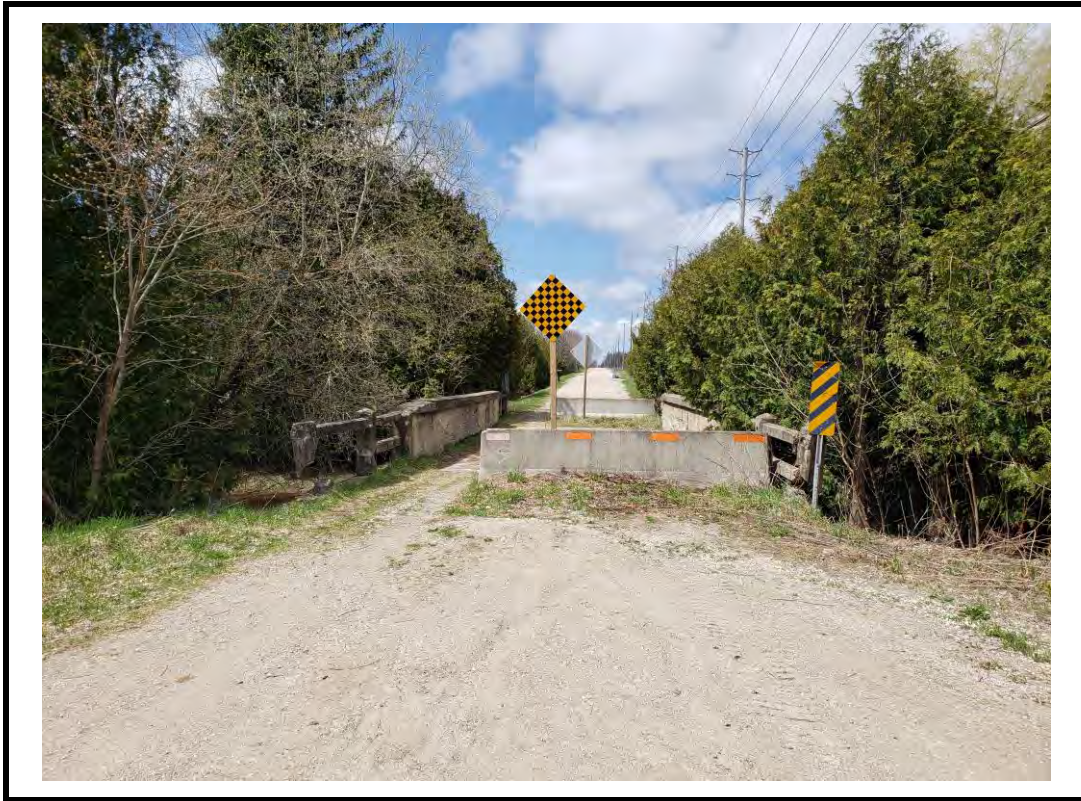
Photo 1 Structure from north approach

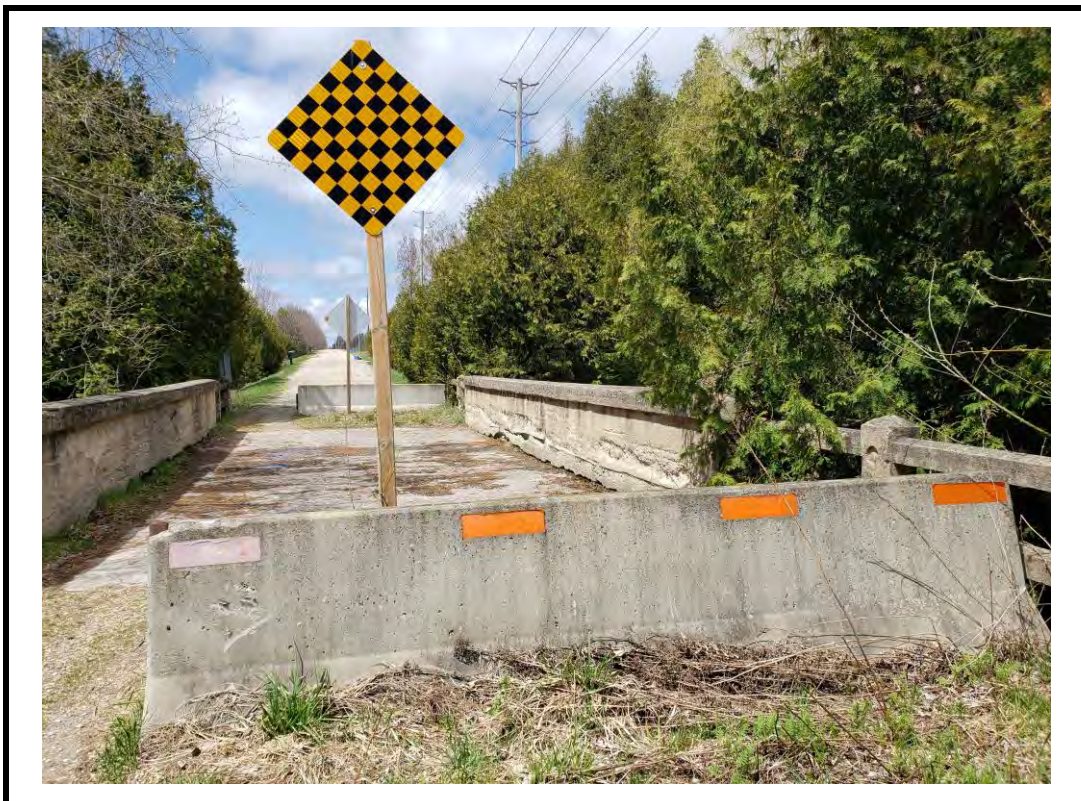
Photo 2 Structure from south approach

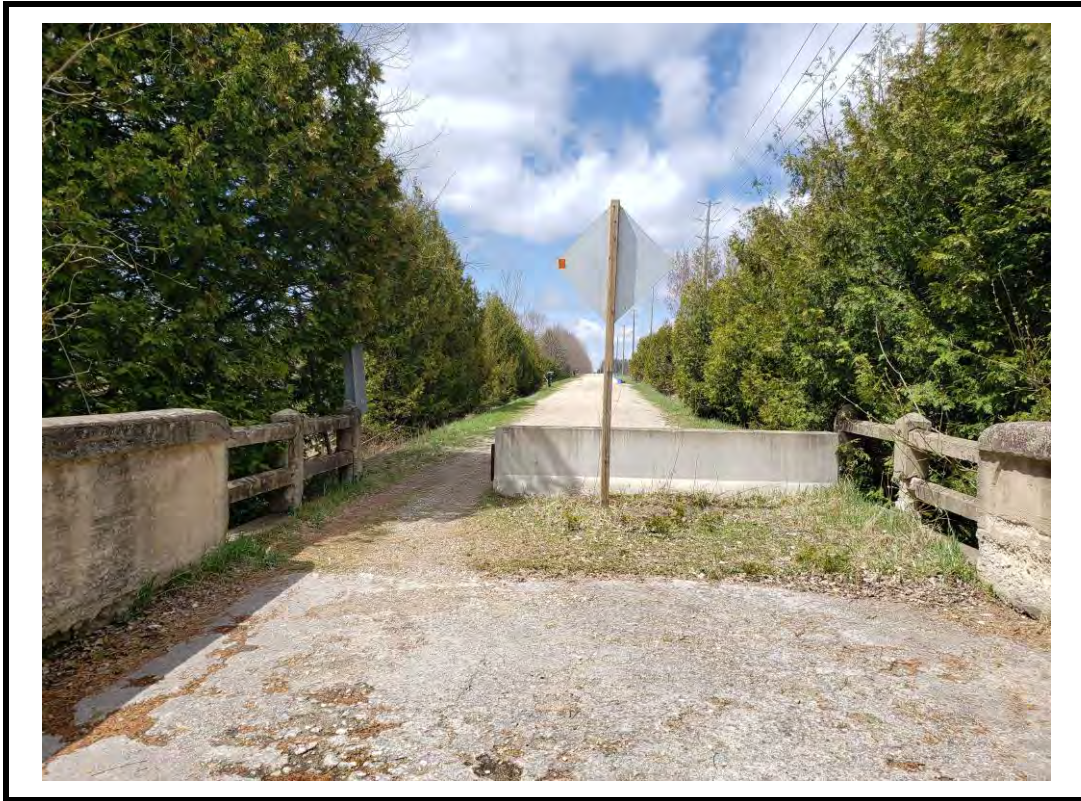
Photo 3 North approach from centre of structure

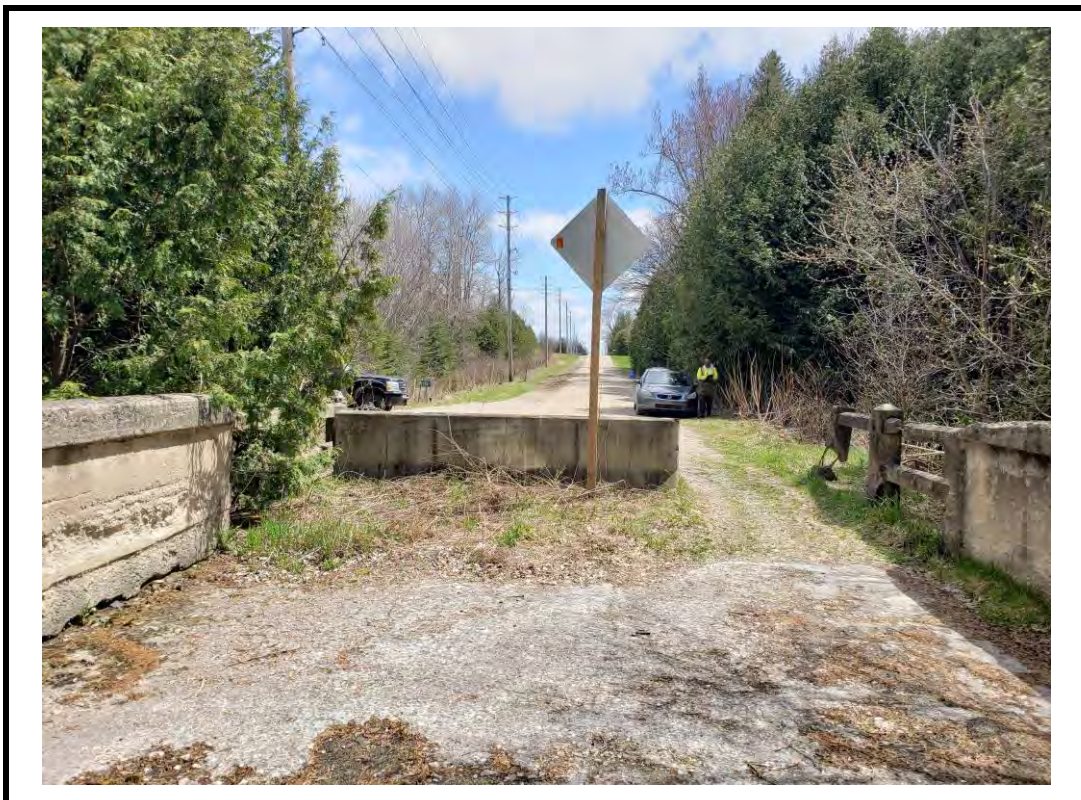
Photo 4 South approach from centre of structure

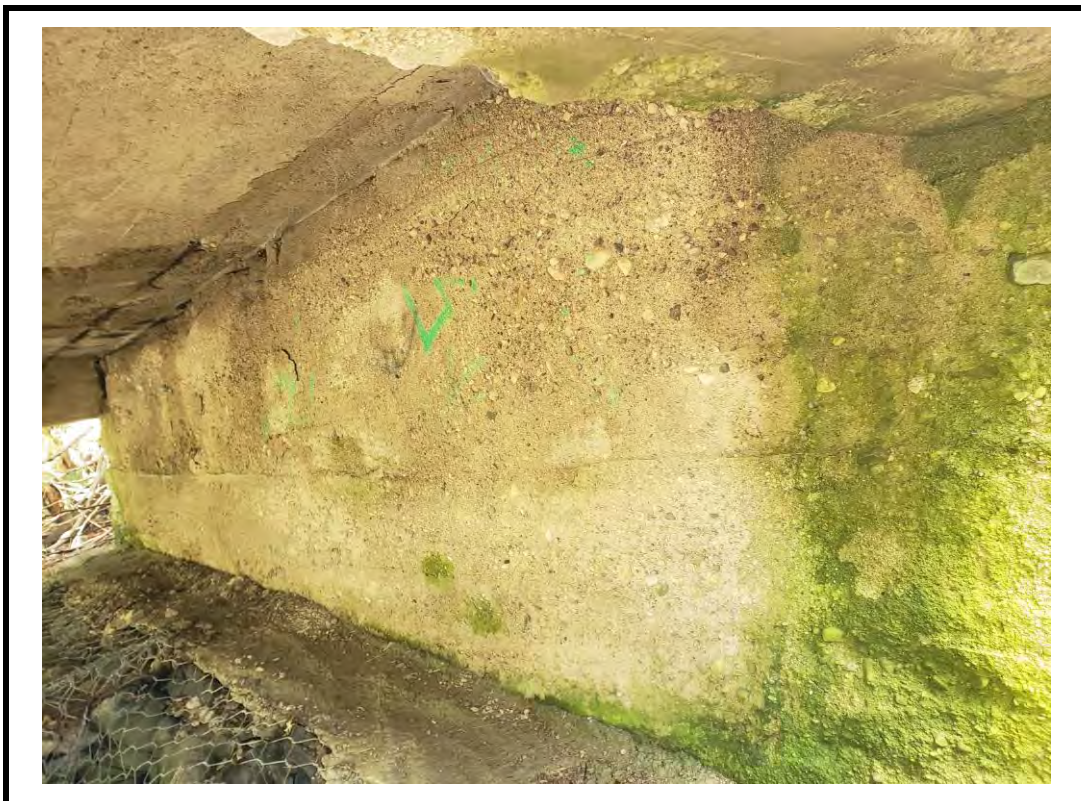
Photo 14 South abutment wall

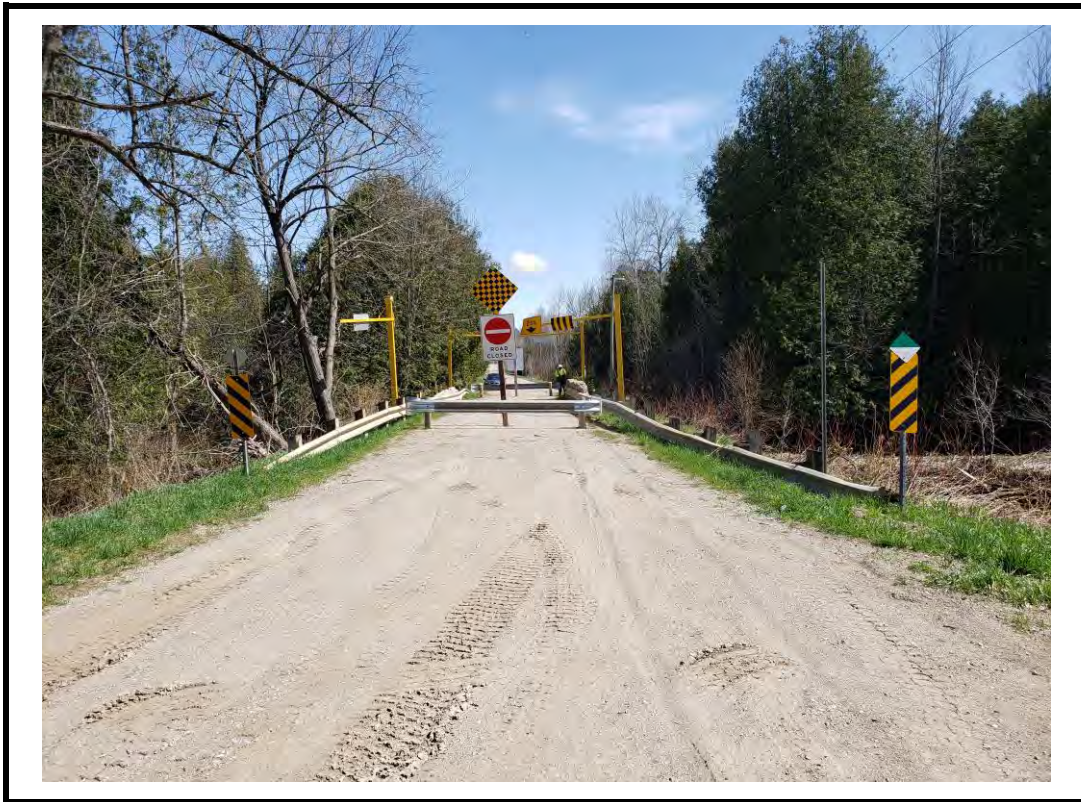
Photo 1 Structure from north approach

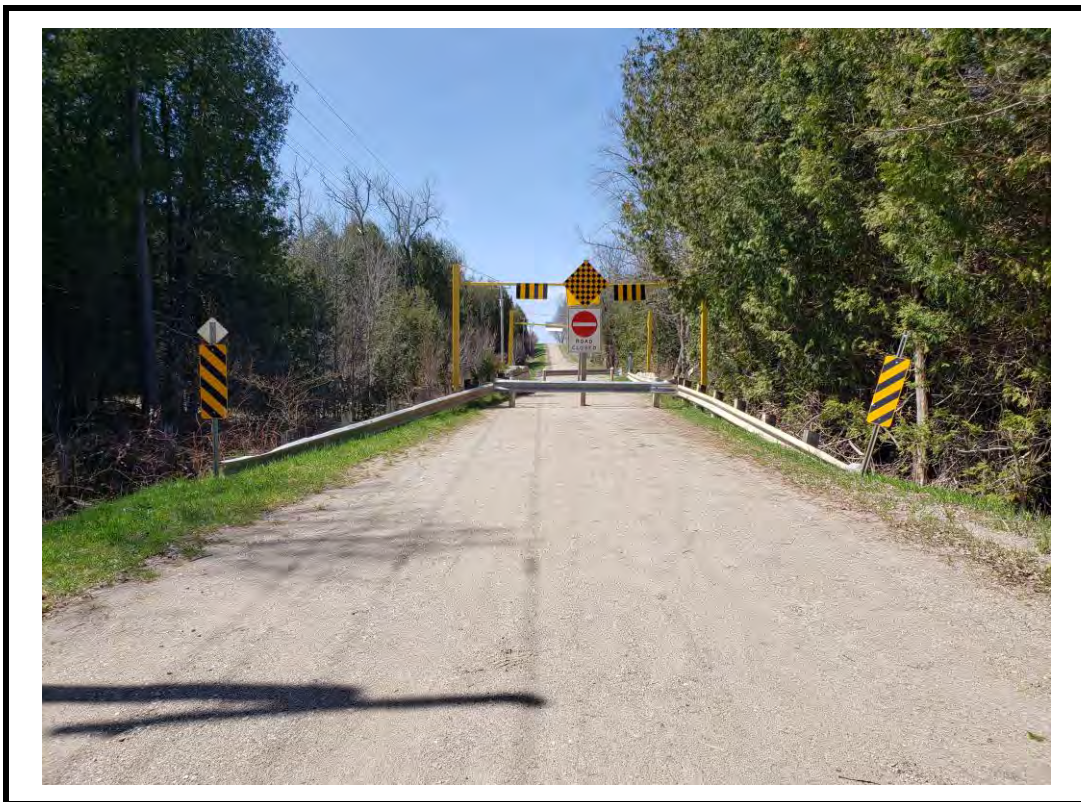
Photo 2 Structure from south approach

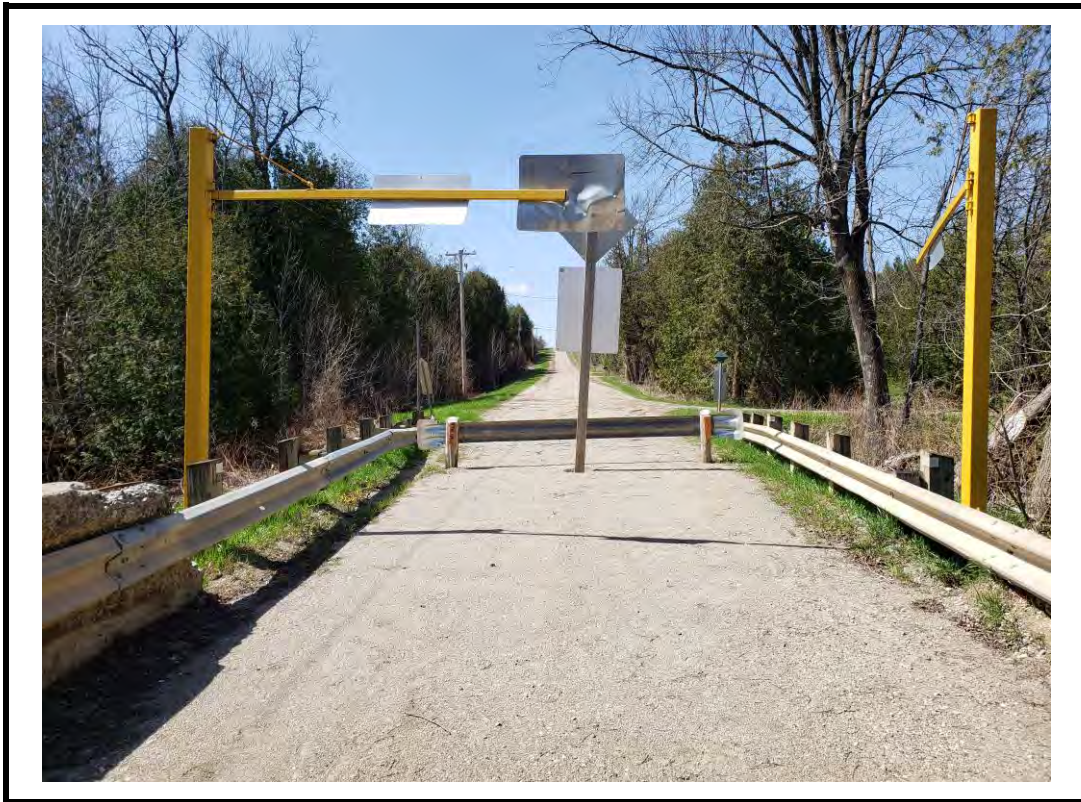
Photo 3 North approach from centre of structure

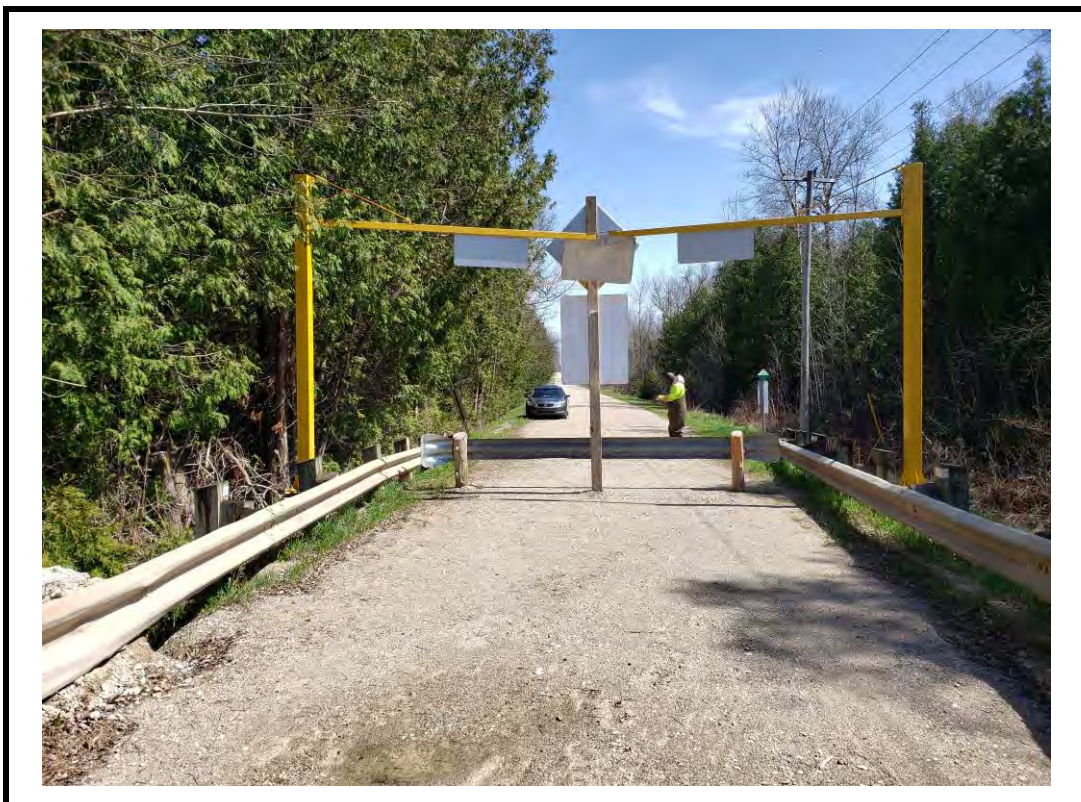
Photo 4 South approach from centre of structure
