# Cultural Heritage Evaluation Report, Municipal Class Environmental Assessment, Bridges 2-WG, 3-E, 5-E and 7-E, Township of Centre Wellington, Ontario

**Project Number:** 2024-0053

**Report Date:** August 19, 2024

**Parslow Heritage Consultancy Inc.**

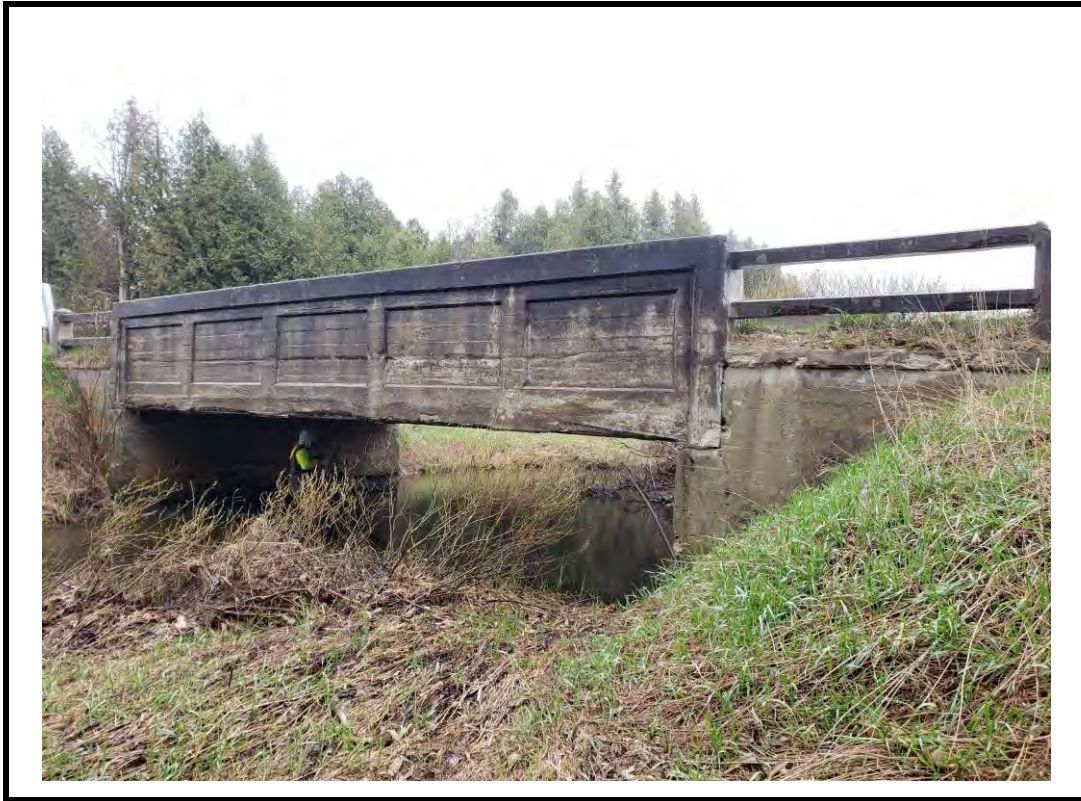
Photo 5 East elevation

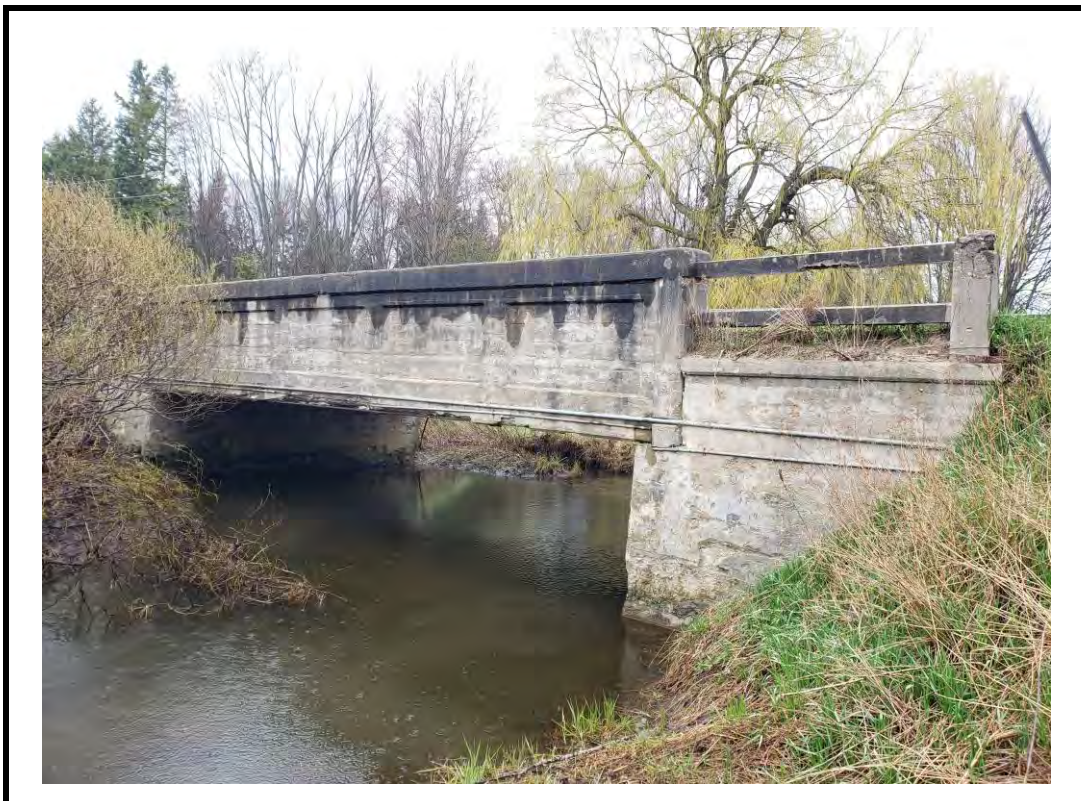
Photo 6 West elevation

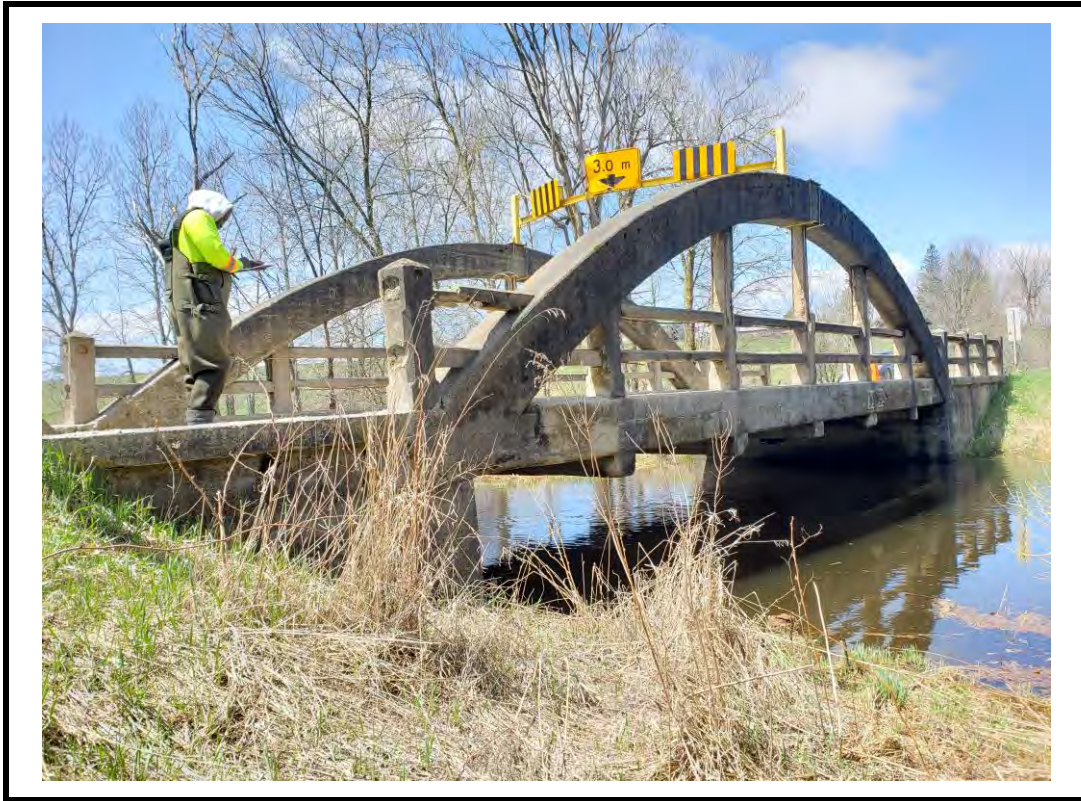
Photo 5 East elevation

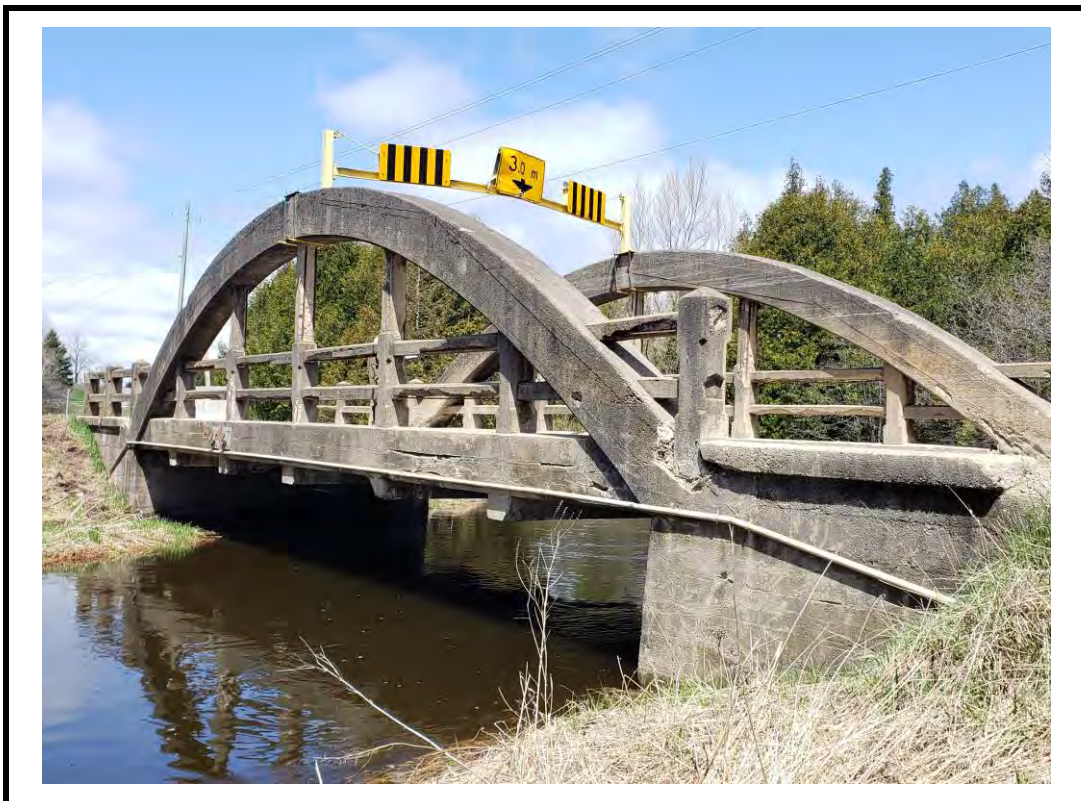
Photo 6 West elevation

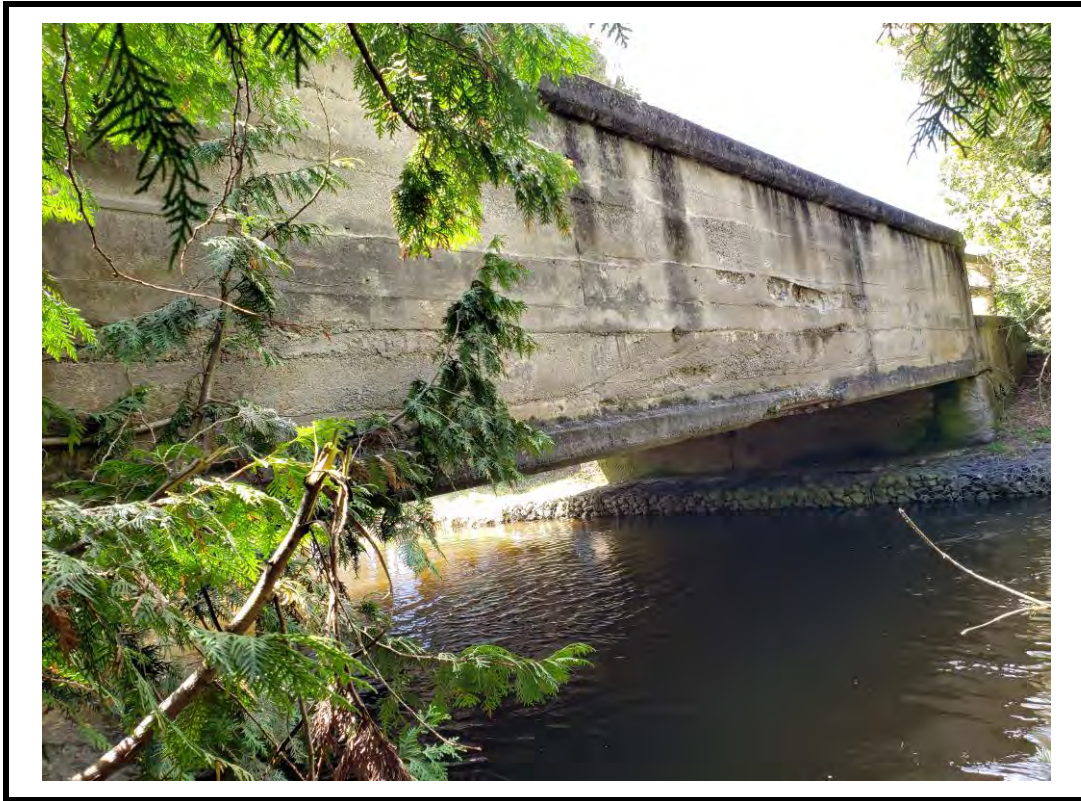
Photo 5 East elevation

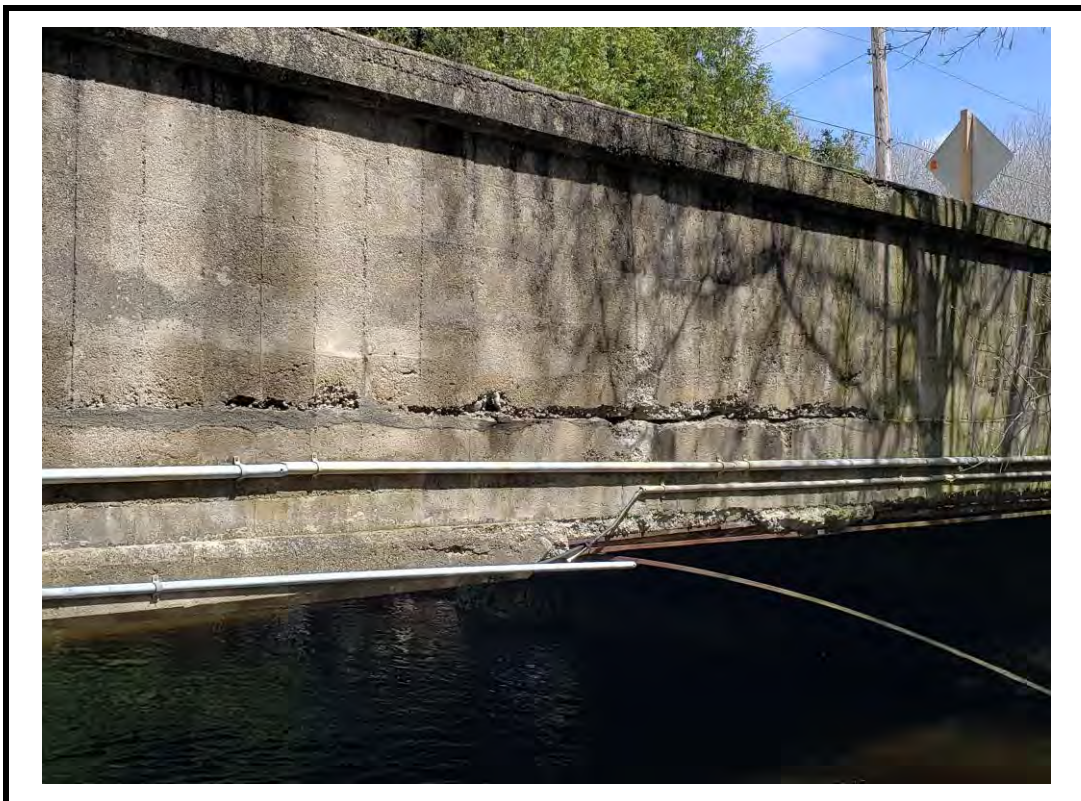
Photo 6 West elevation

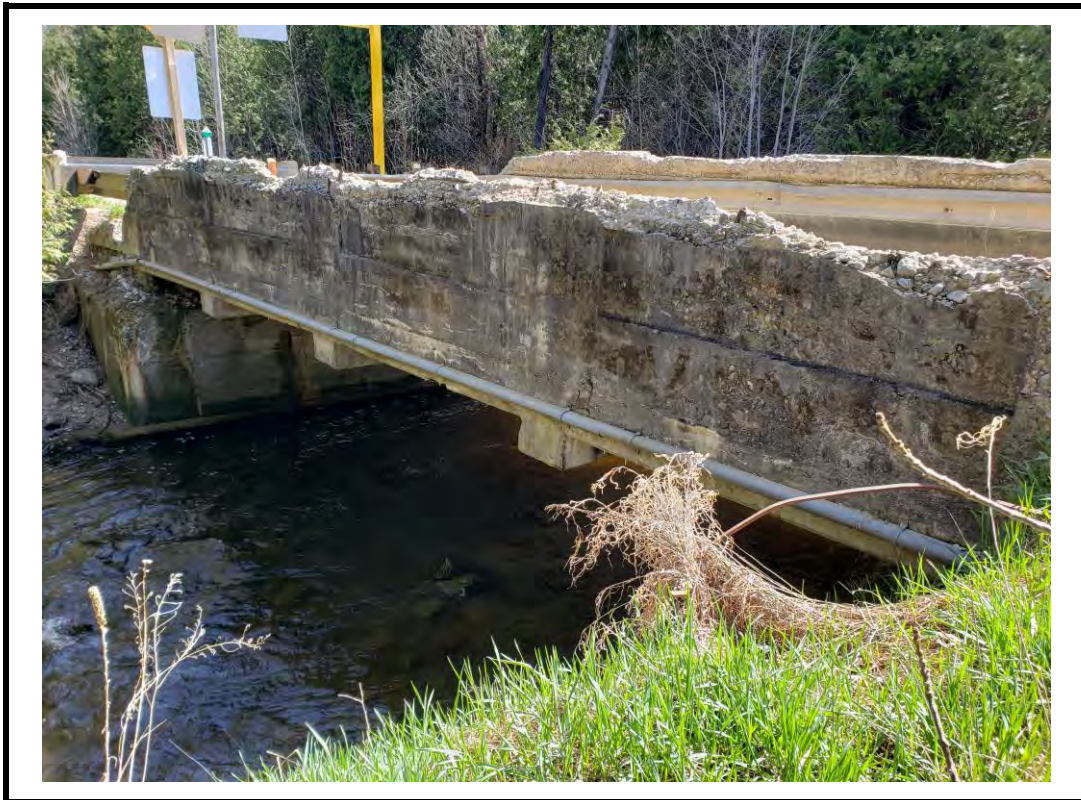
Photo 5 East elevation

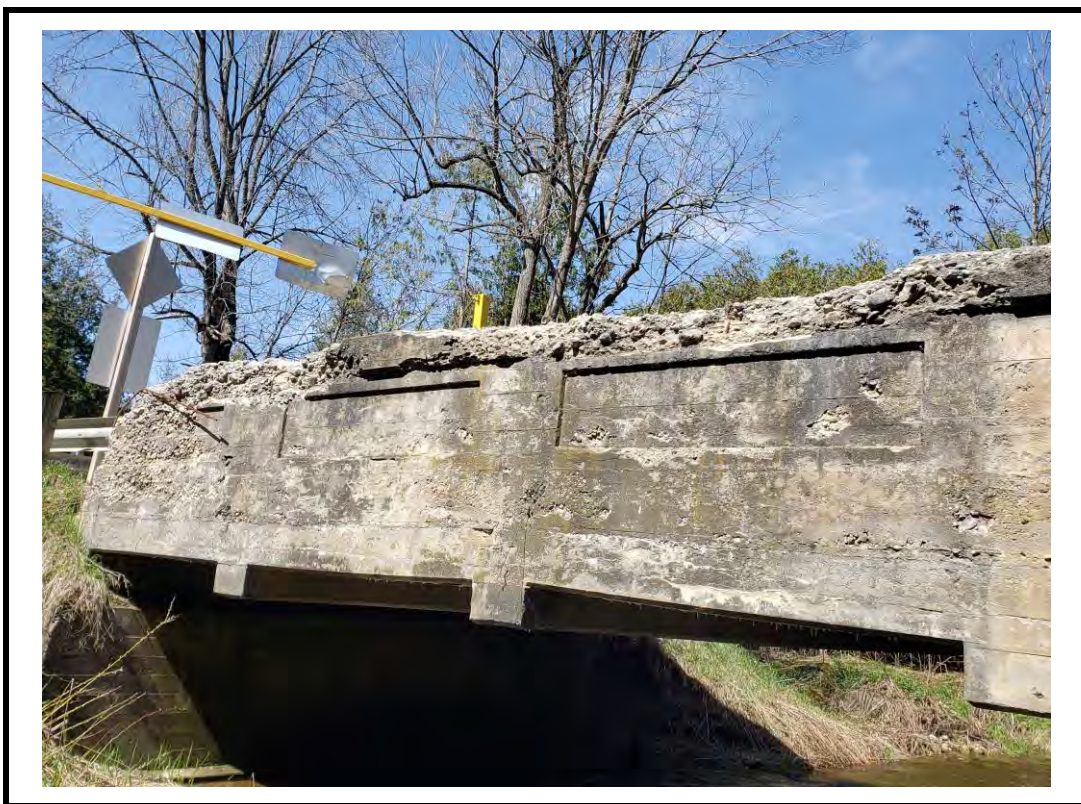
Photo 6 West elevation
